Aircraft Accident Investigation Report

PT. Merpati Nusantara Airlines

Casa 212-200; PK-NCN

Rar Gwarma Airport, Dobo, Aru Archipelago

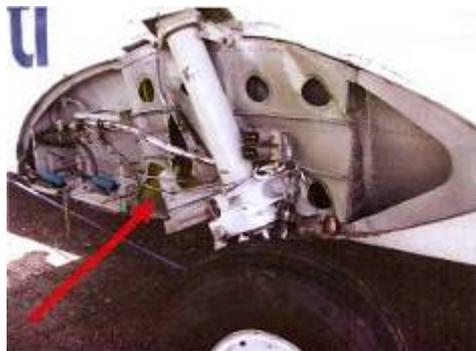
The attachment structure of the left main landing gear was broken and the landing gear moved rearward.

Figure 1: Landing strut shifted backward

The impact of the left main landing gear to the mound has result the left main landing gear shifted backward and out of centre. This condition has result the aircraft veered of to the left during landing on runway 23.

The rubber marks found on the runway 23, showed the mark of the left main wheel was wider than normal, this showed that the left main landing gear has been shifted backward and out of centre.

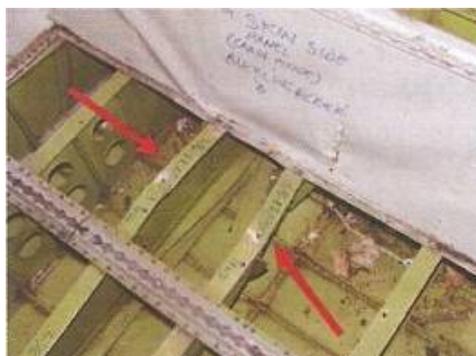
1. Mounting structure of the left landing gear broken.
2. Skin around of handle structure of the left landing gear wrinkled.
3. Frame number 8 bent to backward.
4. Frame number 9 bent backward.
5. Lower skin part in around frame 8 wrinkled and some rivets were detached.

Figure 2: Frame number 8 bent to backward

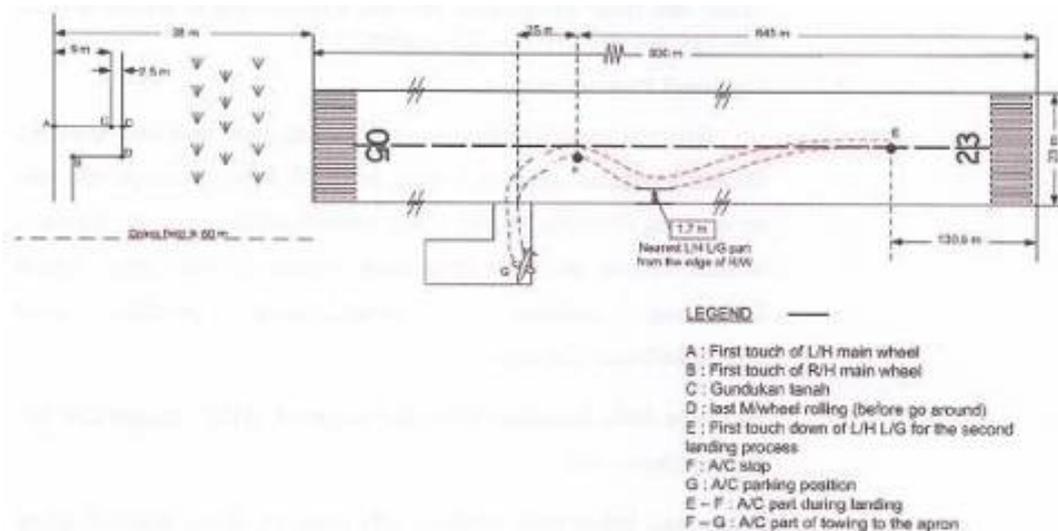
Figure 3: Sketch of accident (not for scale)

The investigation found 8 meters marks of main landing gear started from 38 meters before beginning of runway 05. There was a mark of left main landing gear hit a mound with 25 centimeters high 2.5 meters long. The mark of the main landing gear was end at the mound. These marks showed that the aircraft has become airborne (aborted landing).
