DATA SUMMARY

Date and time	Wednesday, 14 March 2012; 20:15 UTC
Site	Barcelona El Prat Airport (Spain)

Registration	EI-DEA
Type and model	AIRBUS A320-200
Operator	Air Lingus

REPORT

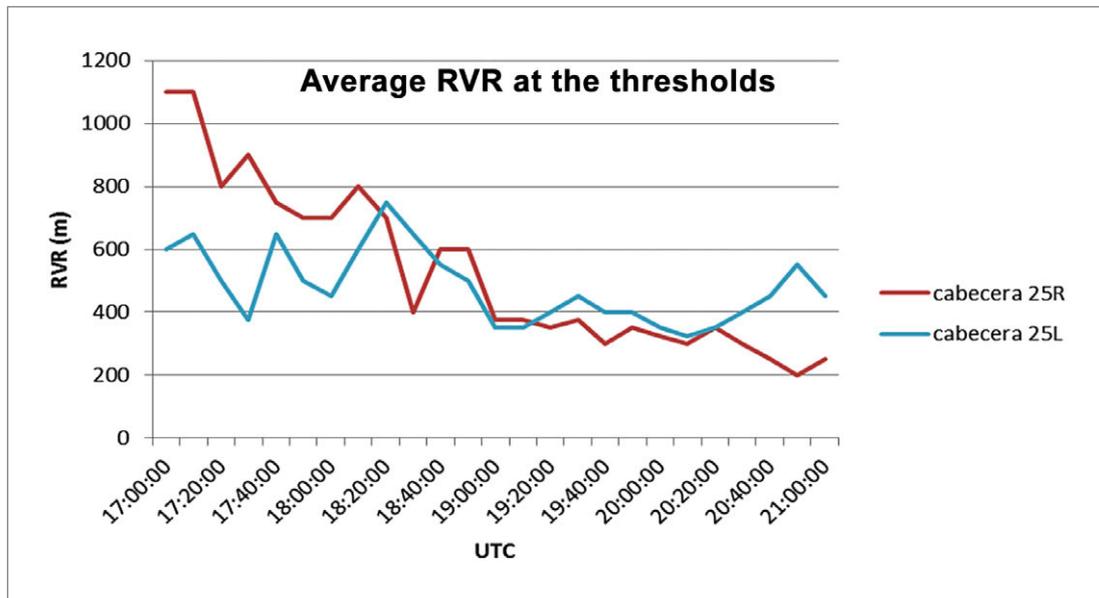
Figure 1. Trend in RVR for both runways on the evening of the incident

The trend in RVR measured and recorded by airport equipment at the runway 25R and 25L thresholds over the course of the evening is shown in Figure 1.

The aerodrome observation reports published at 19:30 and 20:30 indicated values of 325 m and 300 m, respectively, for the 25R threshold.
