**DATA SUMMARY**

Date and time	<b>Tuesday, 28 November 2007; 14:25 local time</b>
Site	<b>Asprella, Elche (Alicante)</b>

Registration	<b>EC-FOA</b>
Type and model	<b>EUROCOPTER AS 350 BA</b>
Operator	<b>TAF Helicopters</b>

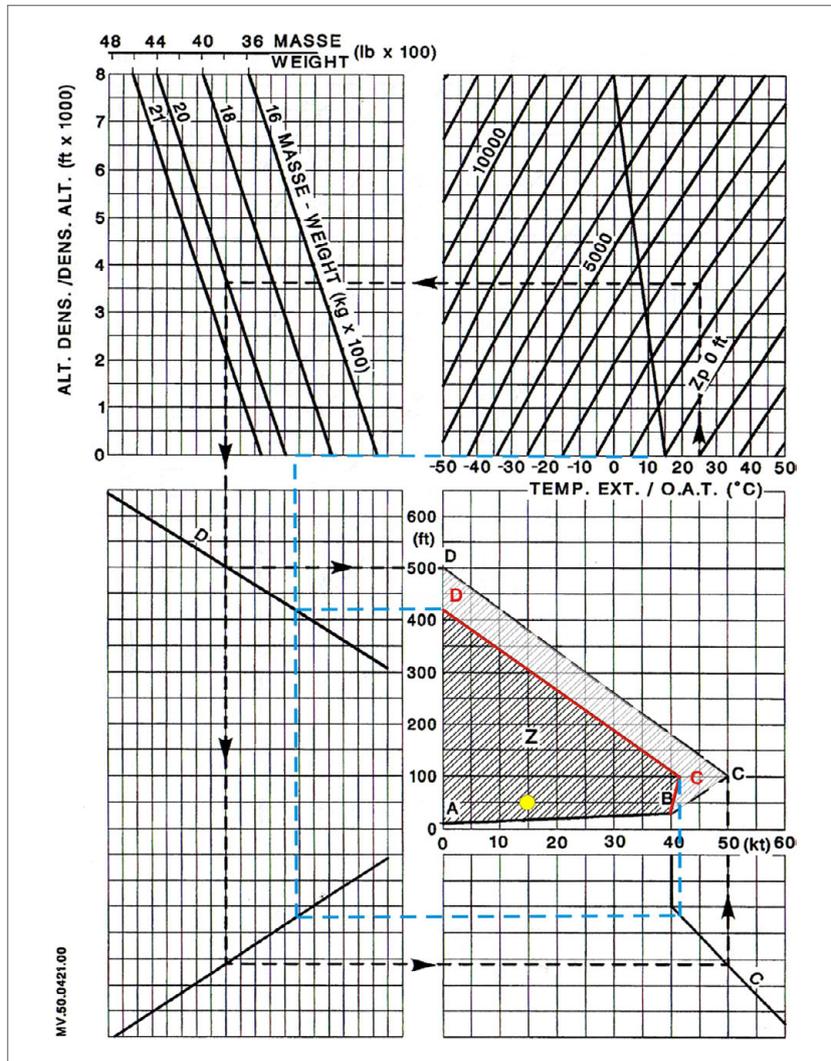
Figure 1. Height-velocity chart

Using these data and the graphs in the aircraft’s flight manual, the restricted area was calculated, as shown in Figure 1 and defined by points A and B (fixed) and C and D (variable, in red).

At the time of the engine stoppage, the aircraft was at an height of 50 ft. It had a very low translational speed since it was decelerating in preparation for hovering, being the speed estimated of 15 kt. With these data the point where the aircraft was flying at that time is shown in Figure 1 by a yellow circle. As shown, under these conditions the aircraft was flying inside the shaded, restricted area.

It can also be deduced from the chart that, given the conditions that existed on the day of the accident, the minimum hovering height was 425 ft.

As shown in Figure 1 (height-velocity chart) included in Section 1.6.5, practically the entirety of the flight to inspect the power line was conducted inside the unsafe area of the height-velocity chart.

Operating outside this area requires a combination of height-velocity such that flying at the height of the cables would require a speed of at least 40 kt, and hovering would require a minimum altitude of 425 ft.

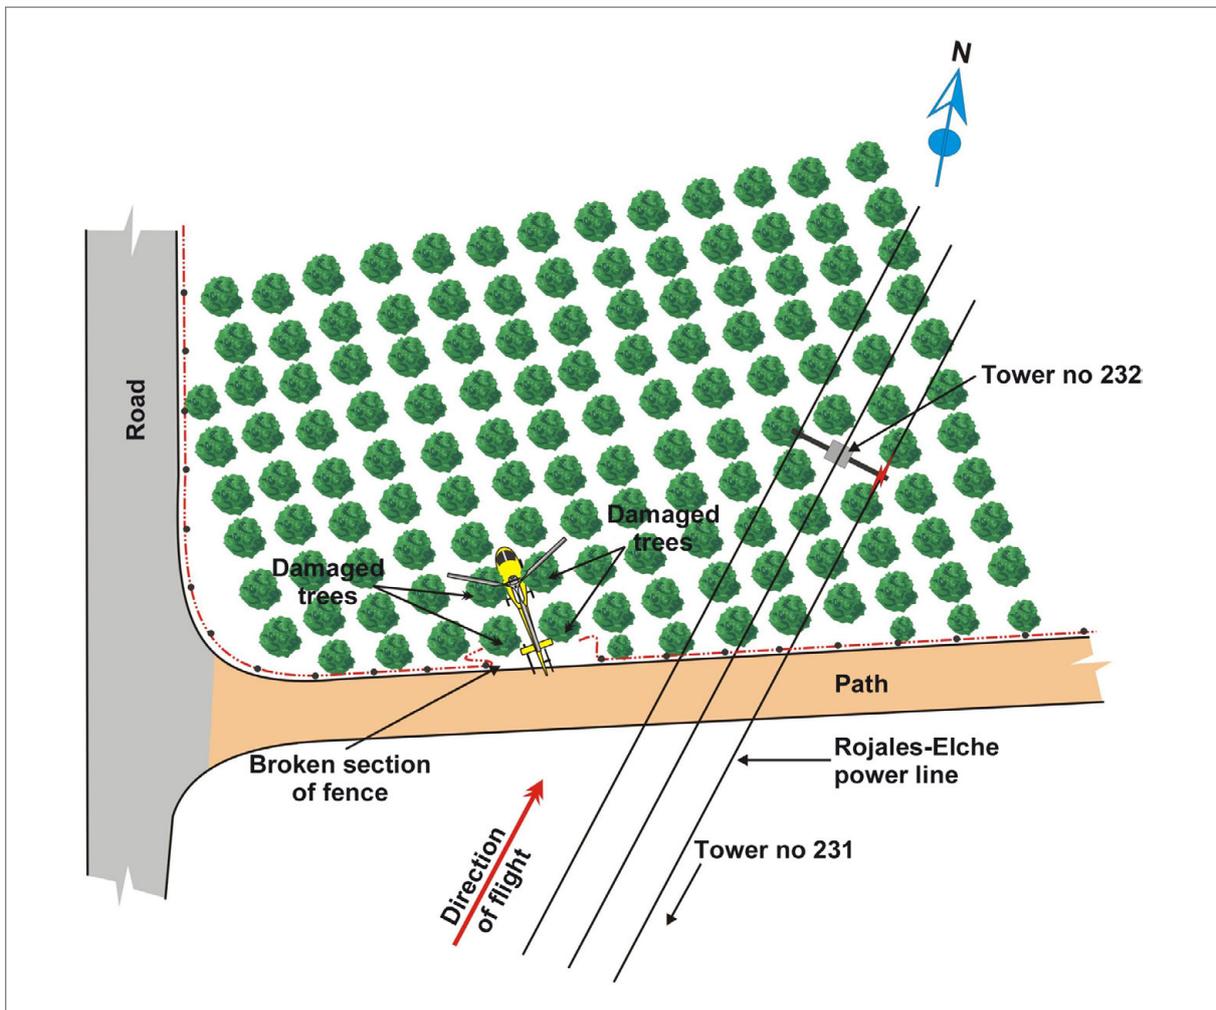
Figure 2. Sketch of the accident site

As can be seen in Figure 2, the aircraft impacted the ground in a mandarin grove. The aircraft's longitudinal axis was practically aligned with the rows of trees and lay between two of them. The aft part of the aircraft's tail protruded slightly outside the limits of the grove.

The aircraft wreckage was some 9 m away from the nearest cable of the Rojas-Elche power line that was being inspected. Its longitudinal axis was at a 25° angle with the power line.
