DATA SUMMARY

Date and time	Saturday, 14 April 2007; 10:15 local time
Site	Casas de los Pinos Aerodrome (Cuenca)

Registration	EC-JOE
Type and model	PILATUS PC-6 B1-H2 Turbo Porter
Operator	Aerobalas

1. FACTUAL INFORMATION

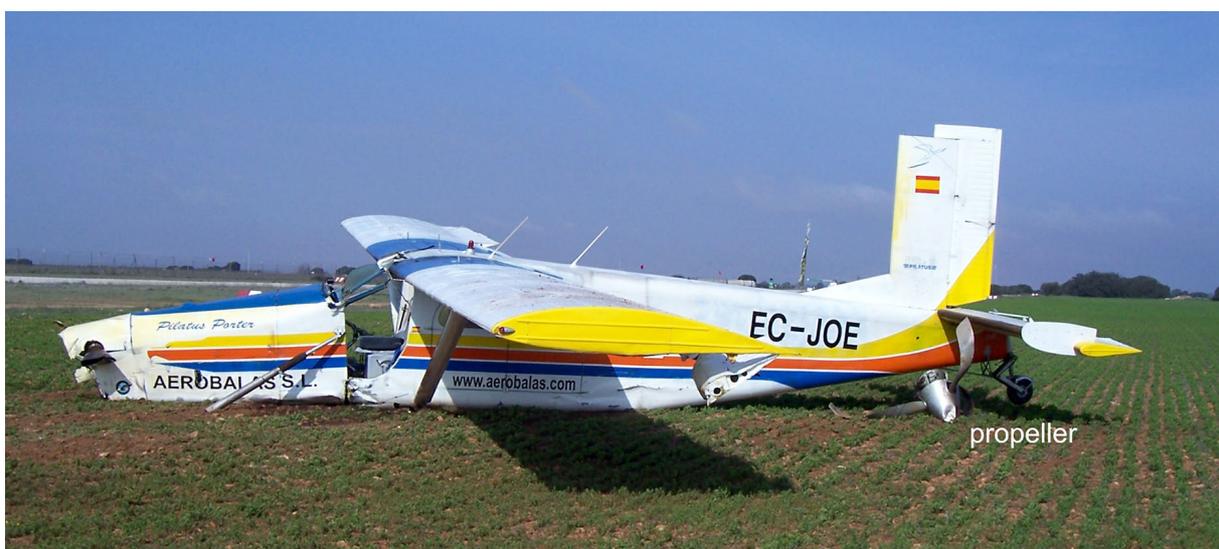
Figure 1. Final condition of the aircraft

The aircraft ended up 25 m from the edge of the runway on a heading of 190°, resting on its lower fuselage, which was damaged along its underside, as were the left aileron and the horizontal stabilizer. The right main landing gear was bent outward, the left gear had detached and was 30 m away from the aircraft, and the propeller had detached at the reduction gearbox and was next to the aft landing gear to the left of the aircraft.

- **Tail section:** the rudder had an impact mark on its lower outside corner, where it had struck the horizontal stabilizer. The elevator was bent downward as a result of the impact. The horizontal stabilizer actuator was cracked and had detached from its lower housing toward the front of the aircraft, indicative of deceleration.
- **Wings:** the left aileron was cracked due to the impact from the wing's left counterweight, which was dragged along the ground and subsequently detached. The flaps were retracted.

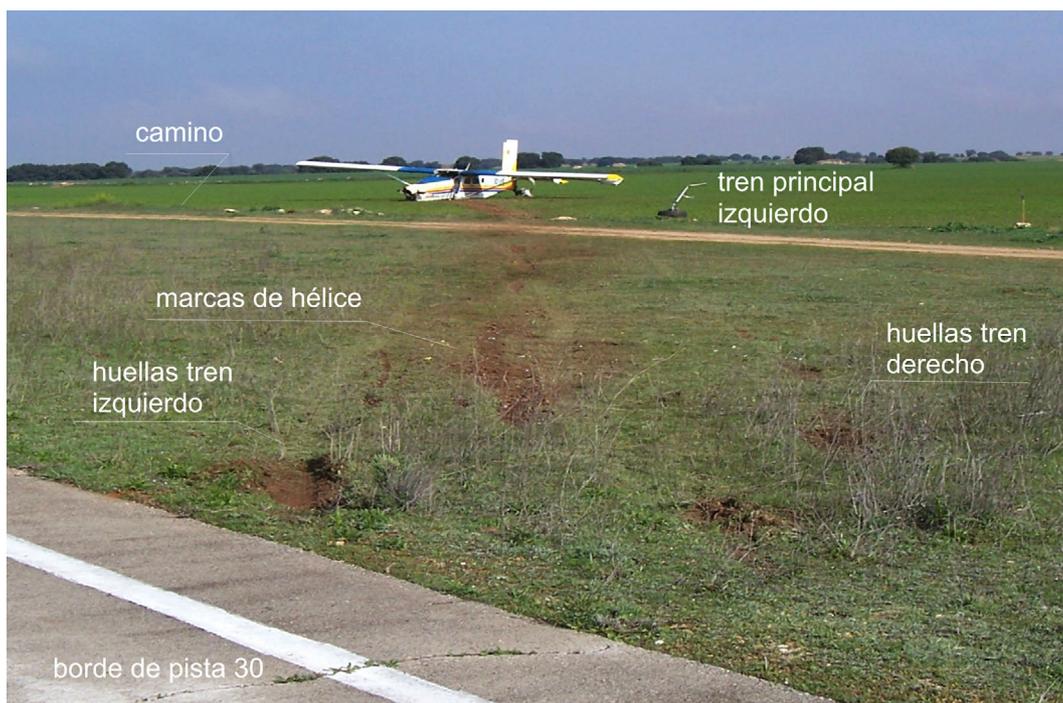
Figure 2. Marks and final aircraft resting place

The aircraft departed the runway at about a 30° angle, leaving marks on the ground with its propeller, main landing gear and fuselage. After traversing 50 m, the aircraft veered left before finally coming to a stop on a heading of 190°.

The tracks left by the aircraft were located outside the runway, in an area of hard, flat ground, and traced out a straight line up to the point where the aircraft made its last turn before coming to a stop. The first marks on the ground were from the main landing gear, and indicate that the gear kept its integrity following the runway excursion and that the impact to the left gear was greater than that to the right. The subsequent separation of the tracks in excess of the design distance between them suggests that the collapse of the right gear and the detachment of the left must have taken place within the first 25 m following the impact. A comparison of the tracks left by the landing gear and the fuselage indicates that the aircraft exited the runway while sliding slightly to the left.

The fuselage marks were more evident in the final 25 m, a single drag mark being noticeable until the final turn, at which point it split in two, with the engine marks on one side and the marks from the rest of the fuselage on the other. As the propeller detached, it left three deep grooves in the ground in the area where the aircraft turned left before coming to a stop.
