**DATA SUMMARY**

Date and time	<b>Thursday, 28 June 2007; 15:00 UTC<sup>1</sup></b>
Site	<b>Belsierre (Huesca)</b>

Registration	<b>PH 1213</b>
Type and model	<b>SCHEMPP-HIRTH FLUGZEUGBAU DUO DISCUS Glider</b>
Operator	<b>Private</b>

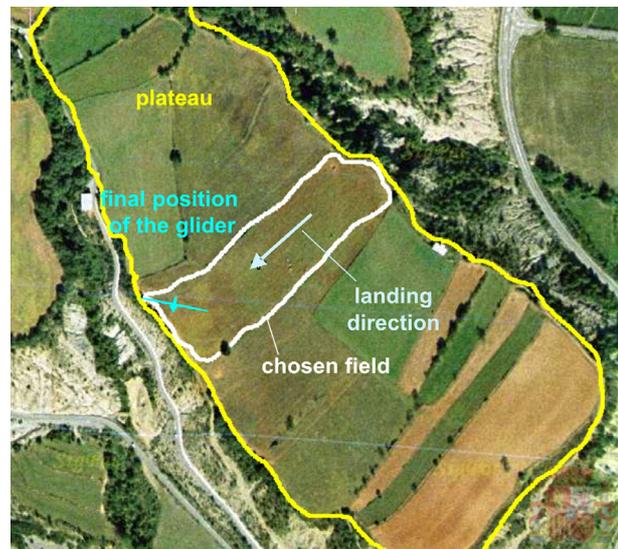
The fields within view were not very long, nor were there any fields which continued onto other fields to make the landing easier. They finally found a field atop a plateau (see Picture 1) that satisfied their requirements. The crew tried using an external

Picture 1. Landing field and surrounding area
