DUTCH  
SAFETY BOARD

# Fatal fall overboard during loading operations

M/V Azoresborg, Bilbao, Spain, 27 February 2013

*The Hague, May 2014*

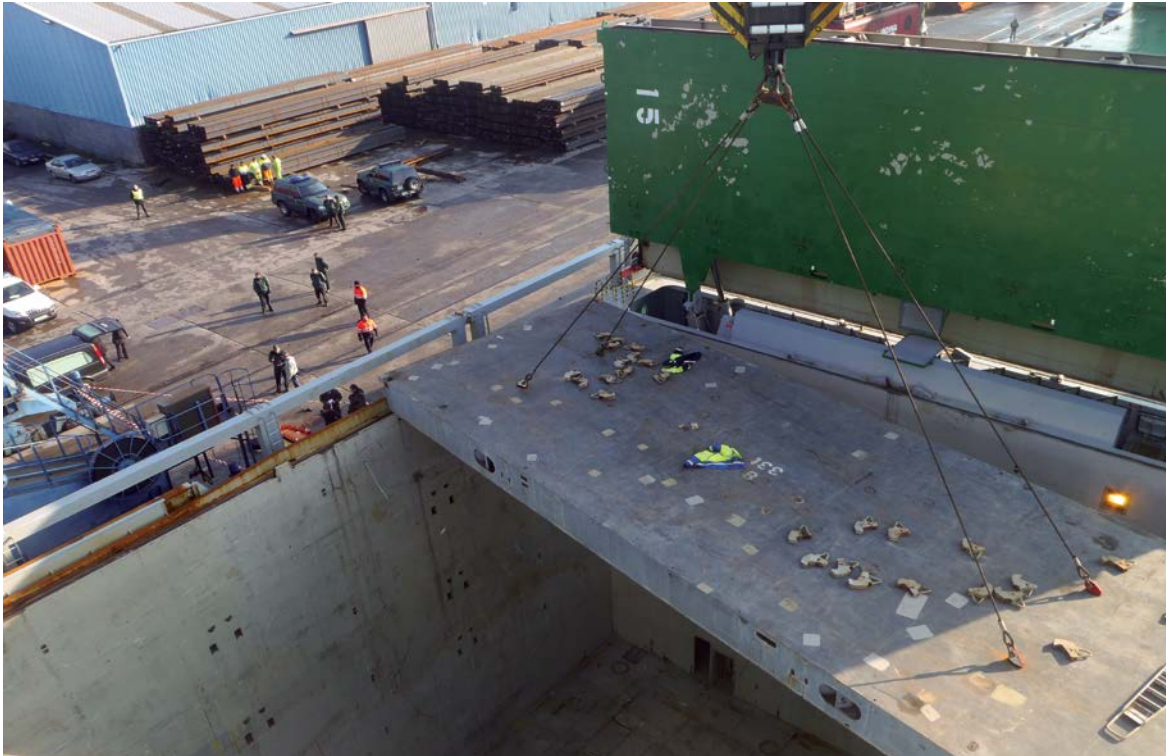
Consoles are usually installed on board the Azoresborg and its sister vessels using a pontoon as a work platform. After placing the consoles that are to be installed on the pontoon, the crew then position themselves between the four hoisting cables, to which they secure themselves with a safety harness (see figure 4).

Figure 4: The pontoon used as a work platform. (Source: Dutch Safety Board)

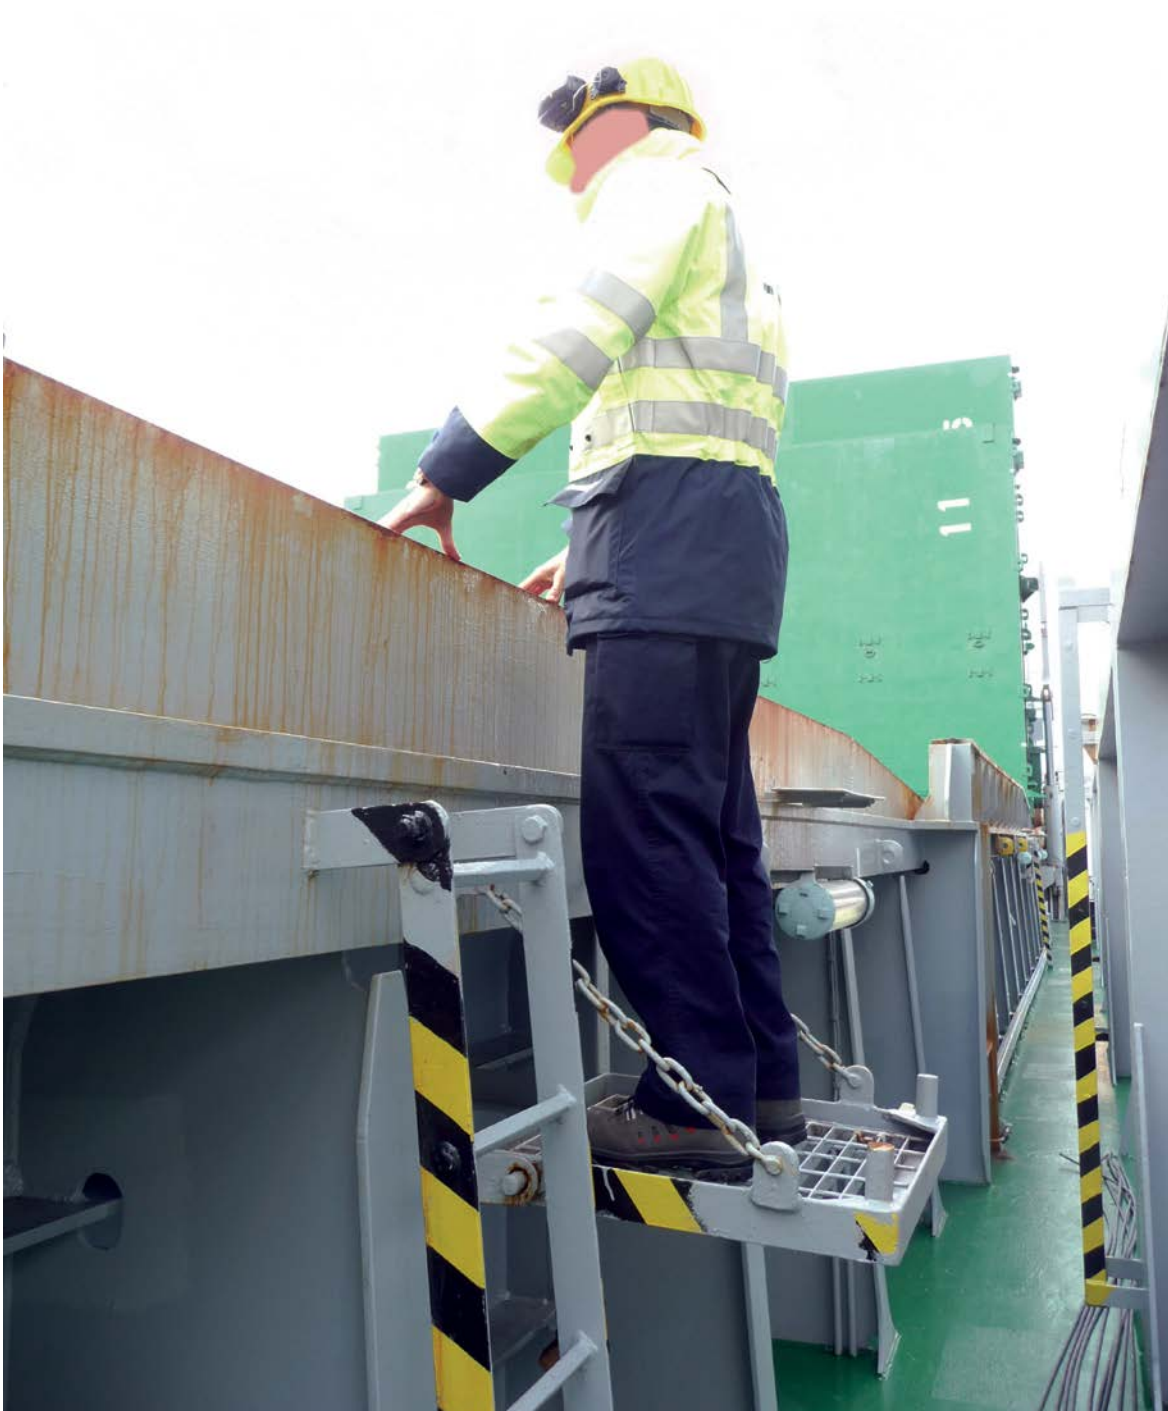
The Azoresborg uses what is known as stevedore platforms to supervise loading and unloading operations from the side opposite to where the ship is being loaded or unloaded (see figure 5). The crew can reach the fold-out platform with a fixed ladder. The platforms contain supports on which detachable fall protection can be installed. None of the platforms had (recently) been equipped with fall protection. This is evident from the fact that none of the platforms, particularly the supports, showed any paint damage. This type of damage inevitably occurs when installing fall protection.

Figure 5: Reconstruction of the position on the stevedore platform. No fall protection had been installed. The platform is located on the aft side of the forward hold. (Source: Dutch Safety Board)

The position and design of the stevedore platform near the ladder made it unsuitable to use for the work carried out. With the removable fall protection installed on the platform, a quick and easy escape would be impossible, once a load would come to close.

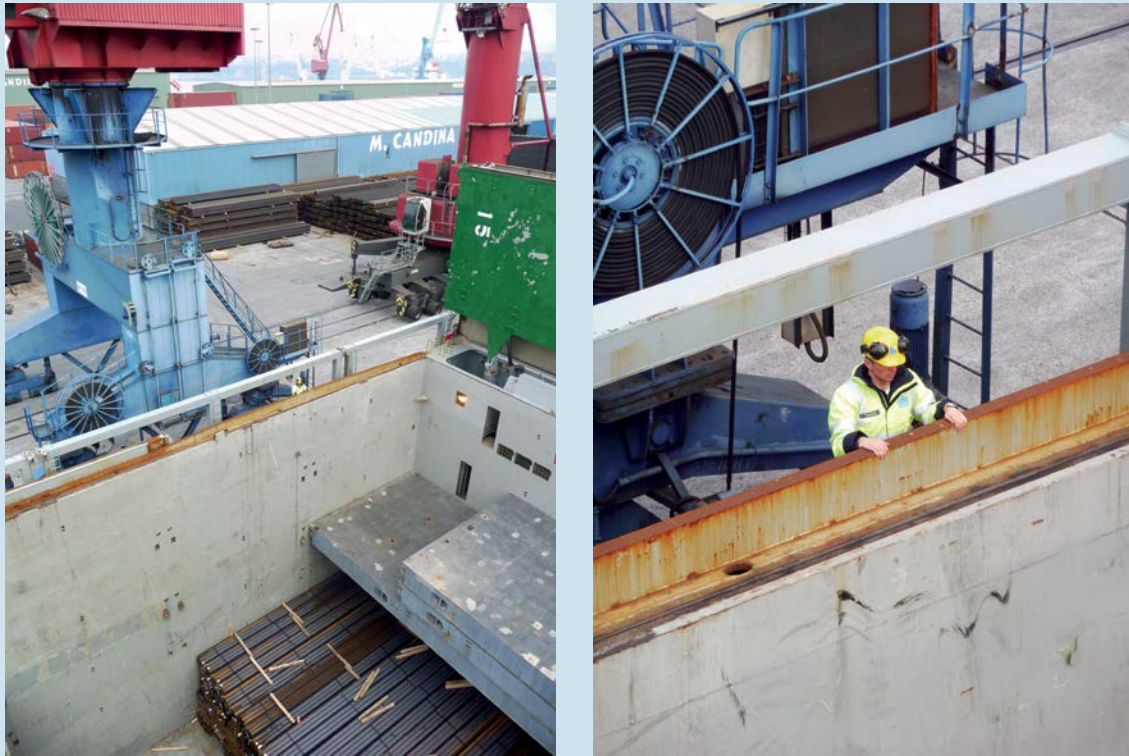
Figure 6: Simulated position of the chief mate on the ladder near the hatch coaming. The person in the photograph is around the same height as the fatally injured chief mate. (Source: Dutch Safety Board)

No one actually saw the chief mate fall. However, in view of the chief mate's position on the ladder, his tasks and the proximity of the moving pontoon, there most probably is a relationship between the fall and the activities performed. It is conceivable that he lost his balance, either because he had been hit by the swinging pontoon, or due to a startle response. The exact direct cause, however, could not be ascertained.

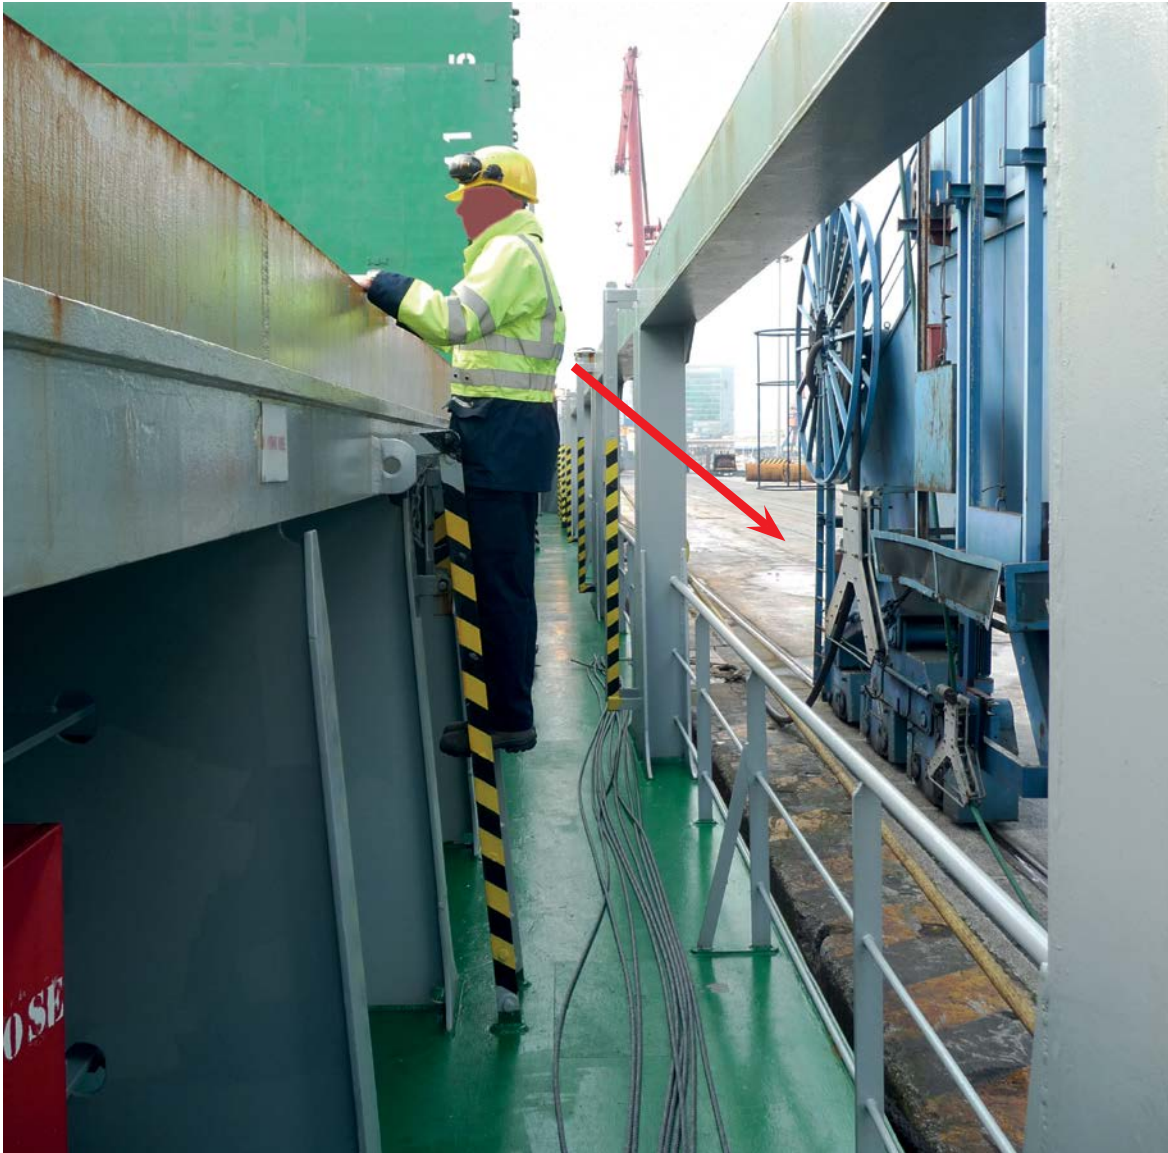
Figure 7: Reconstruction of the chief officer's position and fall. (Source: Dutch Safety Board)

When the chief mate was last seen, he was standing on a ladder at a height of about 80 centimetres. It follows from the witness statement and the autopsy report that the chief mate fell over the railing onto the quay and then ended up between the quay and the vessel. The proximity of the hoisted pontoon and his unstable position on the ladder meant that it was all the more relevant to have effective fall protection in place. However, there was no fall protection. Because the chief mate was standing on a ladder, the height of the railing proved to be insufficient.

According to the Dutch Working Conditions Act 'there is a risk of falling in any event if there are high risk situations, openings in floors or if there is a risk of falling down at least 2.5 metres'.<sup>3</sup> The shipping company only applied the latter criterion in evaluating the risks of the risk of falling. As a result, the risks of falling from a height below 2.5 metres were excluded. While the chief mate was positioned in a vertical line at a height of only 80 centimetres, in view of the narrow width of the gangway and the manner in which he fell overboard from the steep vertical ladder, the railing with a height of about one metre failed to offer effective protection for the tasks being carried out from the ladder.

As a result of the accident, Wagenborg Shipping B.V. emphasized to ships' crews that the person issuing instructions during tweendeck operations must stand in a safe position, where he can maintain visual contact with the crane driver at all times. Before an operation to hoist and shift tweendecks, a leading line should be attached to the pontoon in order to turn it. In June 2013 the shipping company also reiterated the importance of the safety briefing to seamen in its circular *FleetNews*. The accident was discussed in the safety committee on board the Azoresborg.

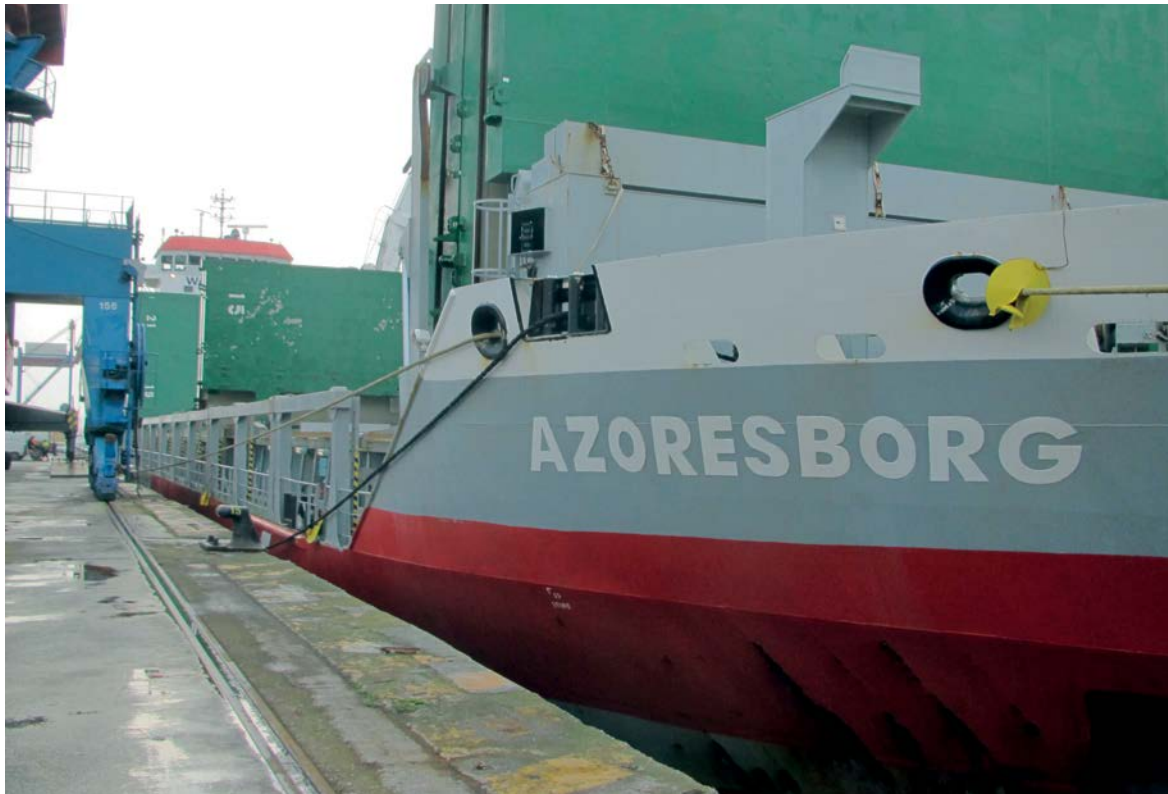
Figure 8: mv Azoresborg moored in Bilbao on 1 March, two days after the accident, showing a gap between the quay and the vessel (seen from the forward part of the forward hold). (Source: Dutch Safety Board)
