Grounding of **K-WAVE** near Malaga, Spain 15 February 2011

SUMMARY

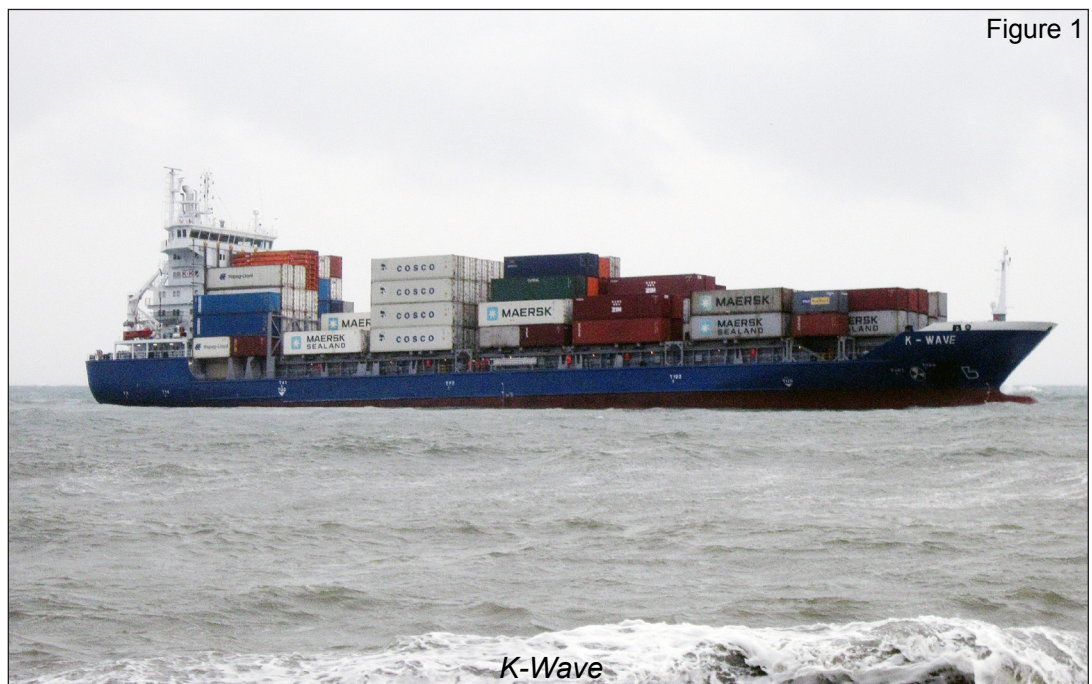
Figure 1

K-Wave

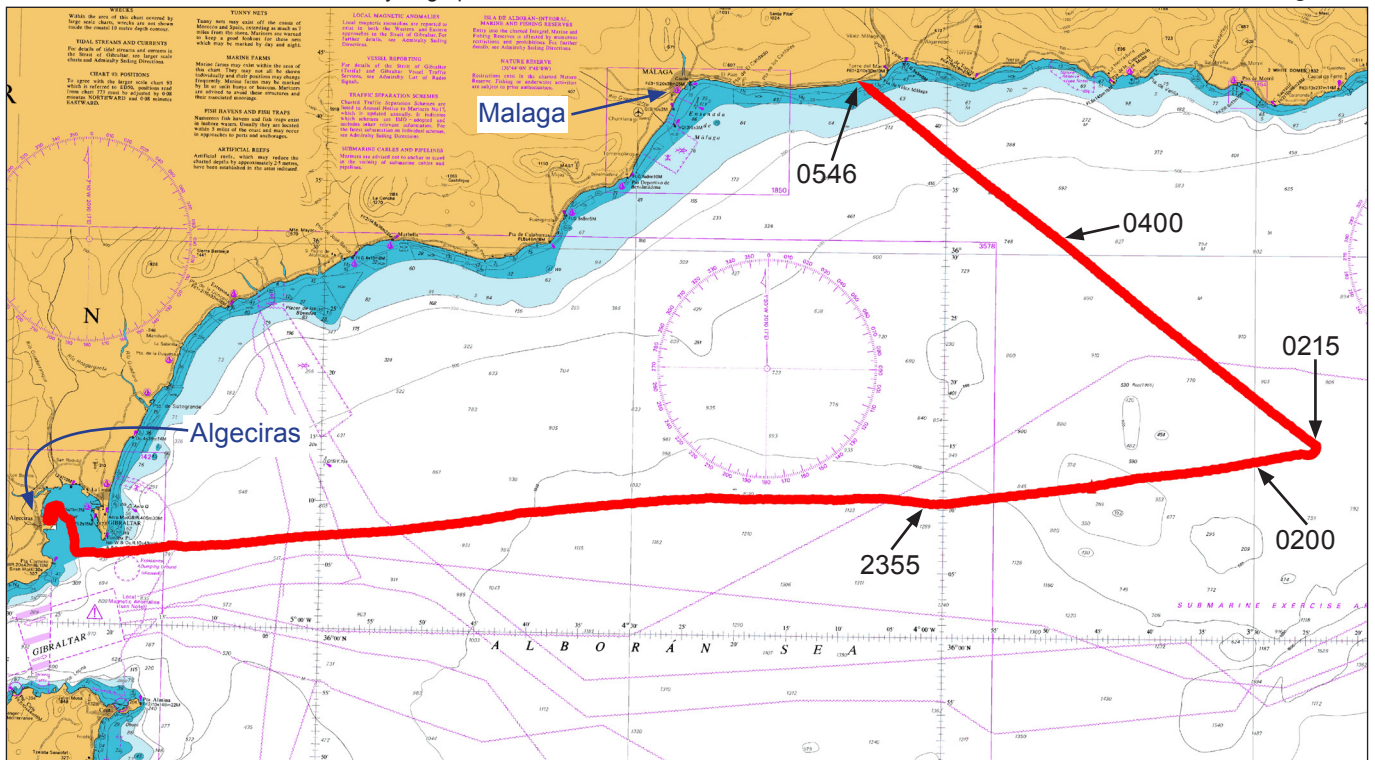
Extract from chart 0773 showing the course of K-Wave on 14, 15 February 2011

At 0216, in an unscheduled departure from the passage plan, the vessel's course was altered from 081° to 305°. No alarms sounded on the bridge during this alteration of course, and the bridge remained silent until the vessel grounded at 0546 on a gently shelving, sandy, shoreline 13 miles east of Malaga. At 0557 the crew of a local fishing boat informed the Spanish coastguard that a merchant vessel appeared to have grounded.

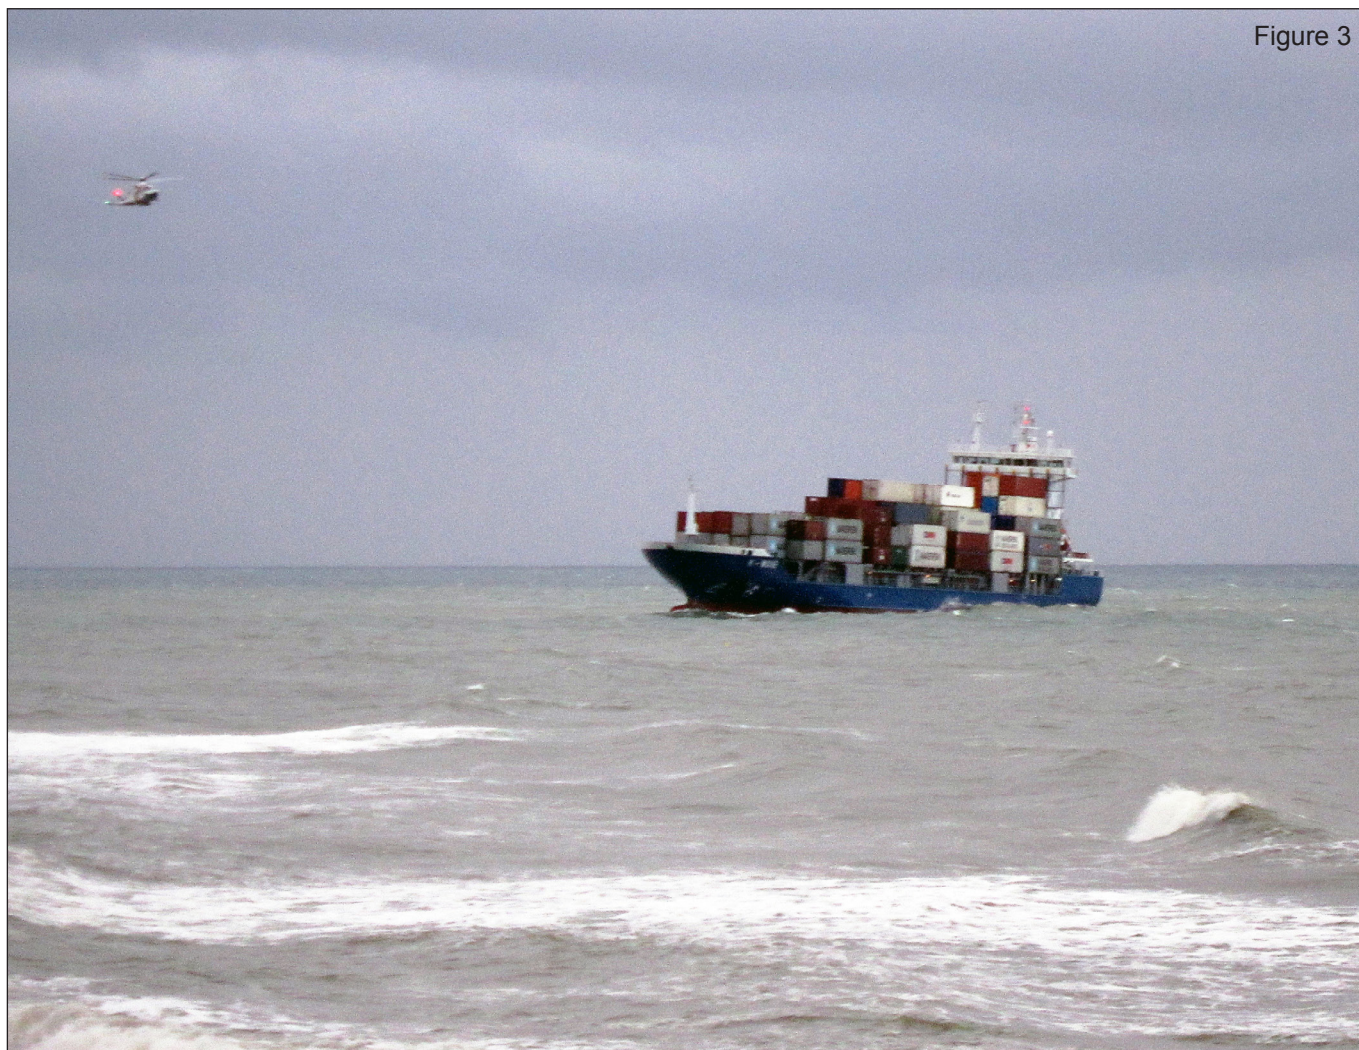
Figure 3

Coastguard helicopter arriving on scene
