Report on the investigation of the
keel failure and capsizing of
the Comar Comet 45 Sport yacht
Tyger of London

1 nautical mile south of Punta Rasca, Tenerife
on 7 December 2017

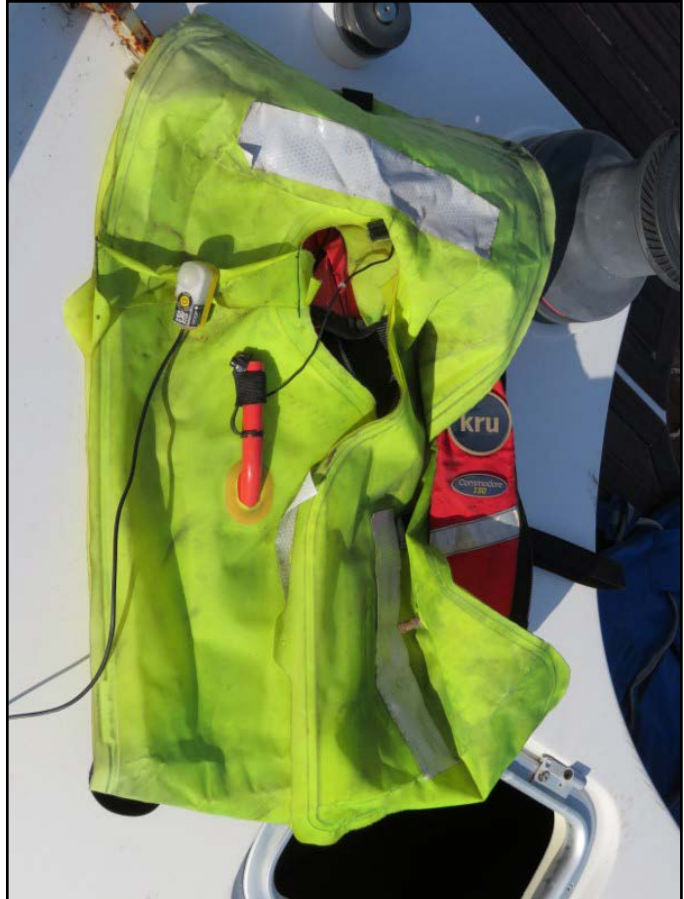
Figure 4: Lifejacket worn by *Tyger of London*'s crew

Tyger of London carried eight 150N self-inflating lifejackets fitted with lights and whistles. The skipper of the yacht made the decision that the crew would each wear their lifejacket and safety harness during the passage from La Gomera to Tenerife. Therefore, when the yacht capsized unexpectedly, and the crew fell into the water, their lifejackets self-inflated. Four of the crew swam clear, unhindered; one became trapped under the cockpit by the netted guardrails. Although the inflated lifejacket delayed this crew member's escape, ultimately they were able to free themselves.

The decision as to which lifejacket to carry is a matter of personal choice. Nevertheless, the fact that all five of the crew were wearing lifejackets when they entered the water directly contributed to their survival by keeping them afloat and allowing *St Barbara V* to quickly locate them. However, crew must never wear an inflatable lifejacket beneath clothing, as one crew member on board *Tyger of London* did, as this can result in the lifejacket either not activating, or not inflating properly. In particular, it could prevent the wearer from being able to manually operate the lifejacket, top it up using the mouth piece, or access the whistle. Furthermore, it could obscure the light and high visibility reflective strips. Skippers and more experienced crew members should ensure that less experienced crew do not make this mistake.

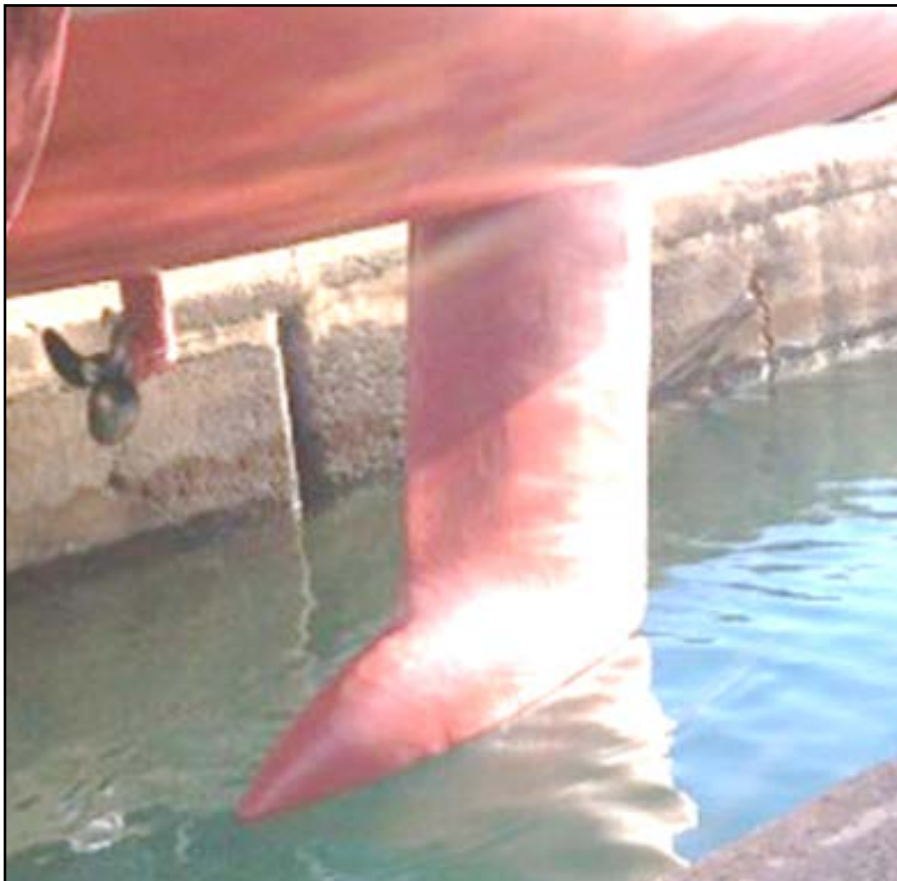
Figure 7: Comar Comet 45S, shallow draught, lead, cruising keel fitted to *Tyger of London*

Tyger of London was fitted with the shallow draught keel.

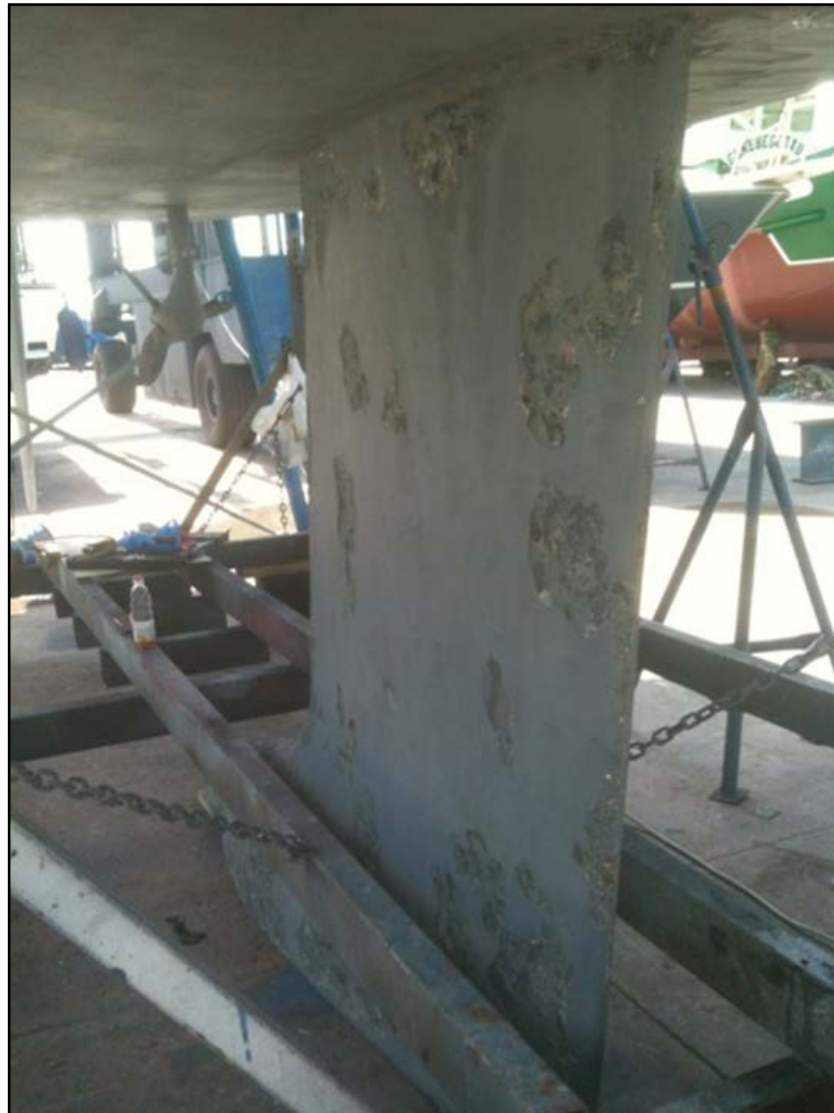
Figure 10: *Tyger of London's* keel, March 2014

- In March 2014, the yacht was lifted ashore for maintenance by its manager in Tenerife. There was some minor cracking along the joint between the keel and hull (**Figure 10**). This area was ground out and filled prior to the hull being painted.

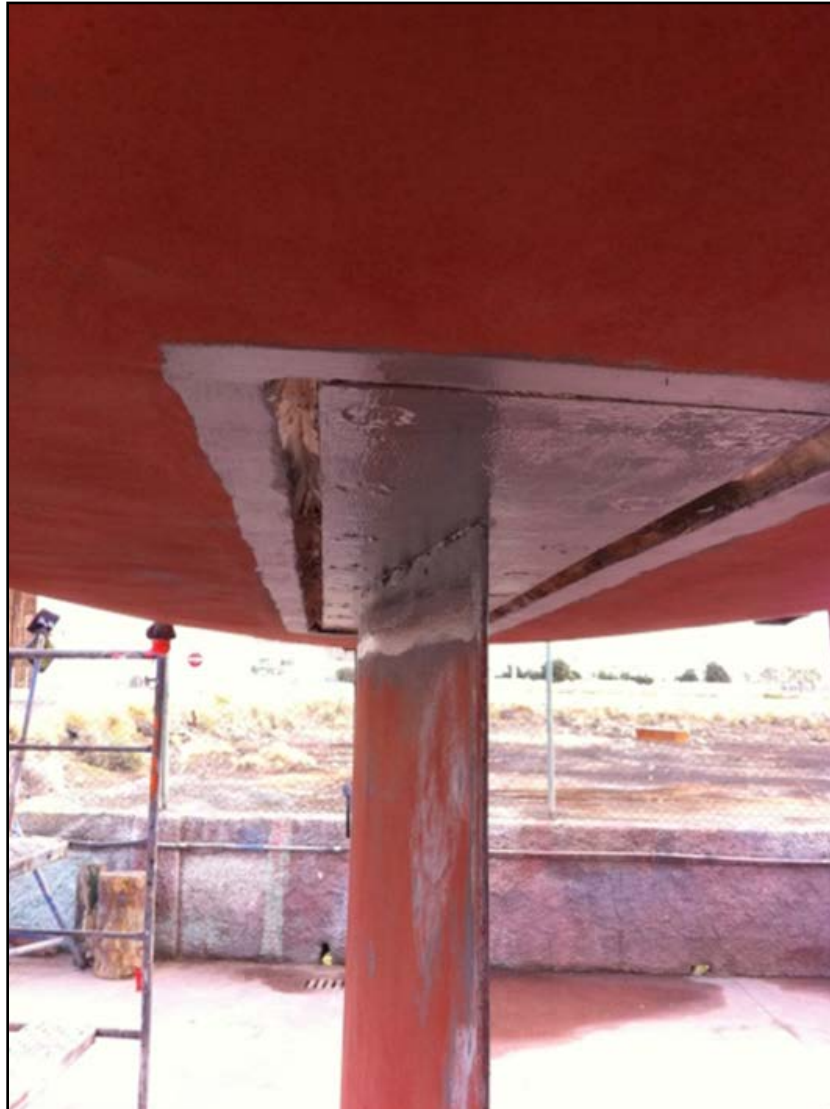
Figure 11: *Tyger of London's* keel, February 2016

maintenance included removal of all paint and filler from the top of the keel, exposing the joint between hull and keel top plate and top plate and keel fin. The manager reported that there were no gaps in either joint (**Figure 11**). Furthermore, to ensure that the keel was secure, the boat was hoisted and the keel pushed by three or four people; no movement within the keel structure was observed. On completion, the joints between both the hull and the top plate, and the top plate and the keel fin, were resealed and faired with filler before being repainted.

These reported grounding events all preceded the last out of water inspection of the yacht's keel by the manager in February 2016. This inspection was thorough and included the removal of all paint and filler from the keel top plate and the upper part of the keel fin. It allowed an external inspection of the join between the keel fin and keel plate, but it was not possible to examine the condition of the internal keel rods that subsequently failed. The inspection also included the yacht being lifted and the keel fin physically pushed to see if there was any movement of the keel structure; none was observed.

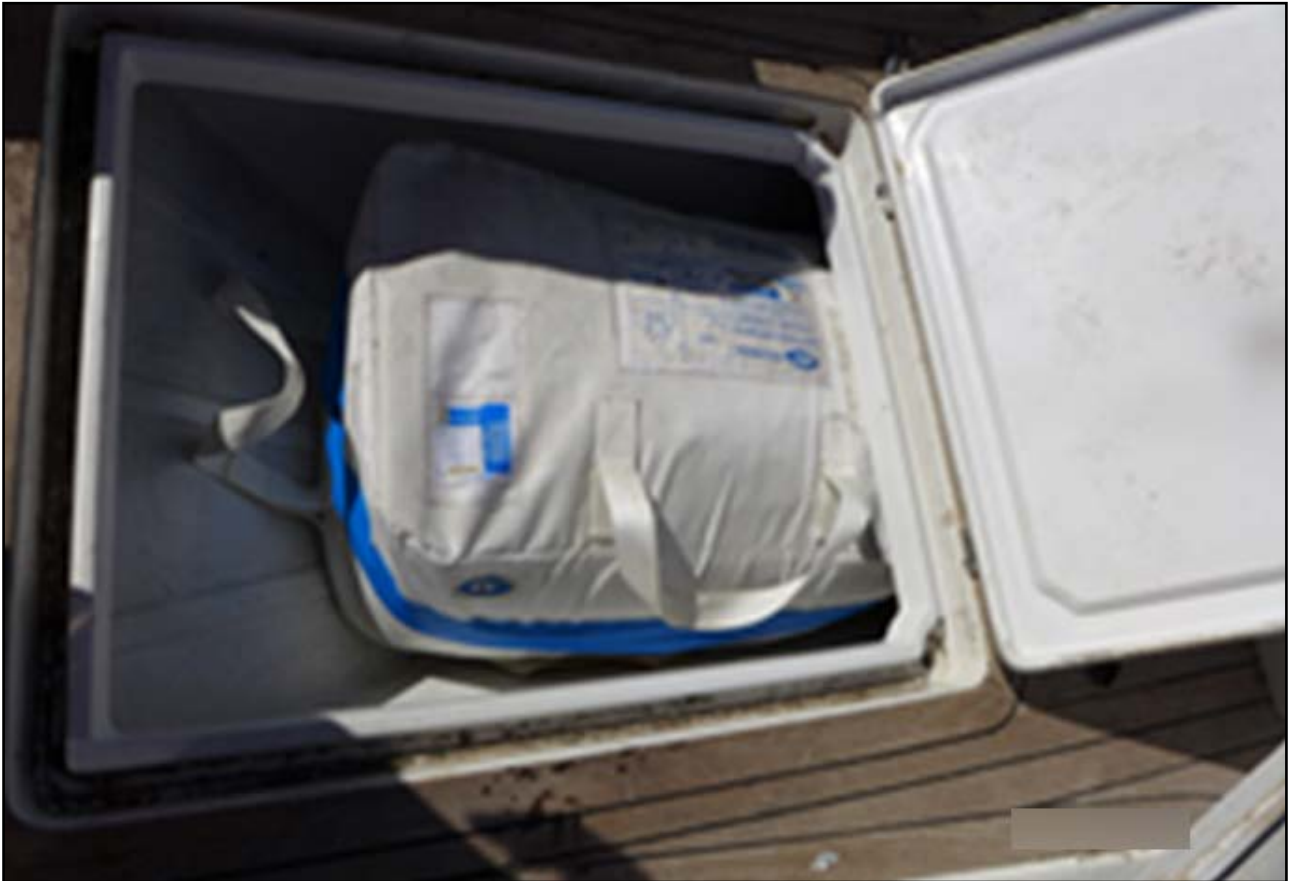
Figure 12: *Tyger of London's* valise liferaft, post-accident, in its cockpit locker

- An 8-person liferaft (without SOLAS pack); post-accident, the yacht's valise liferaft was found in its stowage locker below the cockpit floor (**Figure 12**).

2. *Tyger of London's* crew were all wearing lifejackets, and these contributed to their survival. [2.7.1]
3. The location of the liferaft, grab bag and the electronic position indicating radio beacon, meant that these lifesaving appliances could not be accessed once the yacht had capsized. [2.7.2 and 2.7.3]

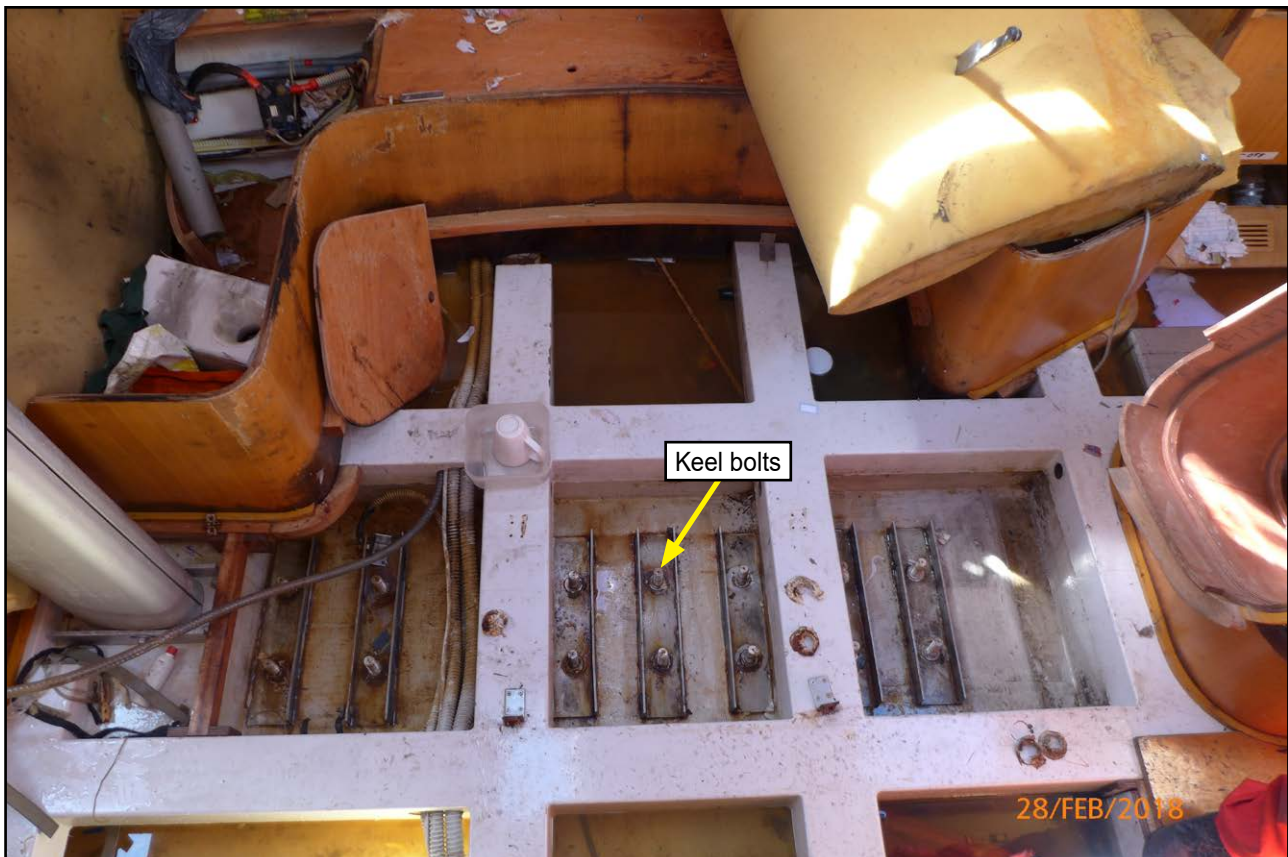
Figure 13: The keel matrix (bolts removed by surveyor prior to keel plate removal)

The internal structure of the hull and the keel matrix was found to be in good condition (**Figure 13**). There was no sign of cracking or damage around any of the internal beams. Externally there were no signs of damage to the hull. The keel plate was removed by the MAIB and shipped to the UK for technical examination.

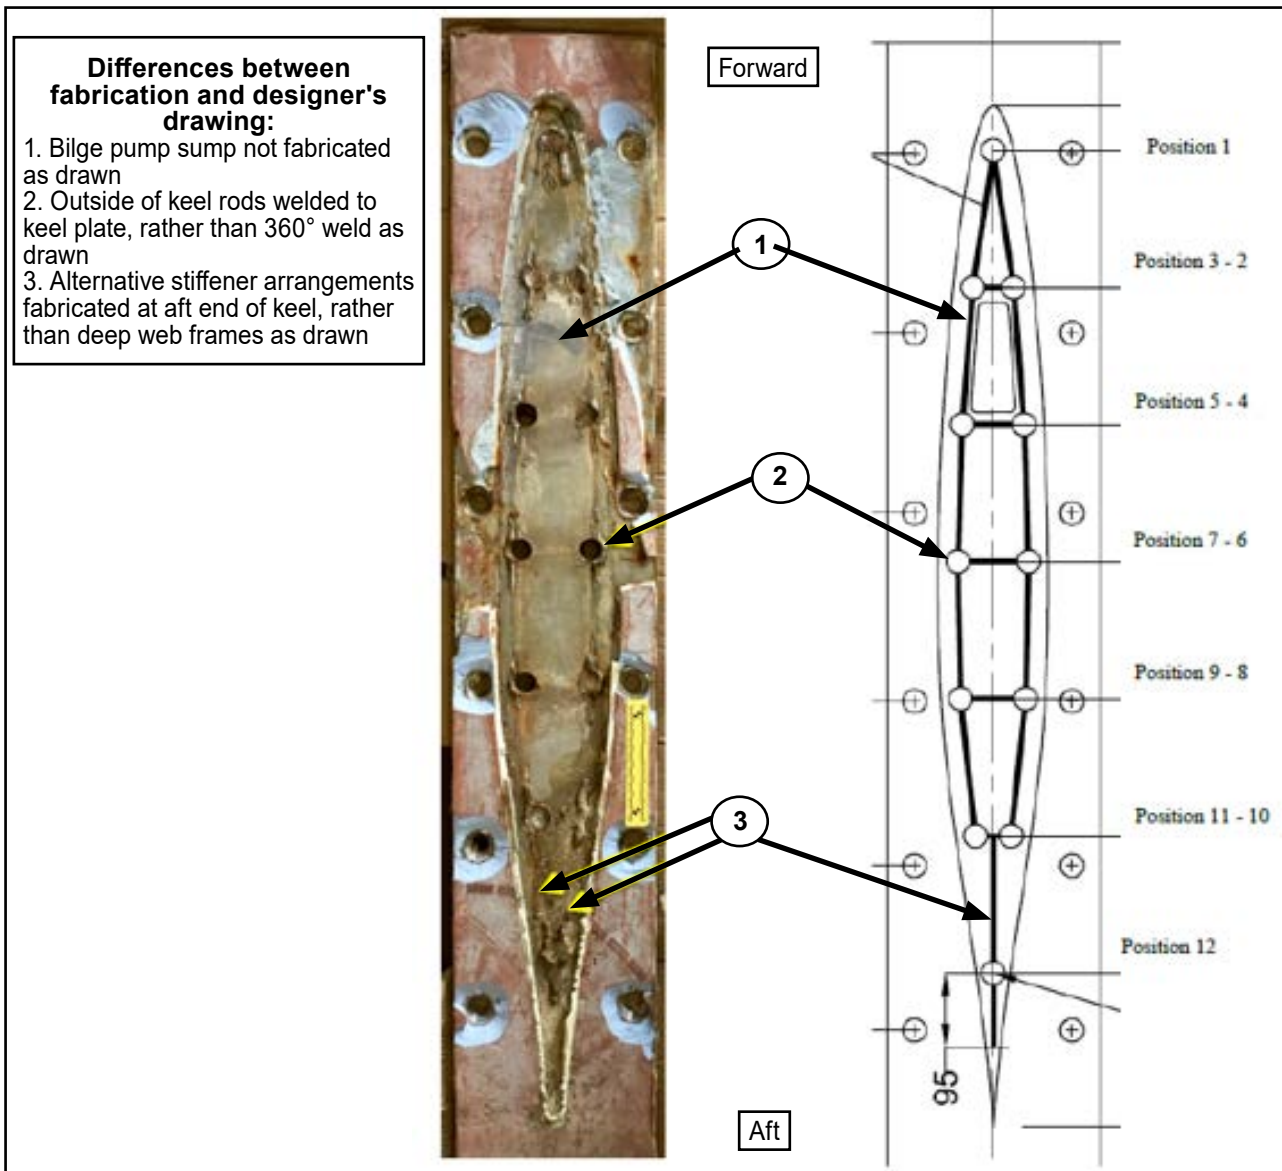
Figure 14: *Tyger of London's* keel plate noting differences between recovered keel plate and designer's drawing

The report concluded that the most likely sequence of failure was that threads on rods 6 and 7, under the heaviest load, began to strip (**Figure 14**). Thereafter, cyclic loading gradually increased the lateral movement between the keel and its top plate. Once these two rods shed their load, the remaining rods steadily failed until the keel fin detached from the keel plate.

The examination of the keel top plate revealed that the stainless steel frame of *Tyger of London's* keel had not been constructed in accordance with the designer's drawings. Most critically, the complex design made it difficult for the fabricator to manufacture the keel frame in accordance with the designer's drawings. As a result, the manner in which the keel rods were welded to the underside of the keel plate was changed. This undocumented change, albeit made in discussion with the shipyard, resulted in less than 50% of the keel rods' circumference being welded as they passed through the underside of the top plate. However, the shipyard did not consult the yacht designer over these changes. Additionally, when the quality of the welds was examined it revealed that a number had fillet leg lengths of 4-7mm when the minimum should have been at least 8mm.

4. The design of the keel was complex and difficult to fabricate. As a result, the shipyard and fabricator made undocumented changes to the design to ease the manufacture of the stainless steel keel frame, unaware that these changes had weakened the joint between the keel plate and internal keel rods. [2.5]

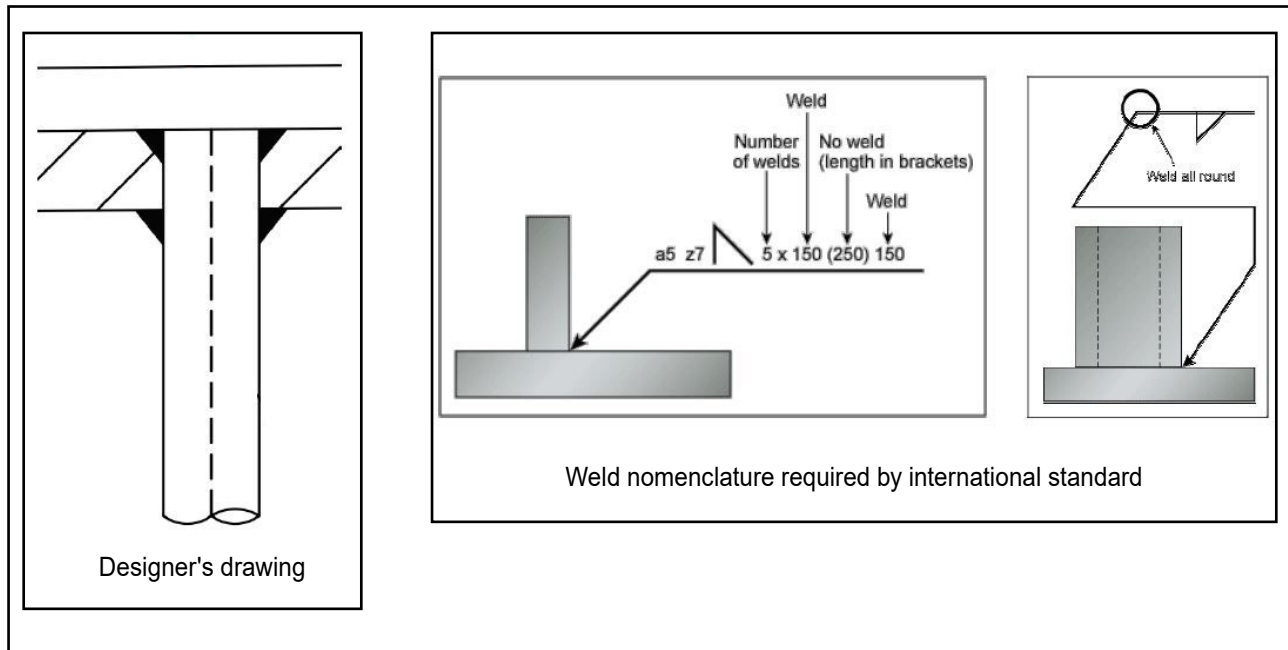
Figure 16: Comparison between designer's drawing and weld nomenclature required by international standard

A further element missing from the keel drawings was detailed guidance on the welds fixing the keel rods and keel plate. Typically, the designer would provide standard notation (ISO 4063-Welding and applied processes-nomenclature of process and reference numbers), which would detail the weld throat size and leg length for this critical element of this keel's construction (**Figure 16**). The Wolfson Report also noted that the design did not take into consideration the access required by the fabricator to achieve an adequate weld with each keel rod in place; a practicality that led the fabricator and shipyard to modify the design.

1. Improved quality control of the keel manufacturing process. This could have been achieved during the RCD Module B approval process where an observation by the Notified Body surveyor could have resulted in these inconsistencies being observed and changes to the keel design being formally approved.
2. Consulting the yacht designer over the proposed changes to his keel design. This, too, could have prevented the structural flaw in *Tyger of London's* keel.
3. More detailed technical drawings of the keel, which would have provided a better understanding of the design intent. The Wolfson Unit noted that the keel drawings represented these welds as simple black triangles rather than full weld notation, including details such as throat size and leg length, as required by international standard.
