**ST VINCENT AND THE GRENADINES
MARITIME INVESTIGATION UNIT**

Report No 1/2019

Very Serious Casualty

m.v. YALIKOY Official No 12202, IMO No 9166510, Loss of life of Chief Mate on the 08.10.2019 at arrival Sagunto, Spain

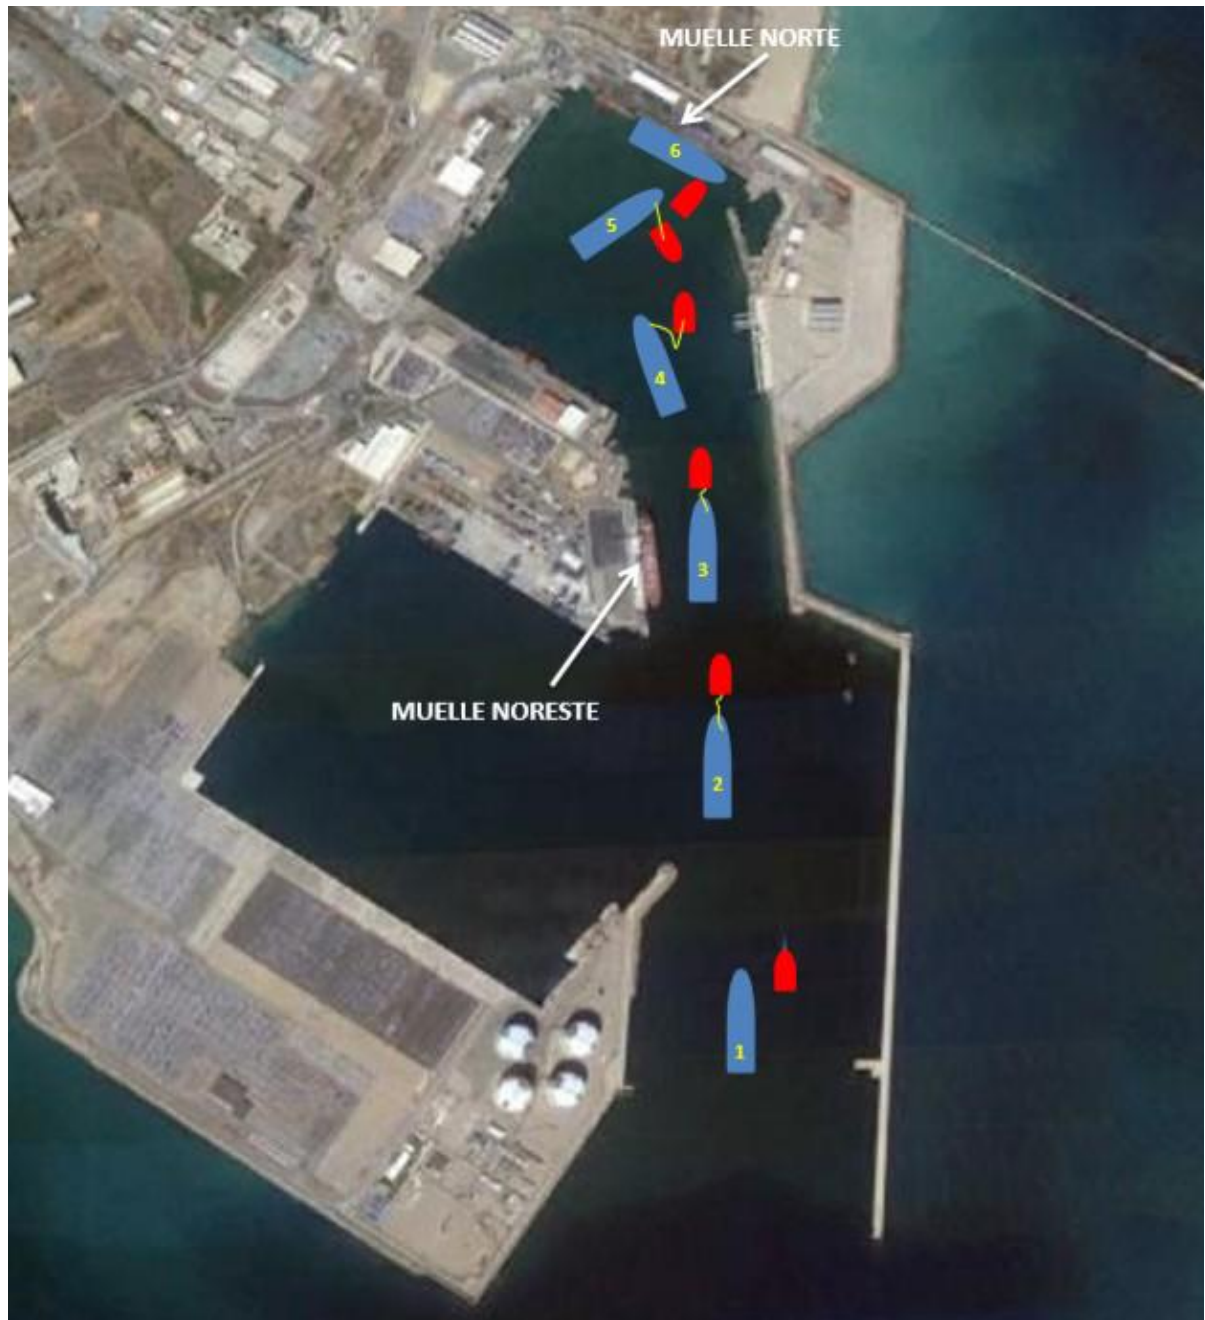
Picture No 1,
Overall view

2. Position where the messenger line from the tugboat was taken through centre fairlead, 3. Position where the AB communicated the accident; 4. Position where the tugboat was fastened from the starboard fairlead

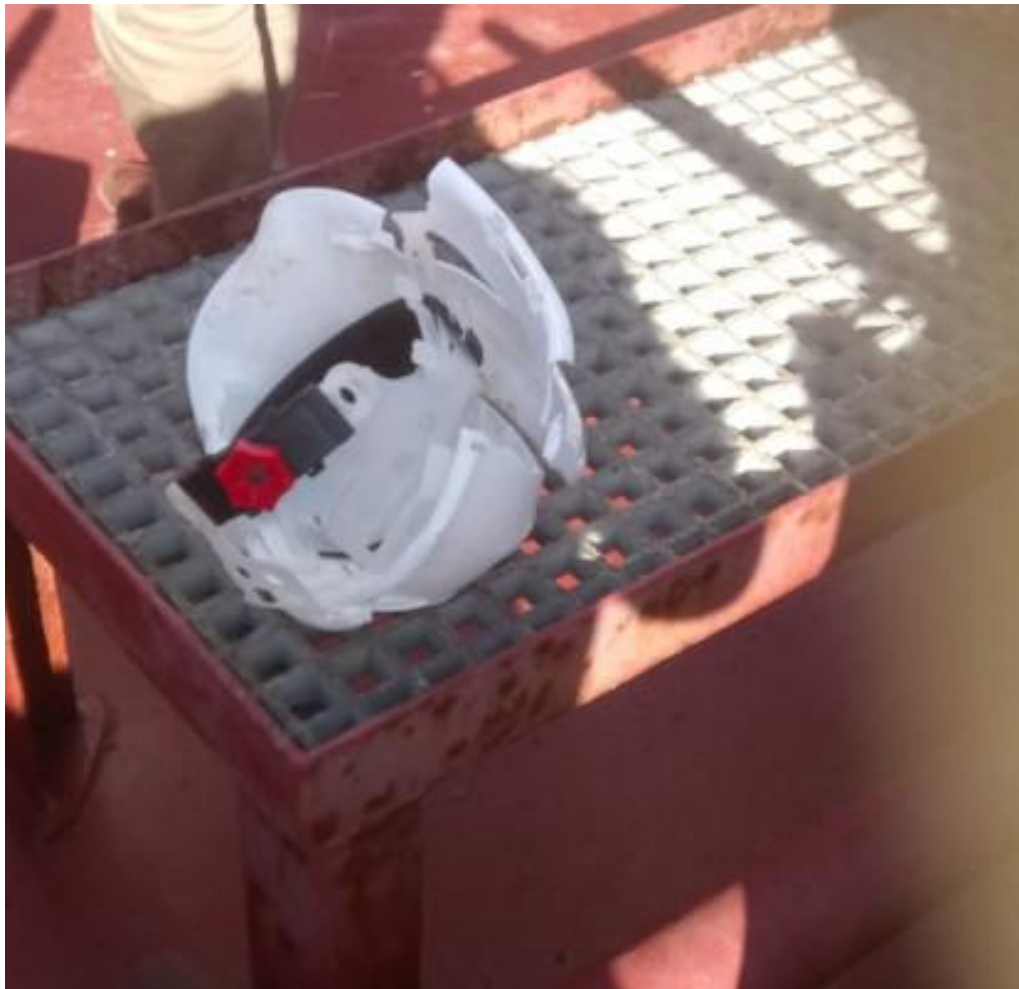
*Picture No 2
Broken Chief Mate's helmet*

He stated that he was hit by the messenger line on the upper part of the helmet. The helmet was pushed down by the strength of the impact and broke his nose. At the time of the investigation his nose was bandaged and he had large bruises under the eyes.

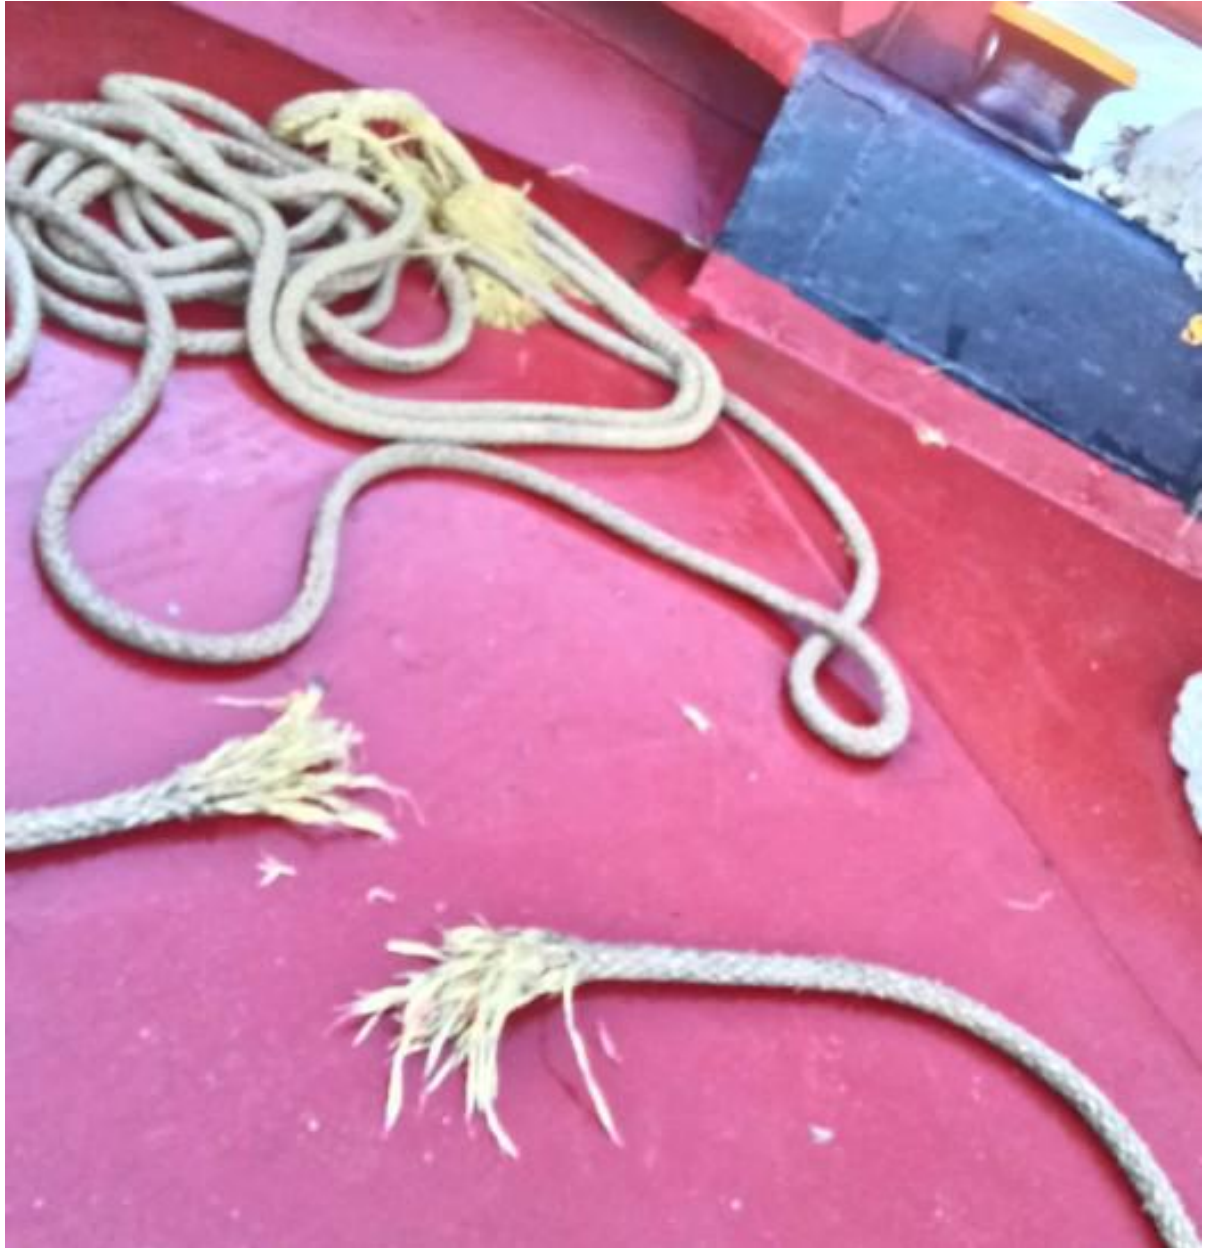
He confirmed that the messenger line parted two meters from the connection point with the tug's rope. There was no friction against rollers or bollard at the breaking point.

*Picture No 3
Snapped messenger line*

According to the rope's certificate the nominal breaking strength of the messenger line was 137 kN. According to the test done by the certified local laboratory the breaking strength of the messenger line was **66.42 kN**.

The relevant Coastal State/Port Authority should develop criteria for periodical testing of the tugs' messenger lines and tugs' lines and to implement it.

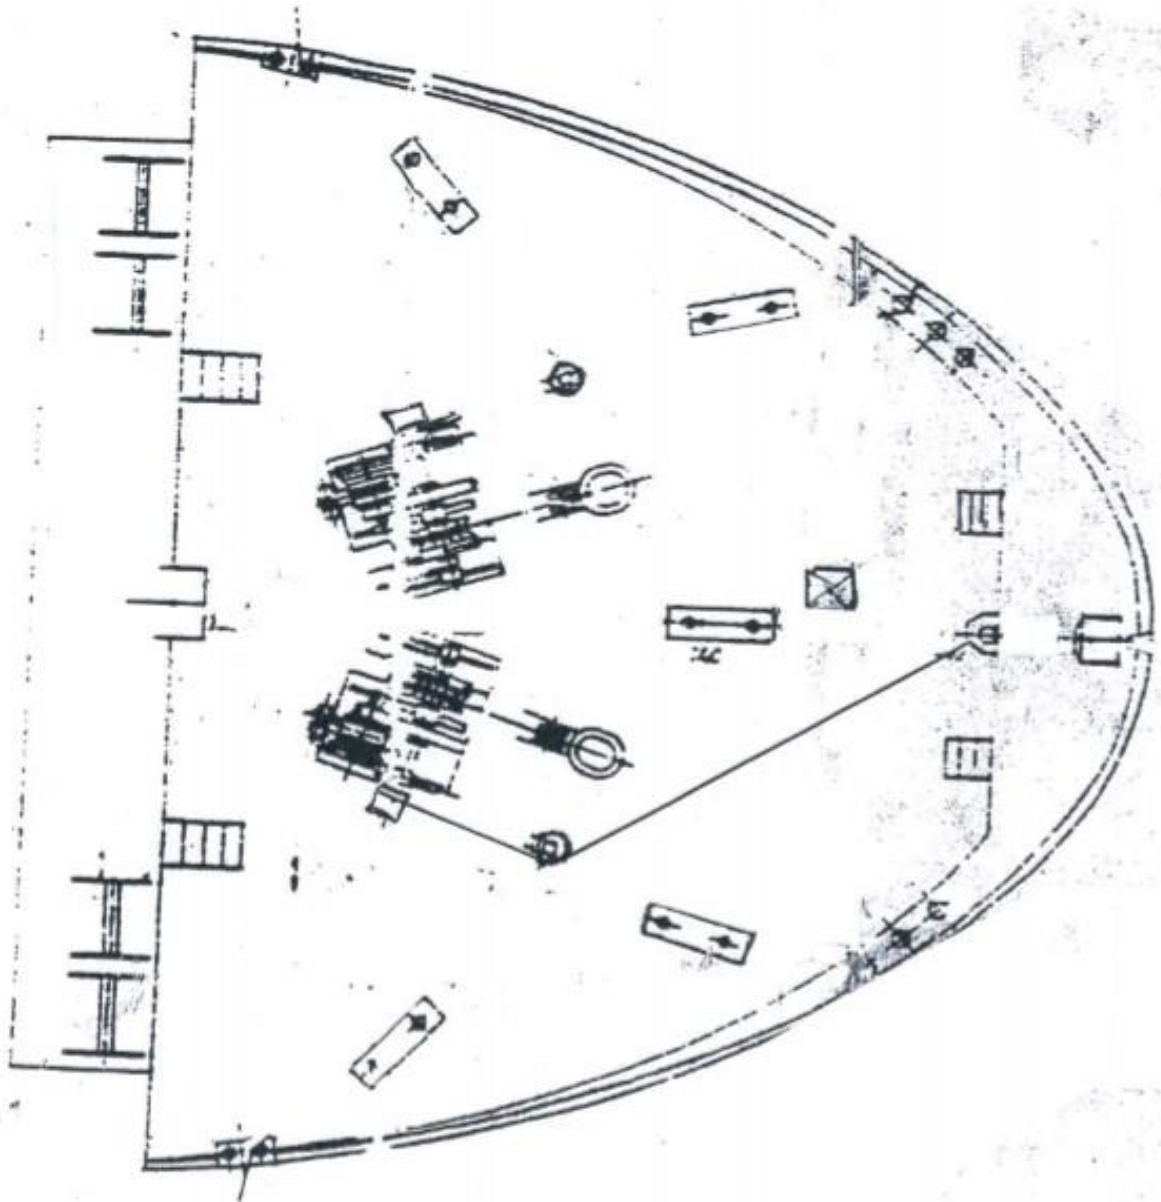
On location, he explained the path of the heaving line, messenger line and tug's line as presented in the picture No 4 was as per Chief Mate's order. The AB also confirmed the path of the messenger line as presented in the picture No 4.

Picture No 4
Path of the heaving line, messenger line and tug's line

The Boatswain and the AB described the way the messenger line was heaved. It is noted that it passed the capstan and ended up on the drum without passing through the bollards.

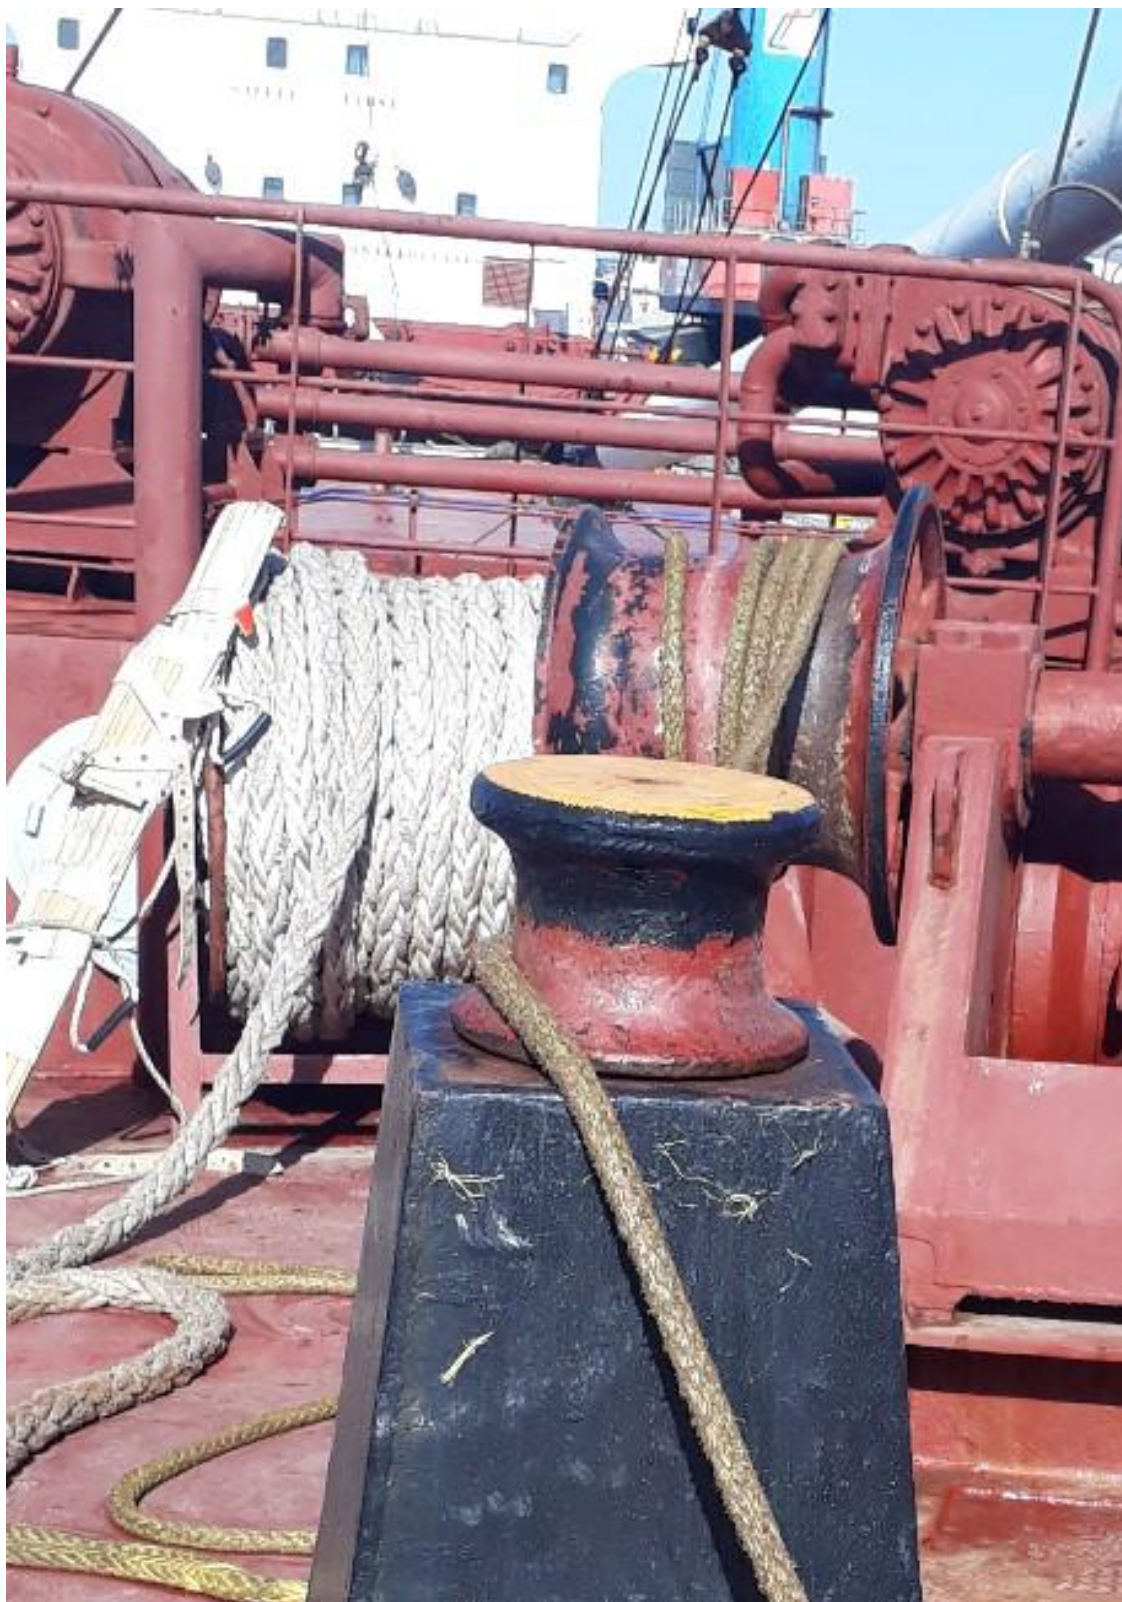
*Picture No 5
Parted messenger line*

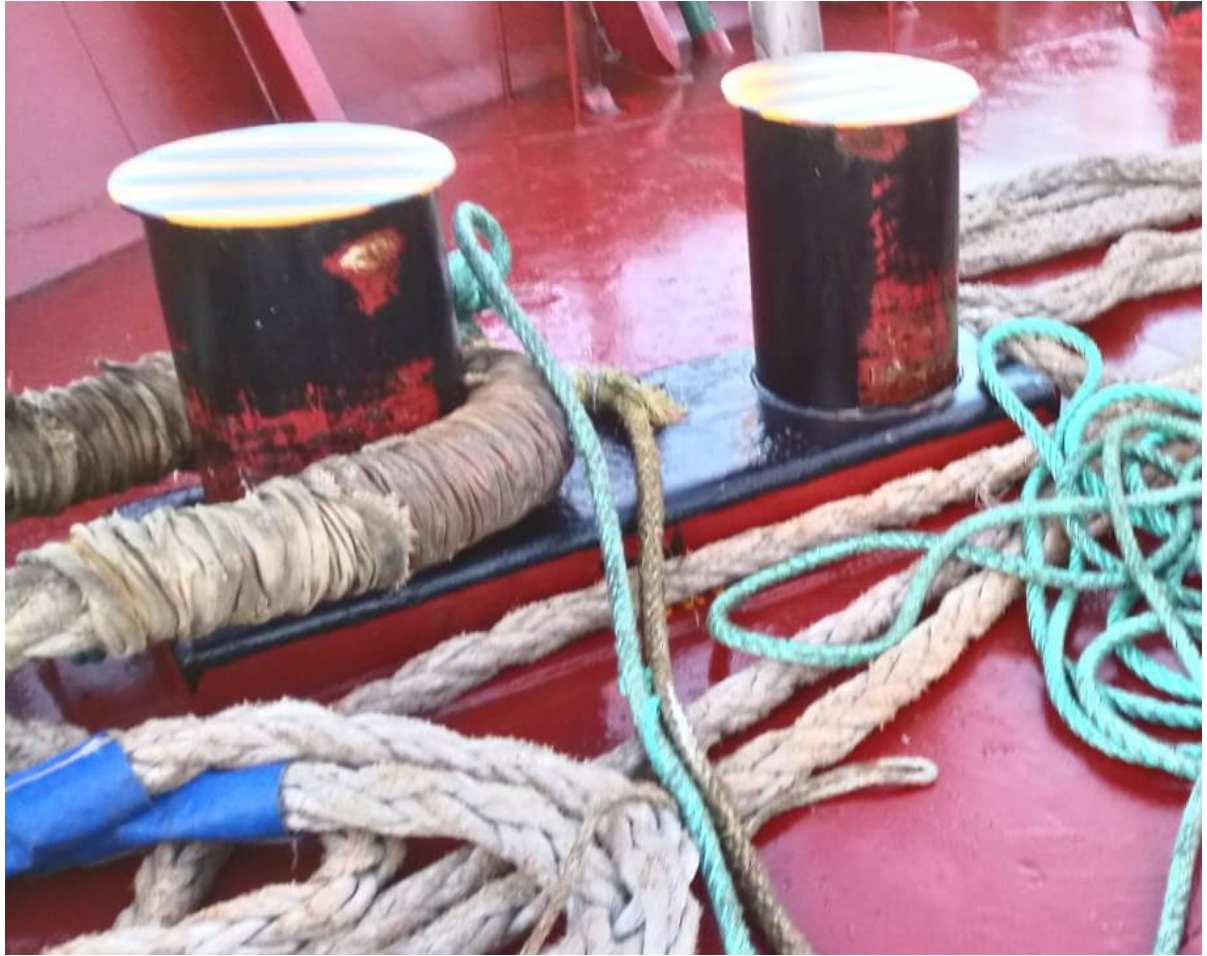
*Picture No 6
Tug's rope fastened on bollard*

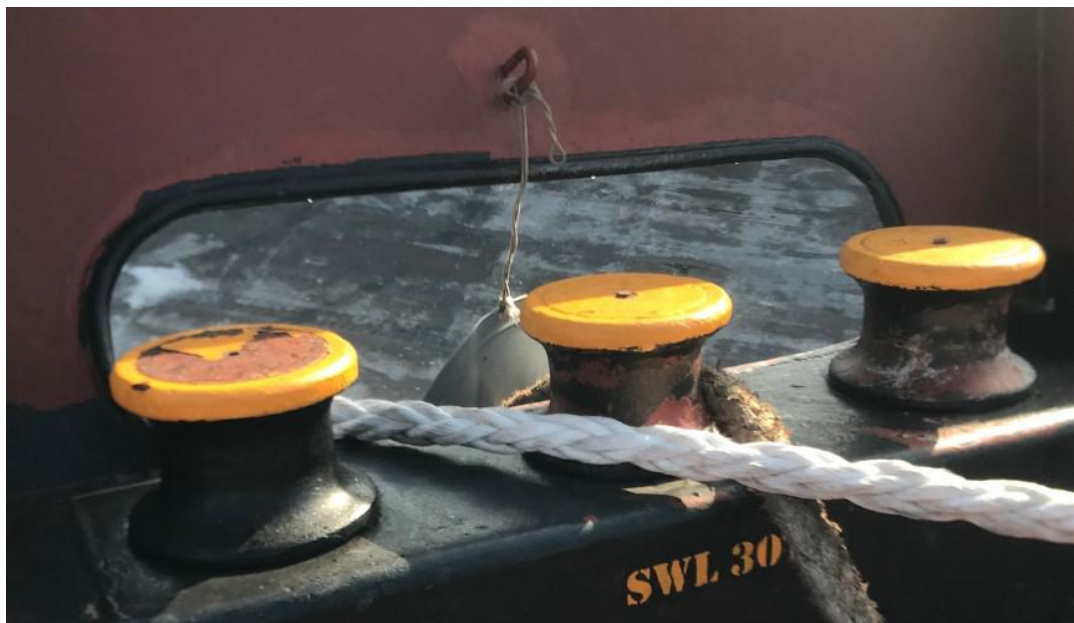
*Picture No 7
Fairleads where the messenger line finally passed*

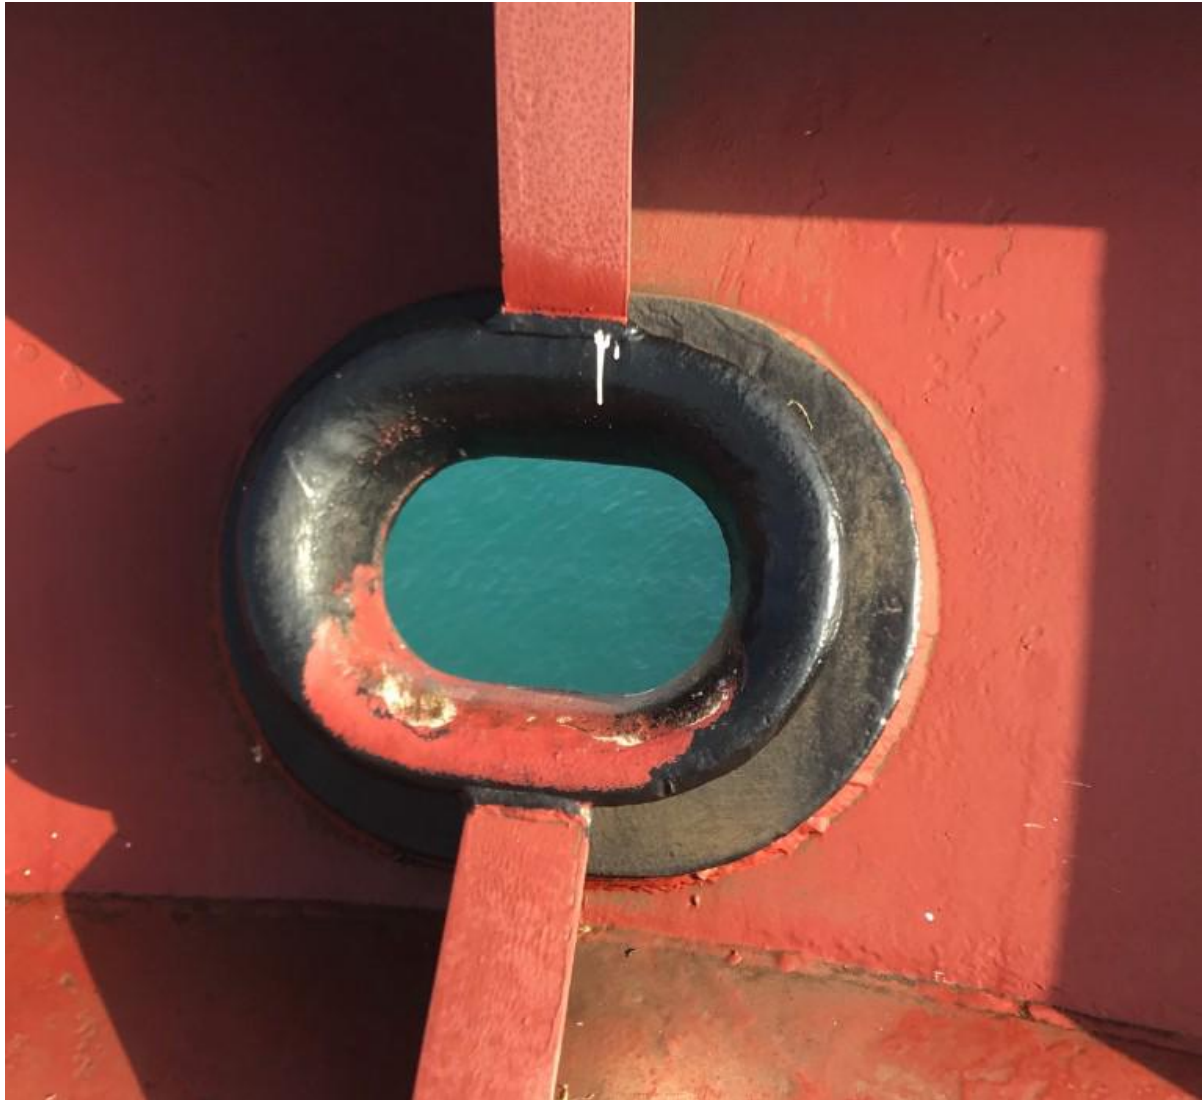
The inner diameters of the centre fairlead (Picture No. 8) were measured. It was discovered that the inner width was 240 mm and the height was 160 mm. According to the tug's rope test certificate the diameter of the rope is 88 mm. The spliced end of the rope was covered with protection (Picture No. 9) which increased the overall diameter of the spliced end i.e. surpassed 160 mm which was the inner height of the centre fairlead.

*Picture No 8
The centre fairlead*

In addition it is recommended that the Company conduct complex risk assessments in relation with the tug fastening and the berthing processes on all ships in the fleet and to update Safety Management System procedures accordingly.

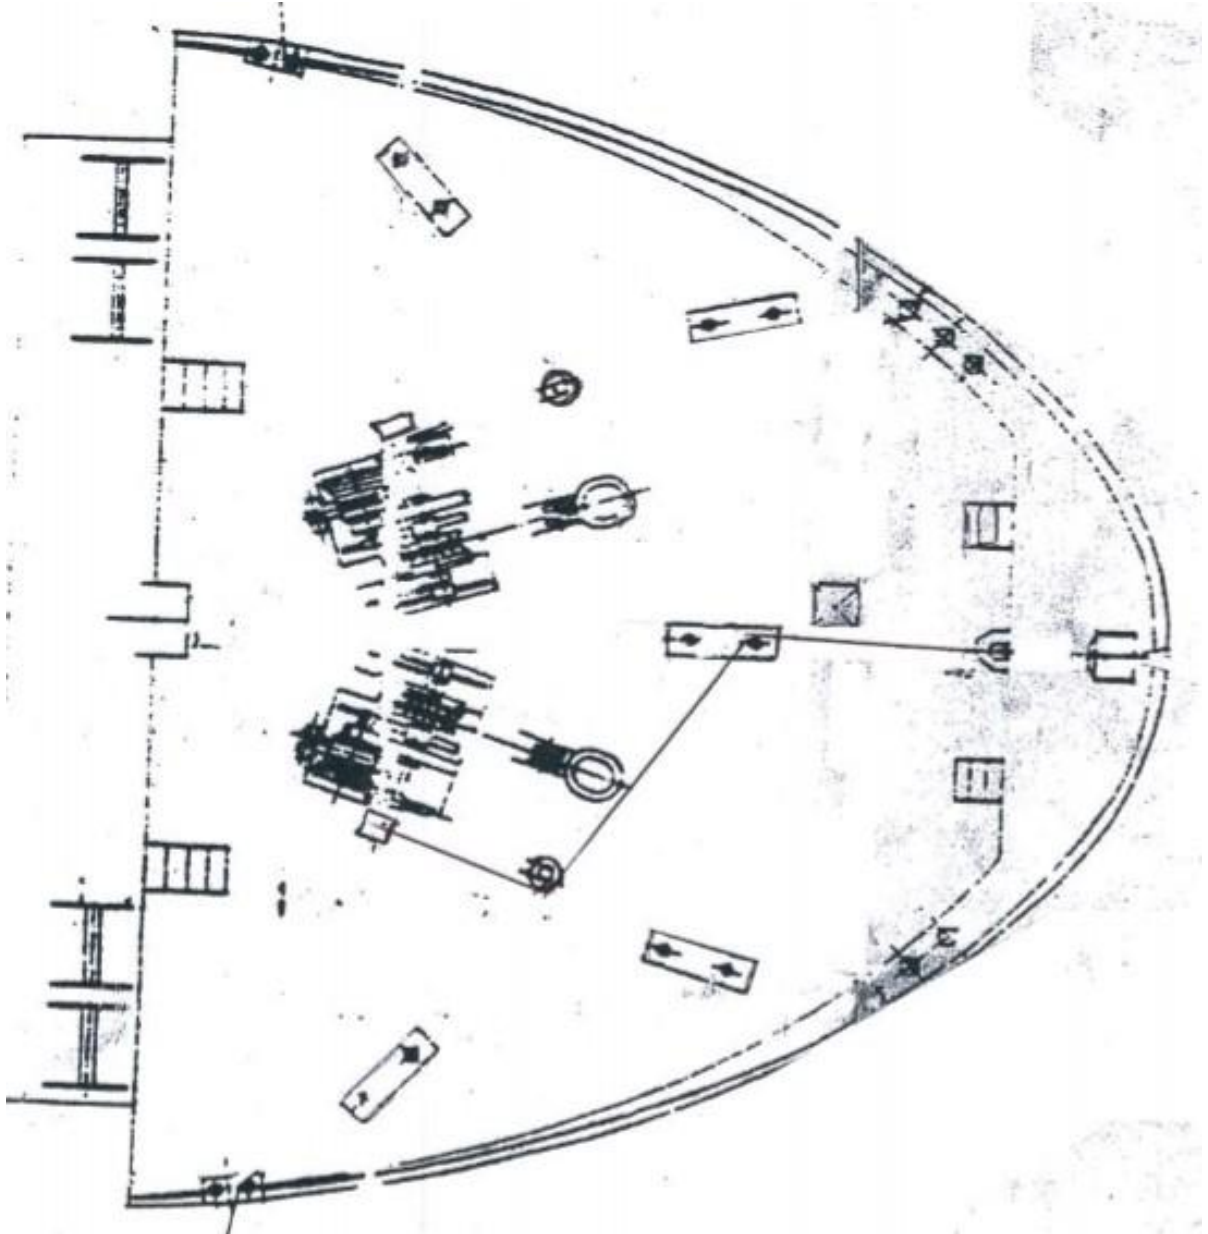
The fastening of the tugboat was not in accordance with good seamanship practice.

On the spot verification proved that the other bollard should have been used for the proper fastening method i.e. fixing the tug's rope of bollard using rope's stopper as per common practice. The correct path of the ropes is shown on the above picture No. 9.

Picture No 9
Correct path of tug boat fastening

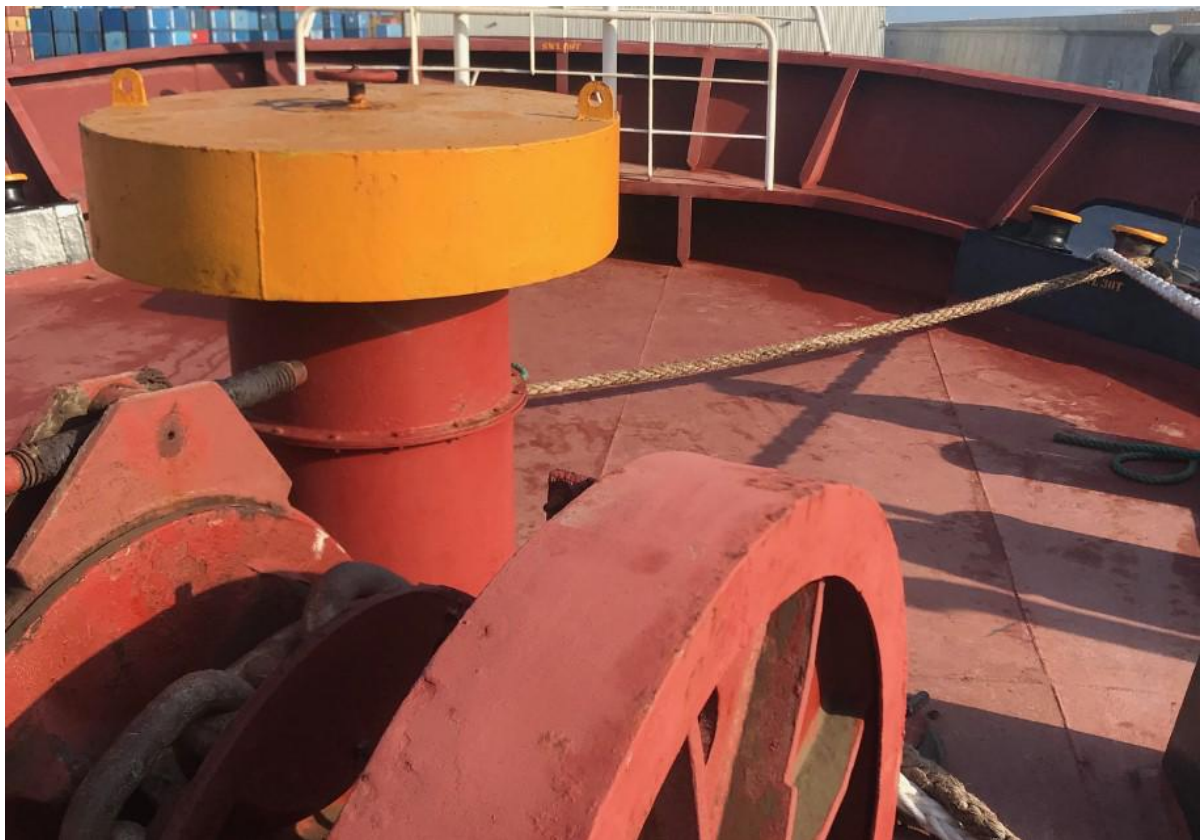
The Officer in charge should monitor the entire operation from a higher viewpoint. The Chief Mate was commanding the mooring winch at the time of the casualty. The view from this position is completely obstructed by the forecastle ventilator cap hiding the fairlead and the rope passing through it, from the Chief Mate's view. It is confirmed on the spot that, without moving completely from his position, the Chief Mate could not see the centre fairlead (picture No.10).

*Picture No 10
Position where Chief Mate was located at the time of casualty, view forward*

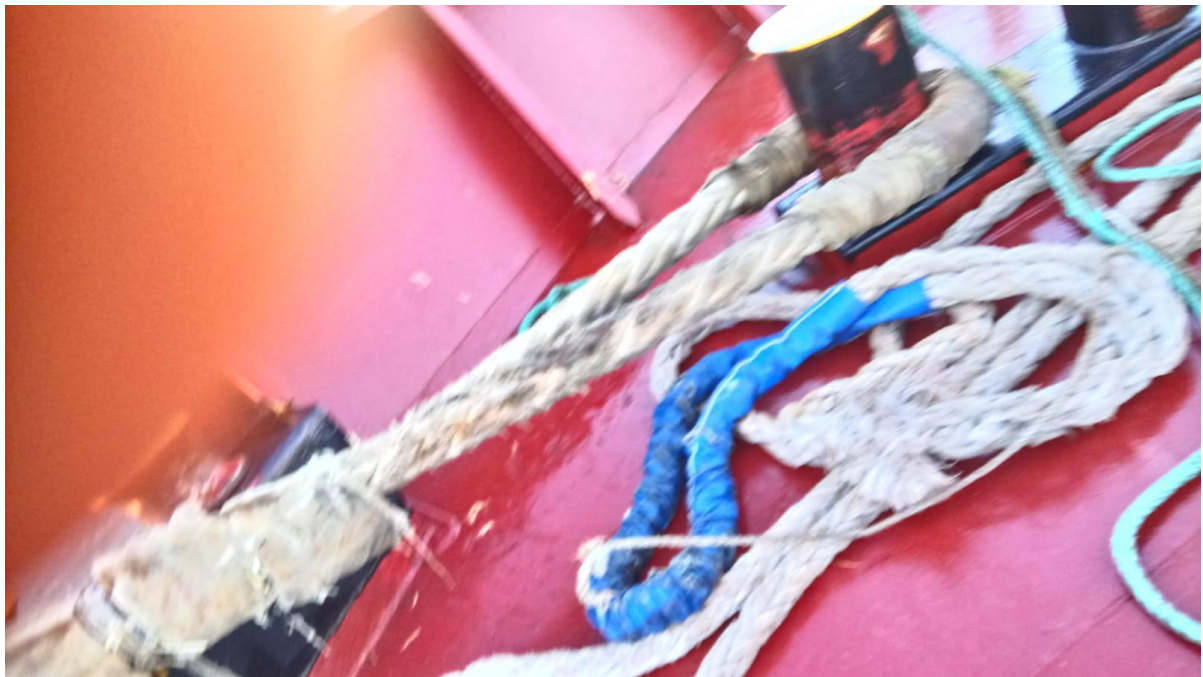
*Picture No 11
The tug's line fasted*

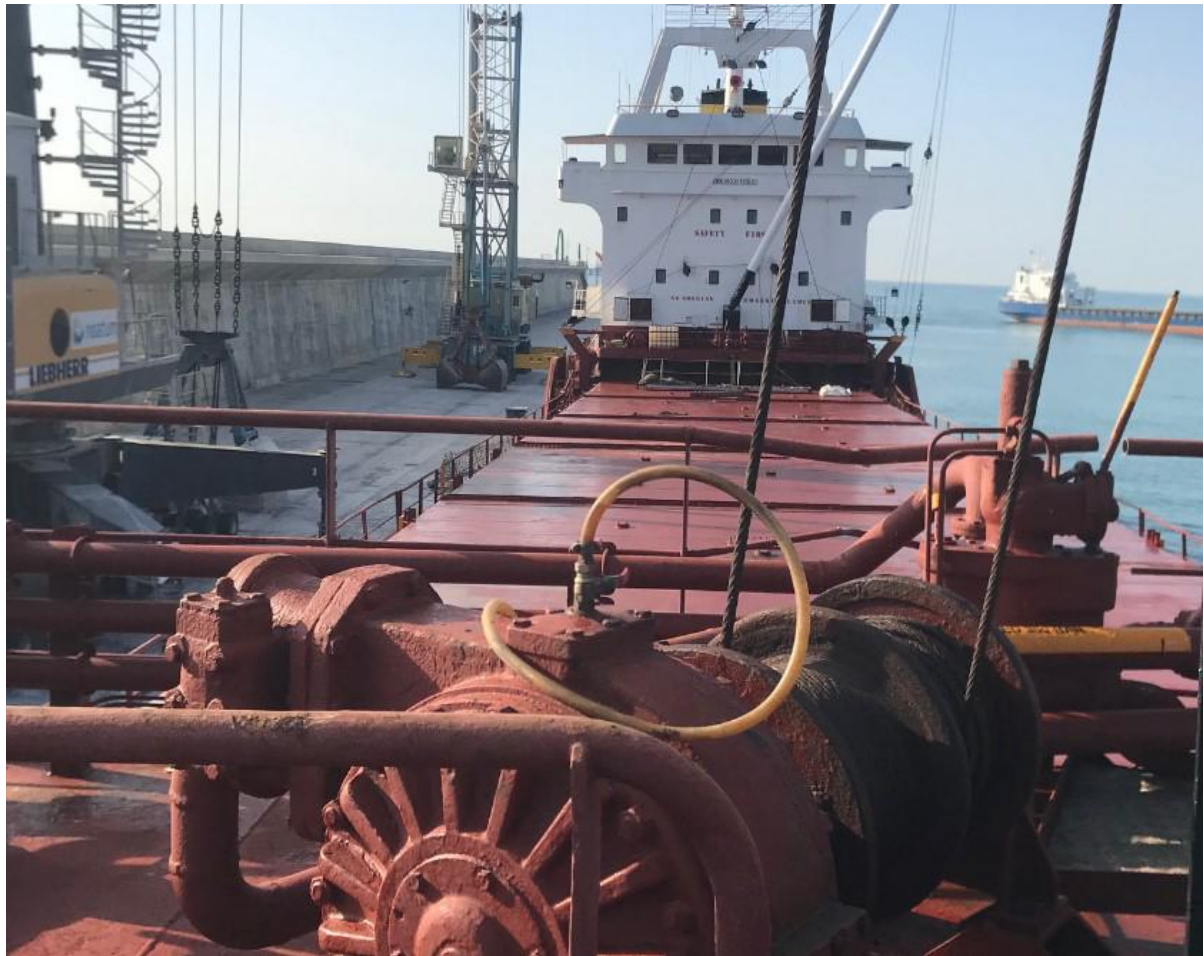
According to the local information sunrise for this area occurred at 08:03 LT. There was no visible obstacle from the bridge to the heaving position on starboard side (picture No.12). The crew described the Chief Mate as a significantly tall person. Consequently the Master should have been able to see his position from the bridge.

*Picture No 12
Position where Chief Mate were standing at the time of casualty, view from behind*
