Report A-008/2011

Accident involving a Bell 407
helicopter, registration EC-KTA,
on 19 March 2011,
in the municipality of Villastar
(Teruel, Spain)

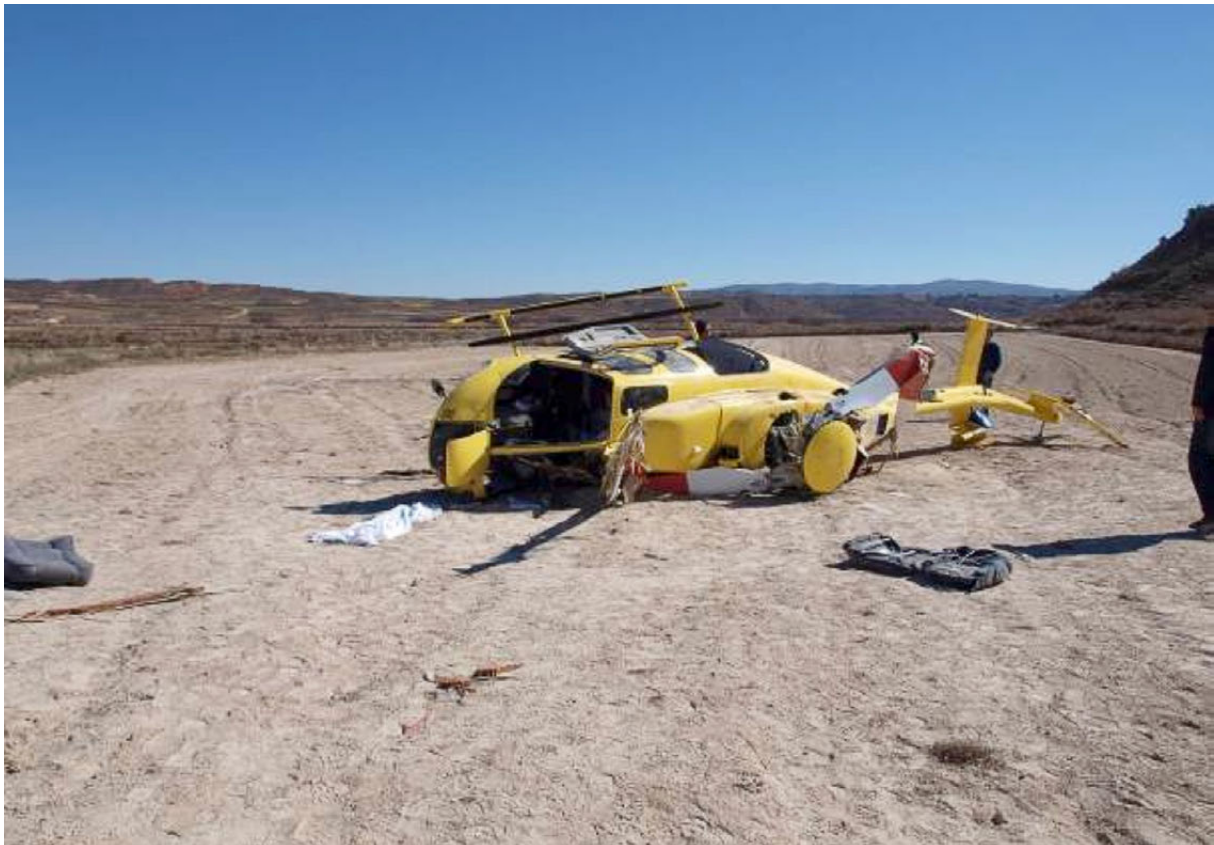
Figure 9. Main wreckage

The main debris field was very small and the helicopter was found lying on its left side a short distance away from the markings left by the skids on the ground. The nose was on a heading of approximately 290°.

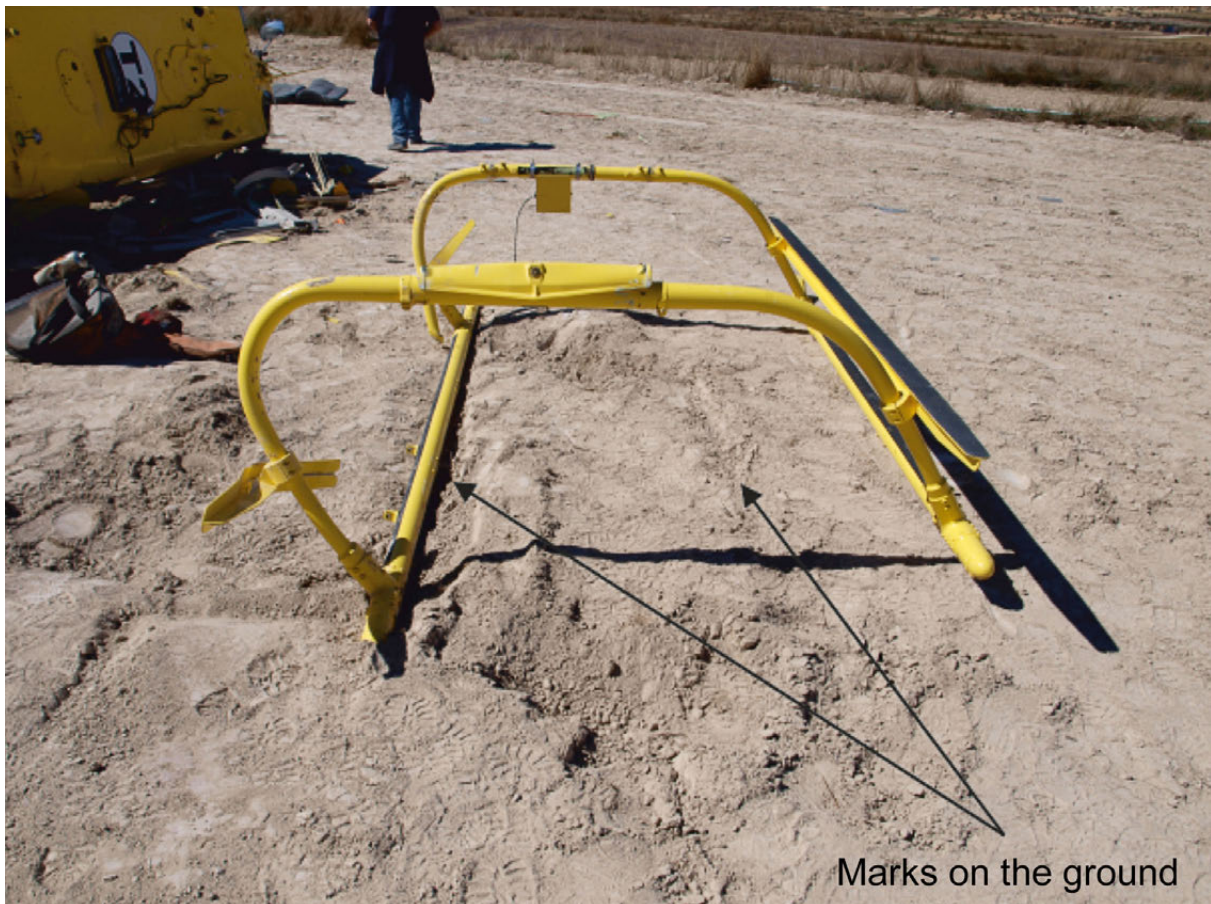
Figure 10. Bent landing gear and marks on the ground

On the ground just north of the main wreckage there were two parallel marks oriented along the same direction as the fuselage (around 270°). The left mark, as seen in the direction of motion, was about 15 cm deep. The right track was very shallow and a little shorter than the left (see figure 10).

The landing gear was only attached to the helicopter by the right rear bolts. The forward cross member on the left side near the skid was broken. Both cross members were bent inward on the left side and outward, and slightly backward, on the right. The left bracket was broken and detached from the landing gear.

The damage exhibited by the cross members was consistent with the markings found and point to the landing gear impacting the ground violently with the helicopter in a left bank angle with respect to its longitudinal axis and with a clear left lateral speed component.

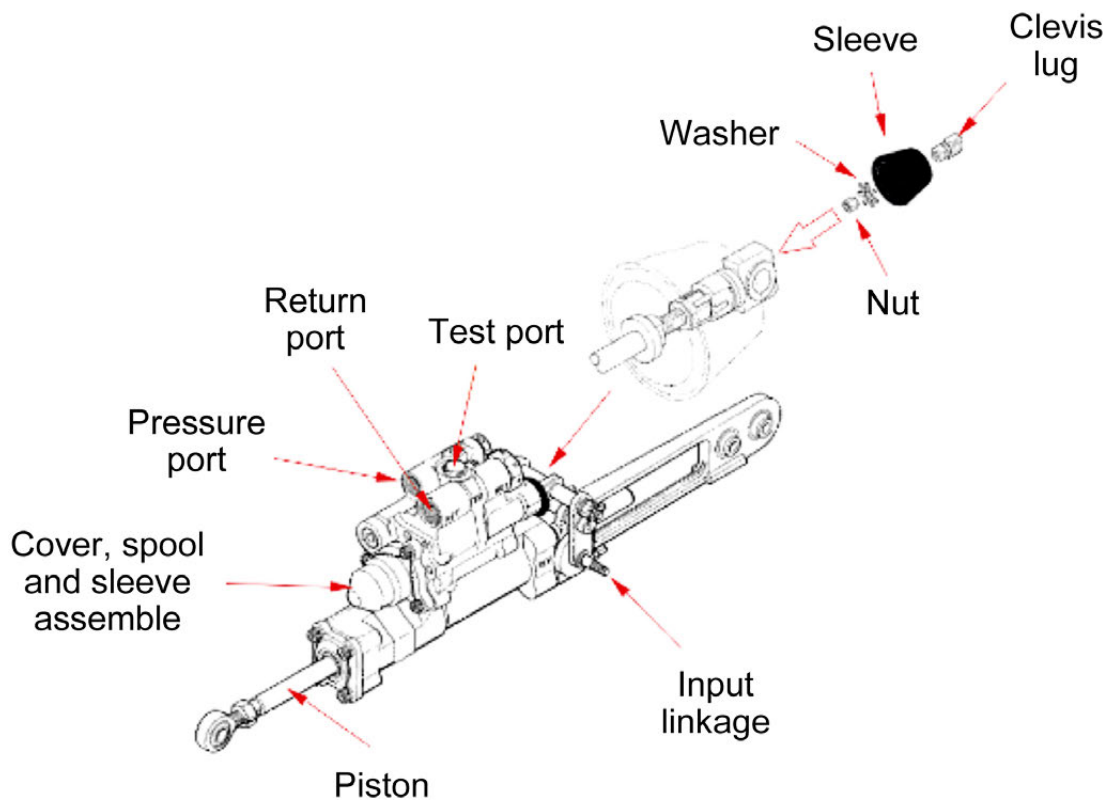
Figure 11. Servo

The three collective and cyclic pitch servos, P/N 206-076-062-107, were also X-rayed. This test did not reveal any type of fractures or internal blockages. Their external appearance did not reveal any significant wear.

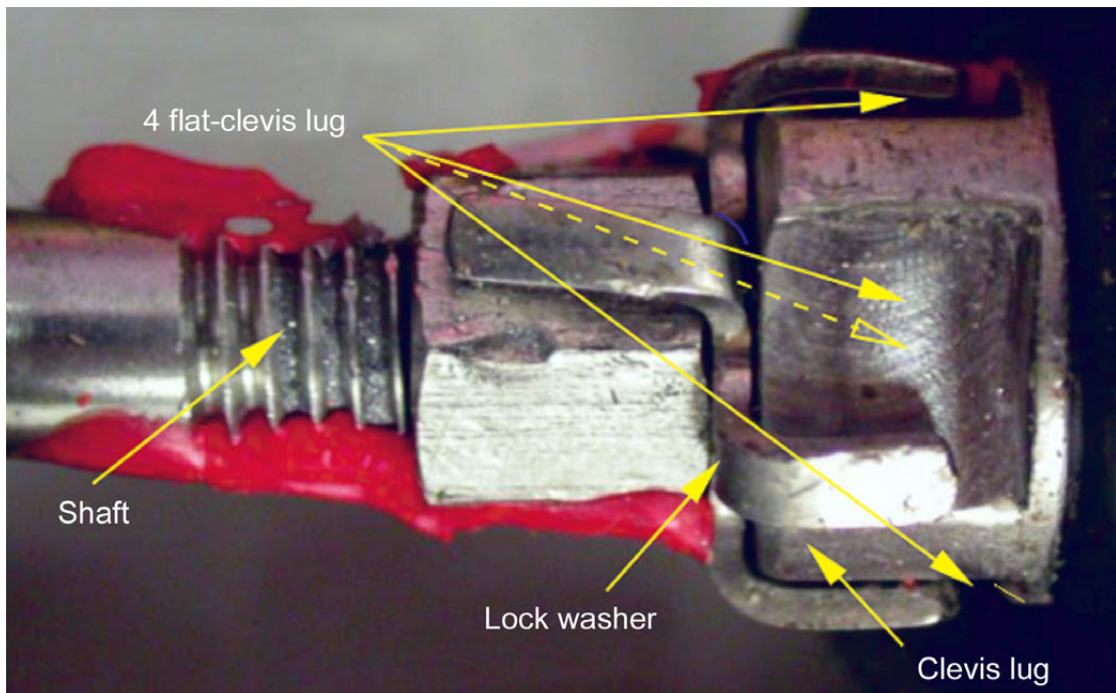
Figure 12. Right cyclic servo HR2588

The protective sheath was removed from the clevis assembly on the various servos in order to check the condition and position of the nuts, lock washers and shafts. The clevis lugs on both the right cyclic servo (S/N HR2588) and the collective servo (S/N HR2539) had four flats. The lock nut had four tabs bent against the corresponding flats on the clevis lug and three tabs bent against the nut. The torque lacquer was in place on the adjustment assembly on both servos, though it was somewhat worn. None of the parts (nut, lock washer or shaft) was loose.

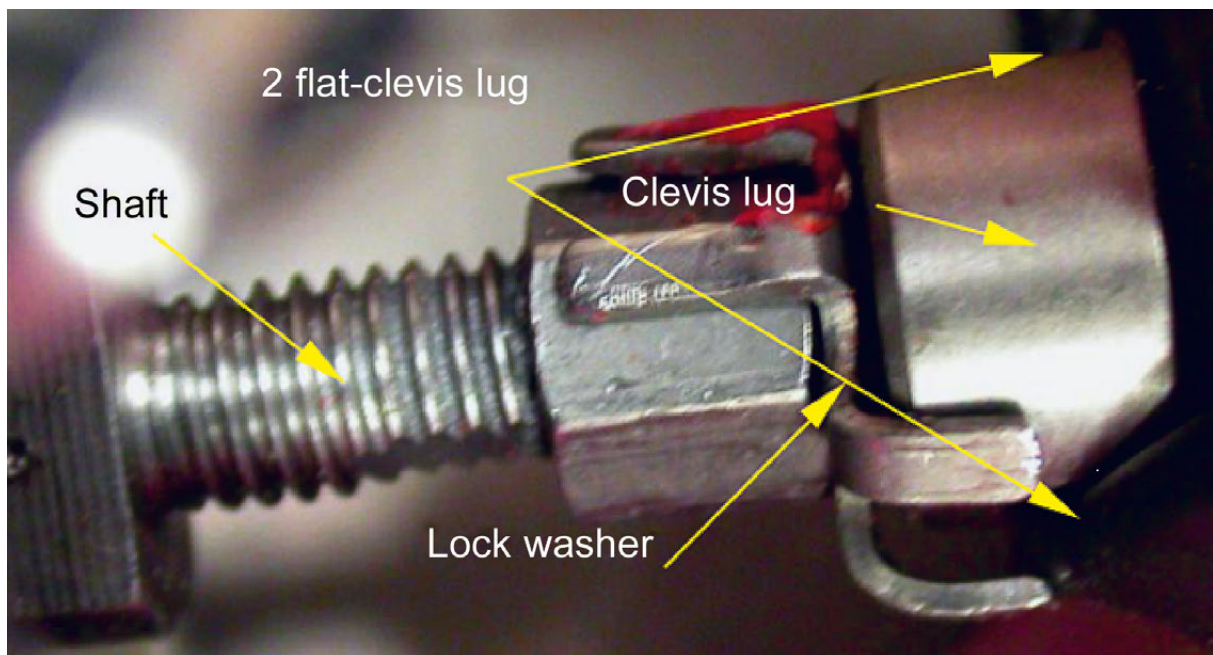
Figure 14. Left cyclic servo HR2036

The clevis lug on the left cyclic servo (S/N HR2036) had two flat surfaces. The lock washer had three tabs bent against the lug and four tabs bent against the nut. The locking tabs on the washer bent against the lug had been bent against a circular part of the lug instead of against the flat surfaces, as evidenced by the angle at which the tabs were bent and the gap present between the tabs and the flat surfaces on the lug. The remains of the torque lacquer were found. The nut and the lock washer were found loose and not in the locking position.

The total travel on servo S/N HR2036 was 0.015" (0.38 mm), while on servos S/N HR2588 and HR2539 it was 0.022" (0.56 mm) and 0.021" (0.53 mm), respectively.

The checks made of the servo (S/N HR2036) after the accident revealed an improper adjustment of the lug and laboratory tests confirmed that the adjustment gradually shifted until it impeded the proper operation of the servo.

On the clevis assembly for the left cyclic servo (S/N HR2036), however, the nut and lock washer were found loose and not in a locking position. Four of the tabs on the lock washer were bent against the nut and the other three were improperly bent against a circular part of the lug instead of being bent against its flat segments, of which there were only two. This was evidenced by the angle at which the tabs were bent and the gap present between the tabs and the flat surfaces on the lug. Only parts of the torque lacquer were found in this assembly.

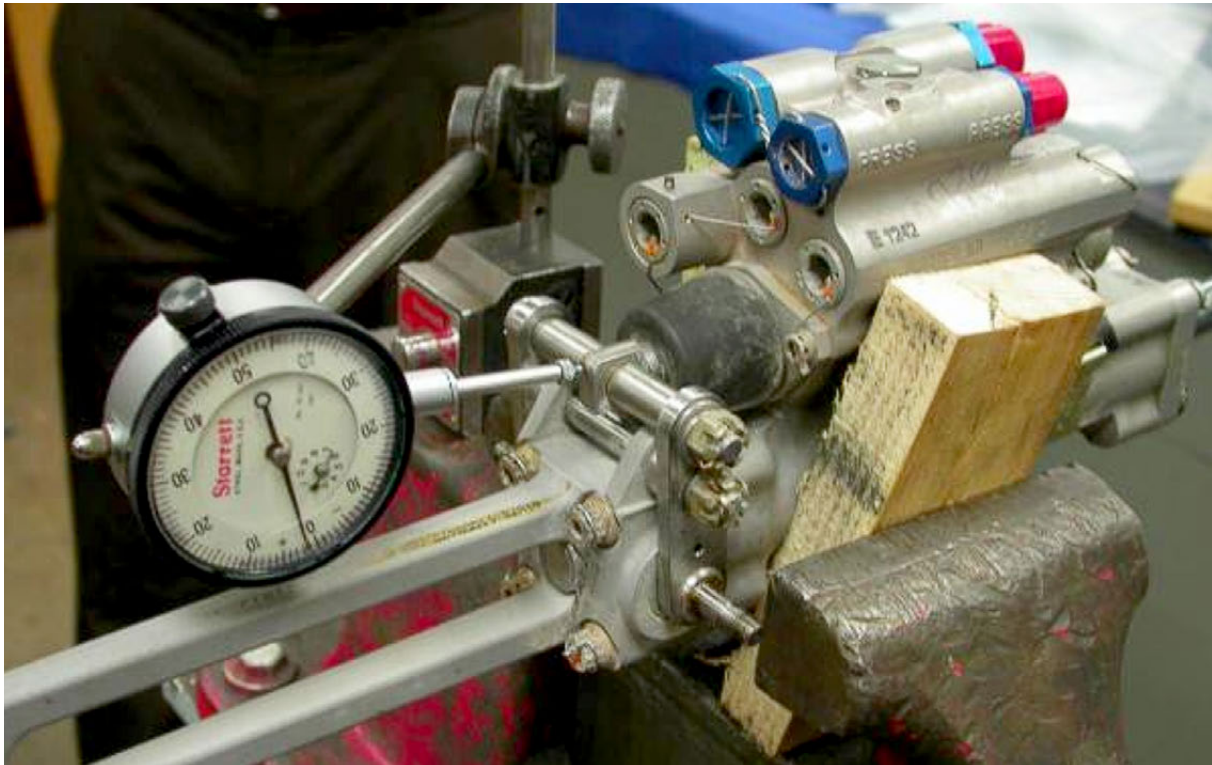
Figure 15. Operational test

All three servos were connected on a test bench so they could be operationally tested. The pistons on the right cyclic servo (S/N HR2588) and the collective servo (S/N HR2539) could be actuated and moved their full length of travel correctly. This was not the case with the piston on the left cyclic servo (S/N HR2036), which was in its extended position and could not be retracted. The input lever total stroke was measured again for the solenoid valve on this servo and found to be 0.011" (0.28 mm), which indicates that the nut and shaft moved while the servo was being connected to the test bench. After being adjusted once more to its initial position of 0.015" (0.38 mm), a second attempt was made to retract the piston, which it did, though very slowly. The extension process occurred at normal speed.

The nut and shaft were then adjusted to the position associated with an input lever total stroke of 0.023" (0.58 mm), corresponding to a normal configuration, as found on the two other servos. This time when pressure was applied, the piston extended and retracted at a normal speed, similar to that recorded for the other two servos.

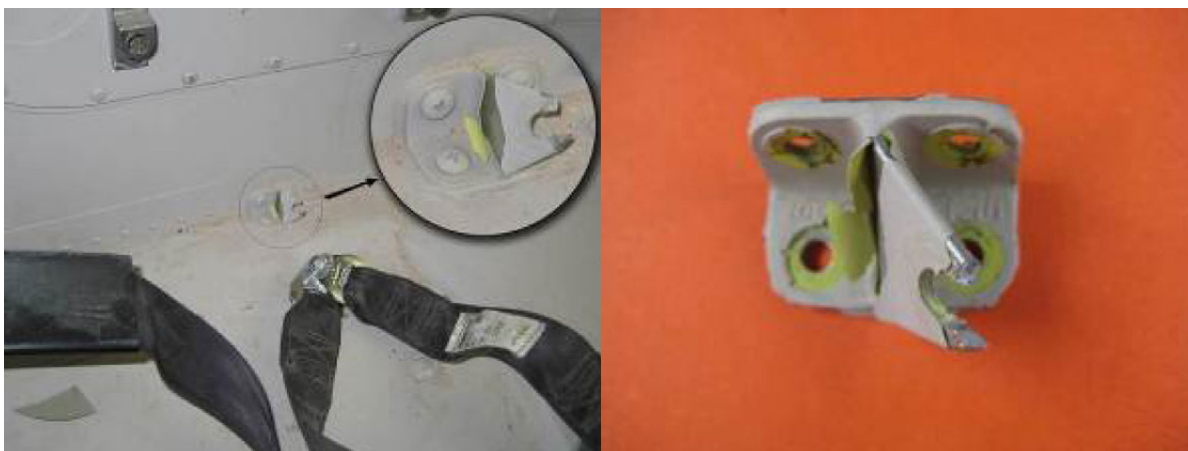
Figure 16. Location of harness attachment and close-up of fracture

The lug on the row of back seats that is screwed to the helicopter frame and used to attach two of the safety harnesses was broken as a result of the accident.

The process that led to the fracture of the lug that was screwed to the structure and that served to attach two of the safety harnesses from the rear row of seats was studied in detail. This analysis concluded that the fracture occurred as the result of a ductile process caused by heavy tension on the central portion of the lug through the hook in the center hole. This significant overload first led to plastic deformation that bent the central portion. The sections on either side of the hole to which the harness was hooked then fractured under the shear stress of the buckle on the harness.

what had caused this lug to fracture, it was sent to the Material Testing Laboratory of the Aeronautical Engineering Department at the Universidad Politécnica de Madrid, which found that the piece had been manufactured from stainless steel with good mechanical properties, and that its performance during the overload was adequate. The piece was subjected to a significant plastic deformation, resulting in ductile failure.
