Report IN-035/2015

Incident involving
a Boeing 737-800 aircraft,
registration number EI-DLR,
operated by Ryanair,
at Barcelona airport,
on 12 December 2015

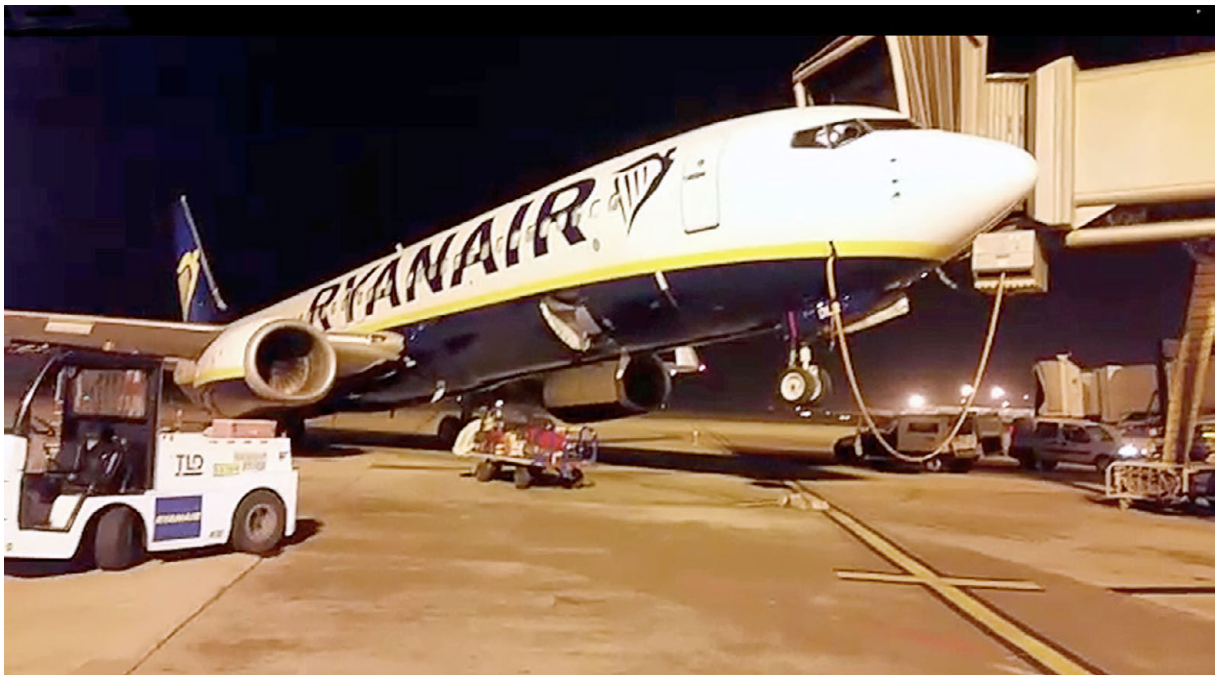
Figure 1. Attitude of the aircraft lifted by the finger

Briefly after this, the door L1 of the aircraft, by which the aircraft was being lifted by the finger, could not bear the load of the aircraft nose, collapsed and the aircraft fell, hitting the nose gear against the platform area.

Several elements of door L1 were severely damaged by deformation due to overload. The “hard landing” and “tail strike” inspection had a negative result with regard to the damages produced to these elements: nose gear and tail skid and cone.

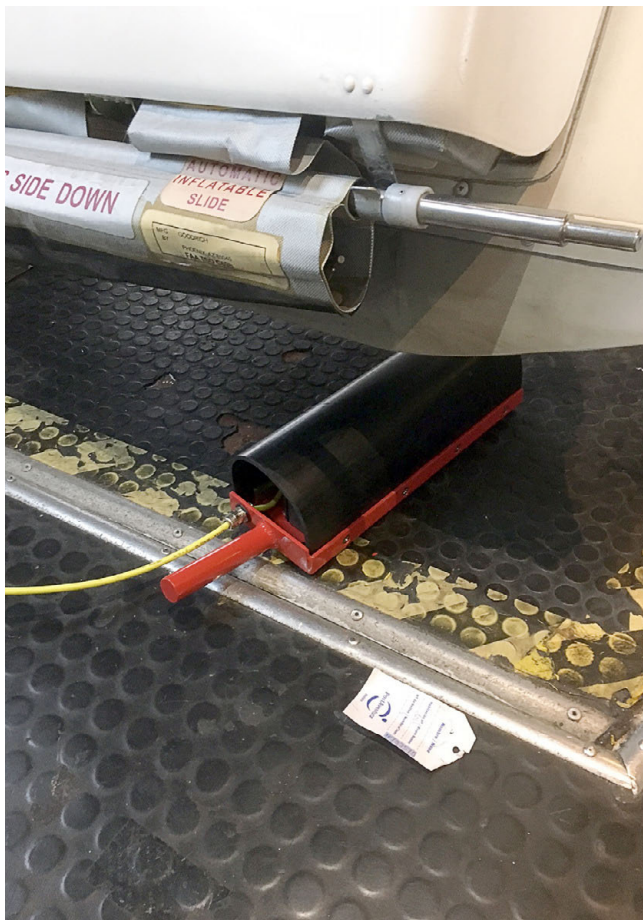
Figure 2. Positioning of the safety shoe between the door and the finger floor

The finger also suffered overload damages: damages to the safety shoe, cabin rotation chain and deformation of the cabin swivel floor.
