Report IN-016/2014

Incident involving a Boeing 737-800, registration OO-JLO, operated by JetAirfly, and a Boeing 737-800, registration D-AHFH, operated by TuiFly, at the Palma de Mallorca Airport (Balearic Islands) on 13 June 2014

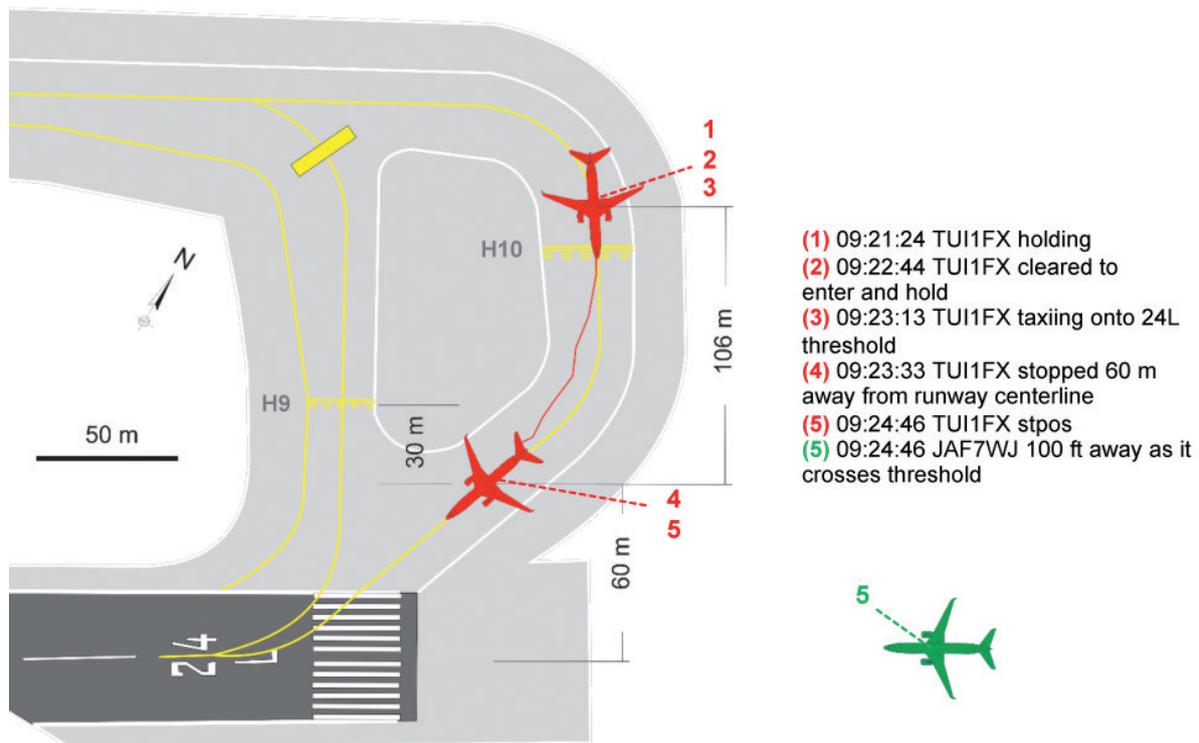
By the time the clearance to enter and hold was cancelled, the waiting aircraft (TUI1FX) had already started moving toward the threshold and had crossed the holding point. Even though it had not entered the runway proper, it was 60 m away from the runway centerline (Figure 1).

Figure 1. Relative positions¹⁴ of the taxiing (TUI1FX, red) and landing (JAF7WJ, green) aircraft

09:23:33 (point 4): TUI1FX we are beyond the holding point, we are beyond the holding point. By this point they were 106 m past holding point H10, 60 m away from the runway threshold and 30 m forward of holding point H9.

two holding points designated H9 and H10, which are 90 and 150 m away from the runway centerline, respectively²⁰. The layout of these two holding points is shown in Figure 1.
