## Report A-022/2015

Accident involving a WSK PZL-M18B  
aircraft, registration EC-FAT, operated  
by SAETA, at the Doade aerodrome  
(Lugo) on 15 July 2015

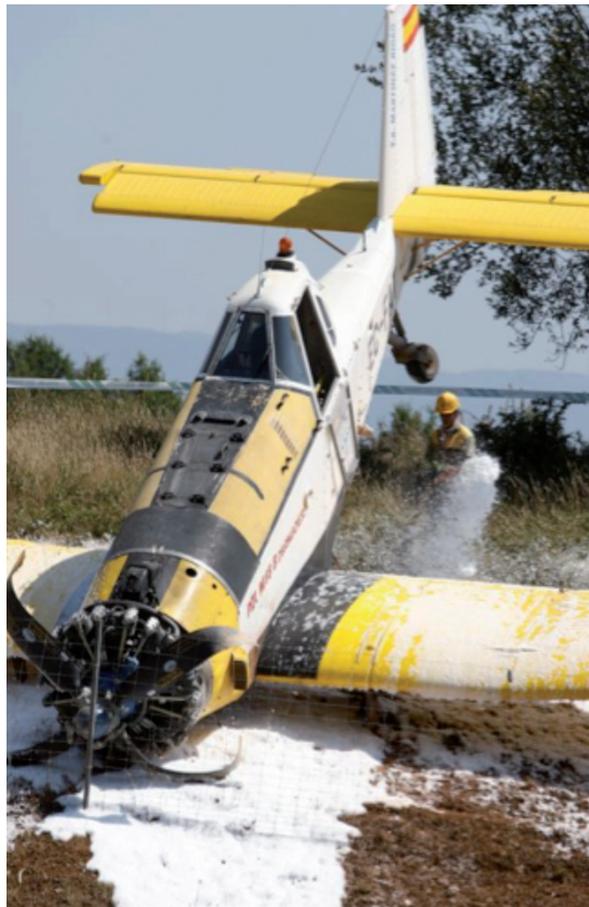
As the figure 1 shows, the aircraft sustained significant damage to all four propeller blades, which, though not twisted, were bent backwards. The damage was such that the propeller had to be replaced.

As for the engine, it had to be overhauled. The oil filter and its support frame were also fractured and had to be replaced.

Fig. 1. EC-FAT. Damaged propelier

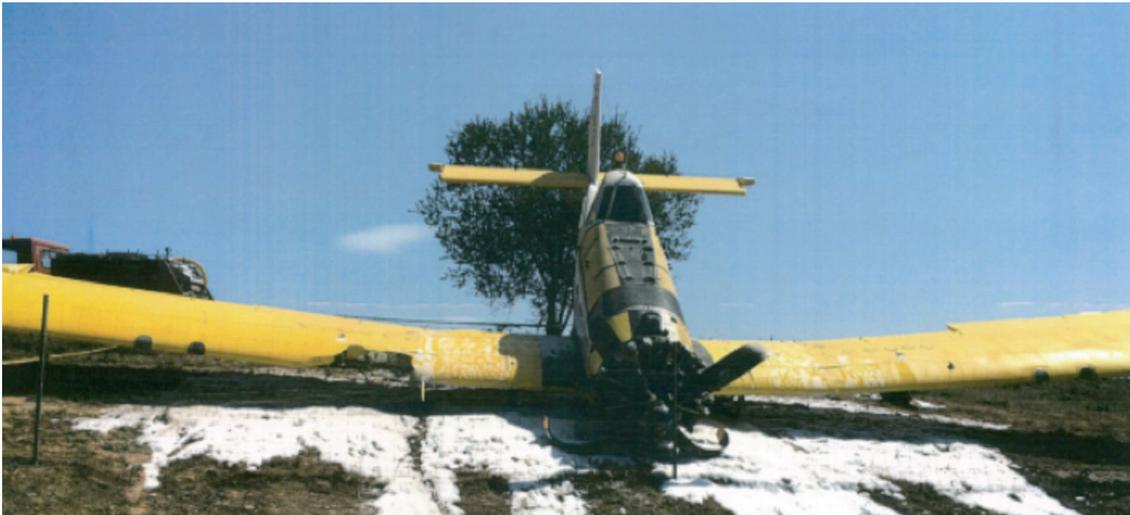
On the right wing, the leading edge exhibited several dents and loss of material at the junction of the right wing and the center wing, as shown in figure 2.

The right wing also had a dent at the tip, and part of the trailing edge on the wingtip was bent.

Fig. 2. EC-FAT. Damage to the right wing

Both wingtips and landing lights were replaced after the accident.

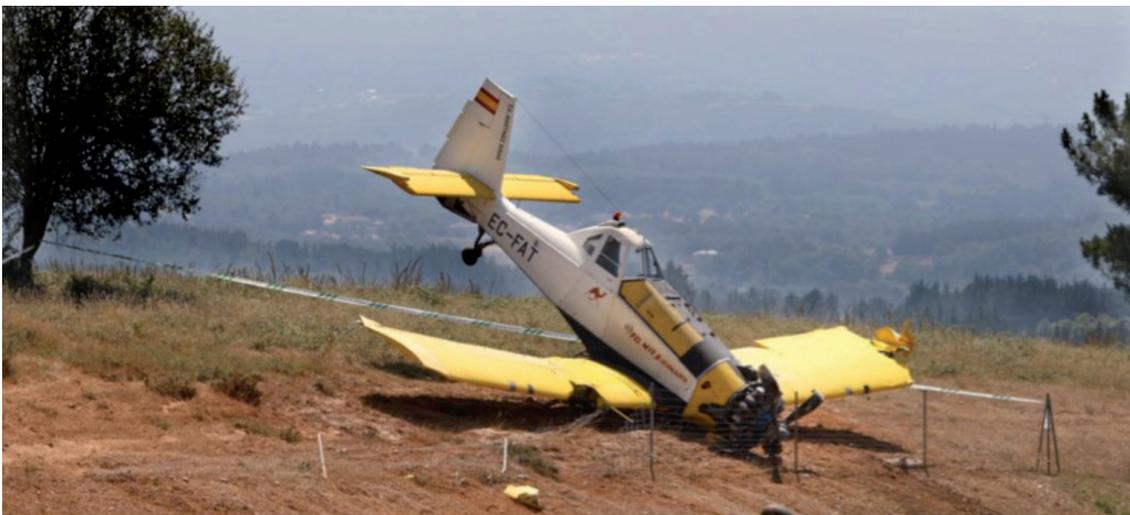
On the left wing there was a dent on the wingtip and several smaller dents on the leading edge. One of the landing lights was broken. The figure 3 shows the damage to the left wing.

Fig. 3. EC-FAT. Damage to the left wing

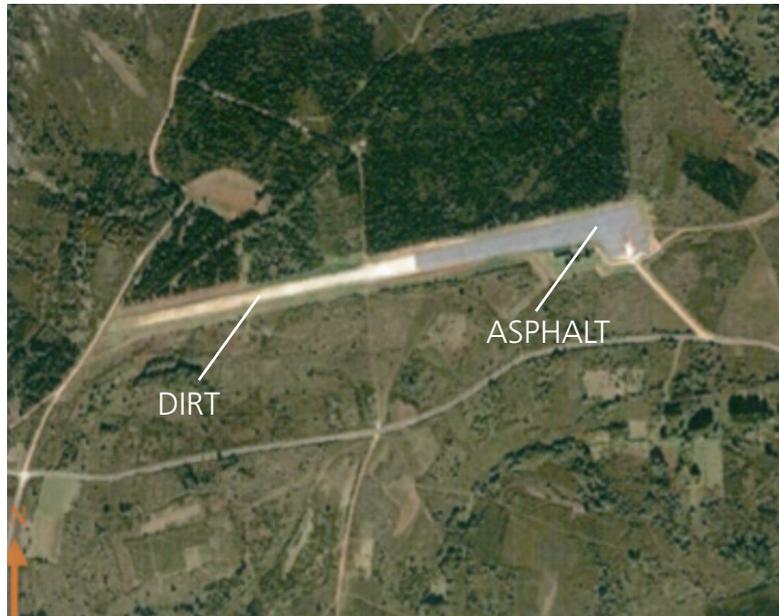
The runway is 900 meters long and 30 meters wide. The runway surface is asphalt in one segment and dirt in another. It does not have lighting. The runway orientation is 08/26.

Fig. 4. Runway at the Doade forest firefighting base

The Doade forest firefighting base does not currently have runway centerline markings, though it does have a windsock.

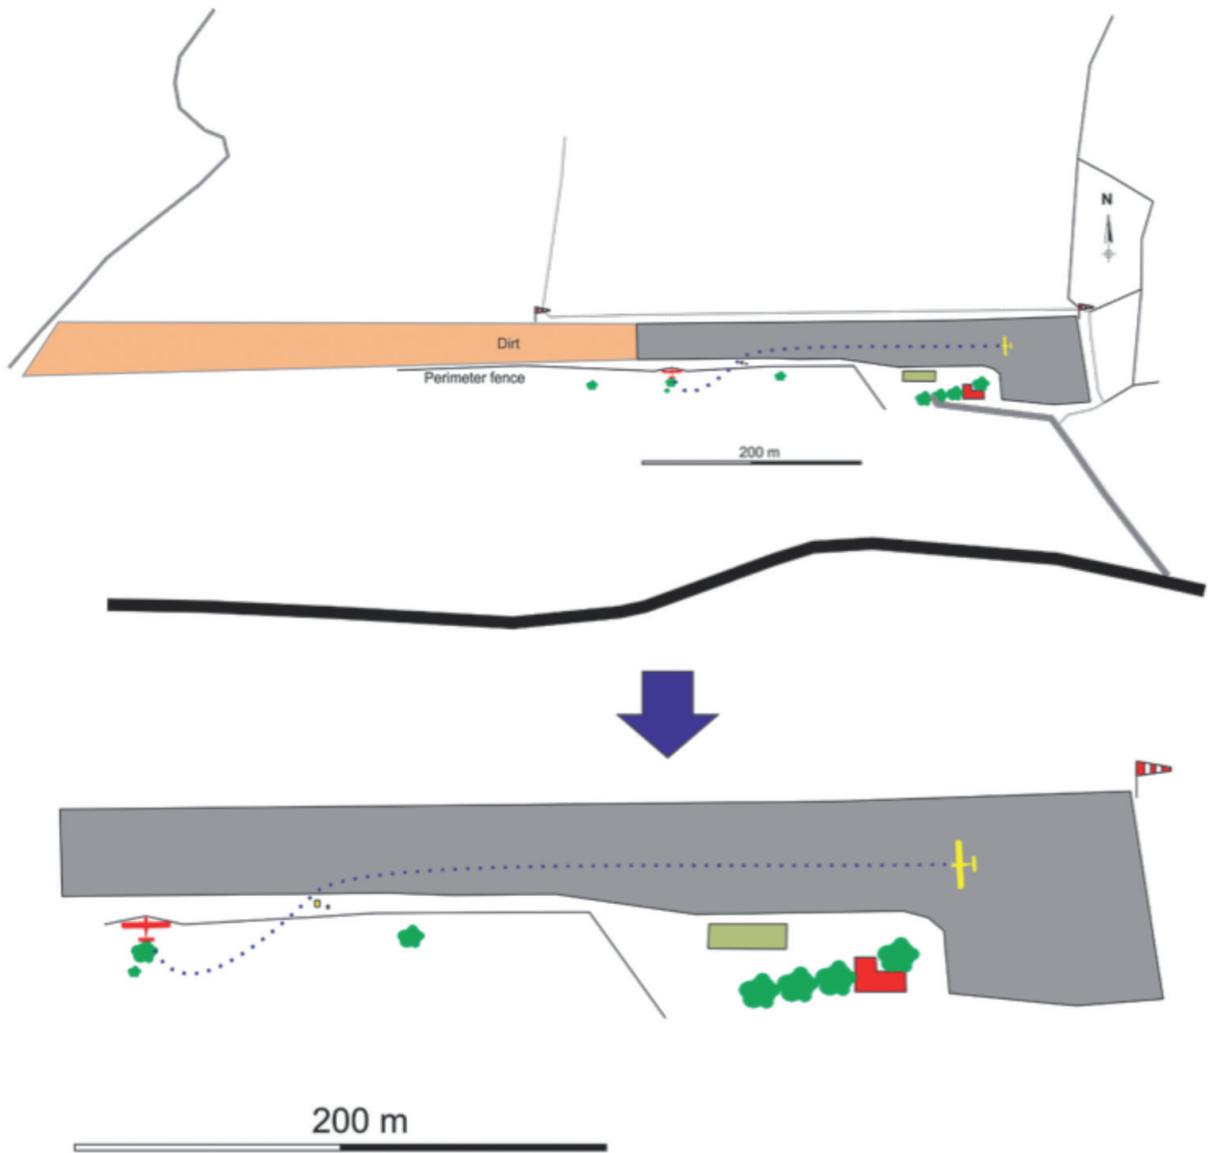
The two diagrams below show the aircraft's path on the ground. The second diagram is a close-up of the first. According to information provided by the operator, the aircraft traveled a total of about 300 meters before departing the runway. The pilot started correcting for the deviation toward the left after 80 meters.

Fig. 5. Diagrams of aircraft's path on the ground

While trying to abort the takeoff, he had approximately 220 meters of runway before he departed the runway, according to information provided by the operator. This is because he traveled a distance of about 300 meters, and he was unaware of the deviation for the first 80 meters. The 220 meters available were not enough to bring the airplane to a stop on the runway.

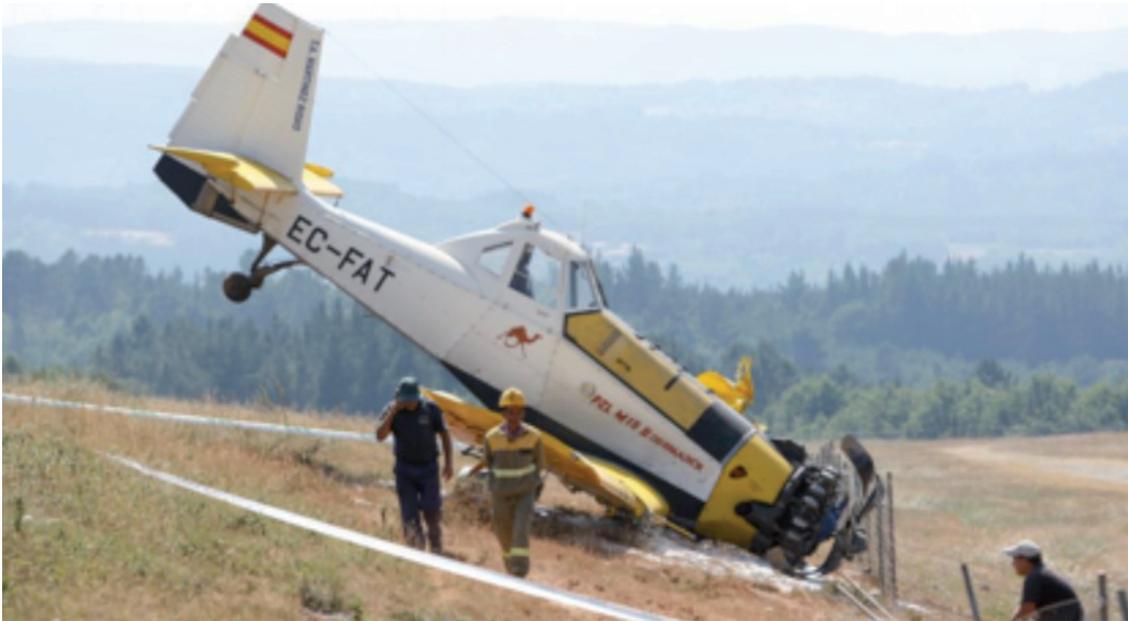
The aircraft experienced a runway excursion during its takeoff run at the Doade (Lugo) forest firefighting base. The runway excursion took place in the asphalted segment of the runway after the aircraft had traveled about 300 meters. The aircraft broke through a perimeter fence protecting the runway and came to a stop to one side of the runway, with the nose facing the runway.

Fig. 6. Orientation of the aircraft with respect to the runway

As a result of the runway excursion, of the fact that it broke through the perimeter fence protecting the runway and that it crashed into the surrounding terrain, the aircraft sustained damage to the engine, both wings and landing gear
