A-040/1999

TECHNICAL REPORT

**Accident of aircraft Agusta A-109-E,
registration EC-GQX, in the municipal area
of Villarejo de Salvanes (Madrid), on 26th
July 1999**

AIR ACCIDENTS AND INCIDENTS INVESTIGATION COMMISSION

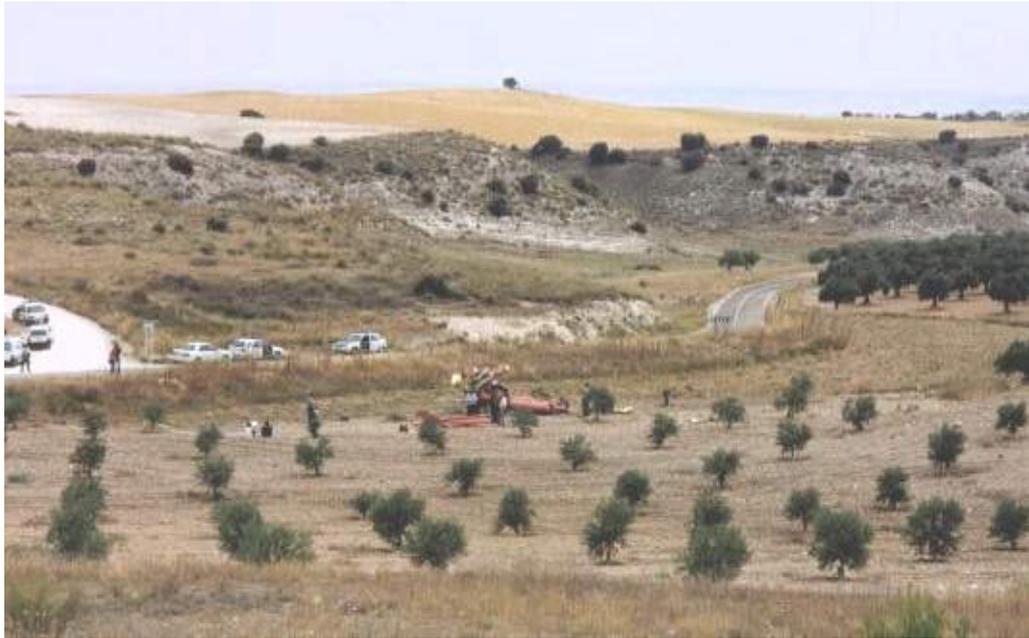
Photo 1.- General view. The helicopter entered from the top right area of the photograph, turned 180° and carried on descending until crashing into the ground

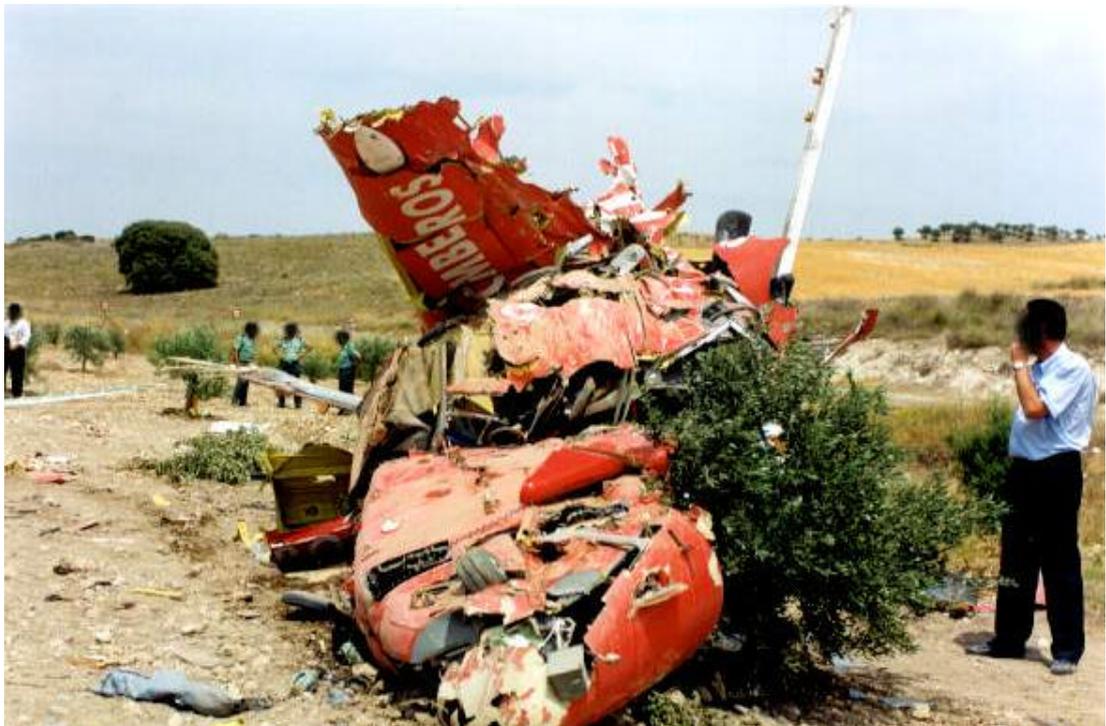
Photo 2.- Nose view. Landing gear retracted.

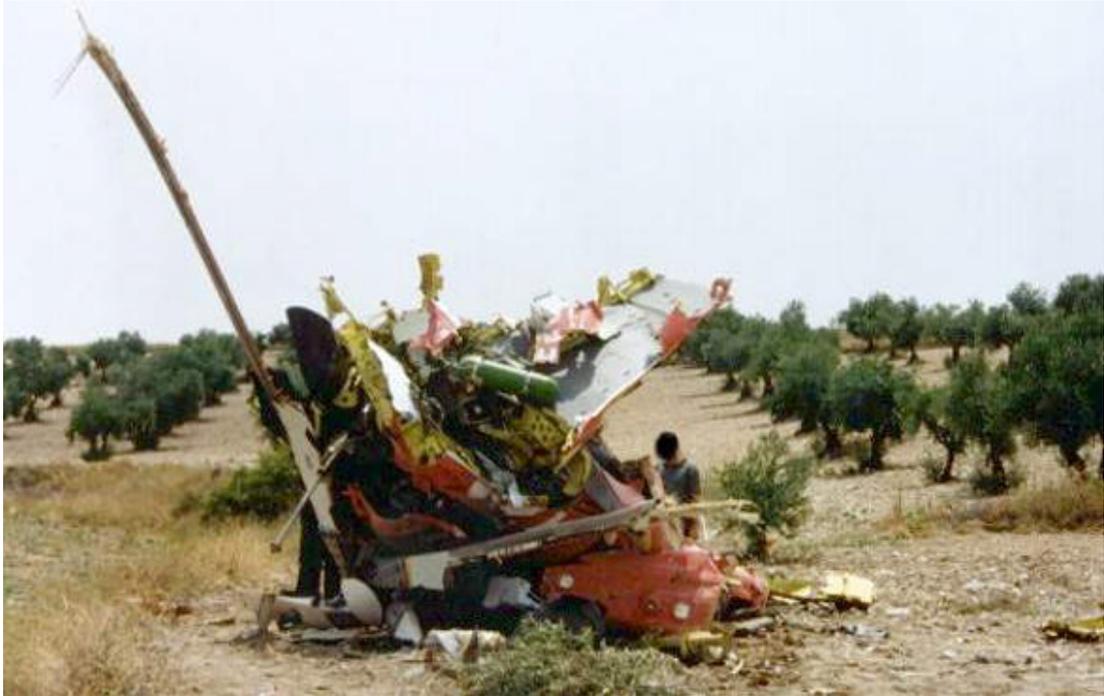
Photo 3.- Lateral view of the wreckage.

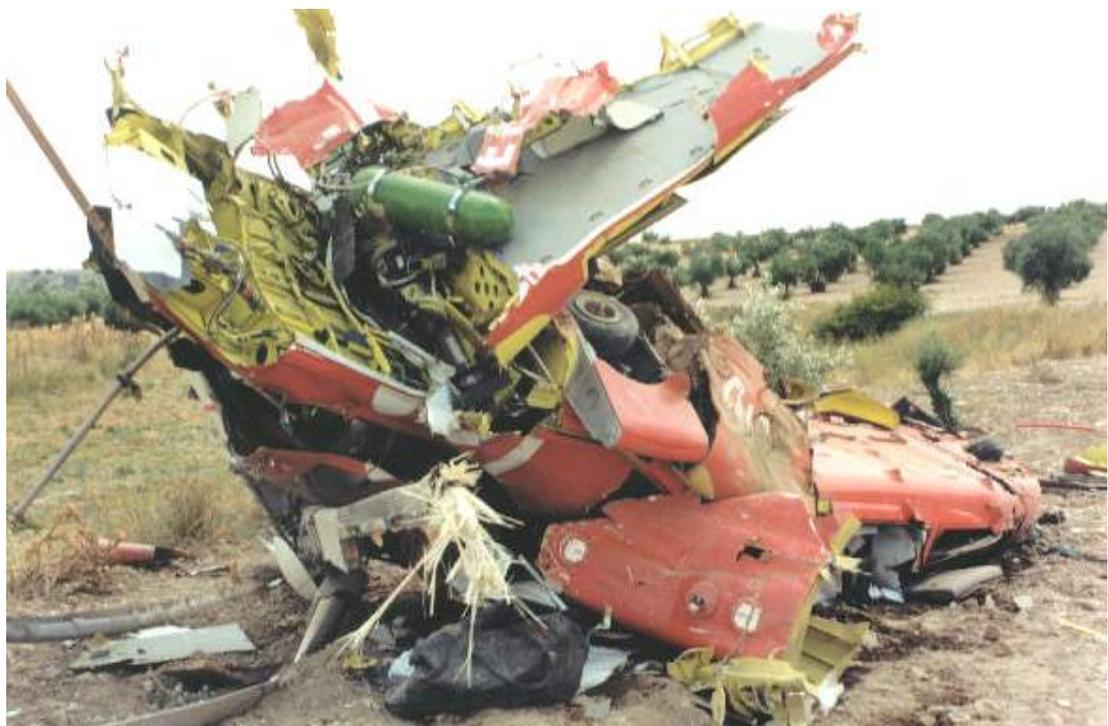
Photo 4.- Left lateral view.

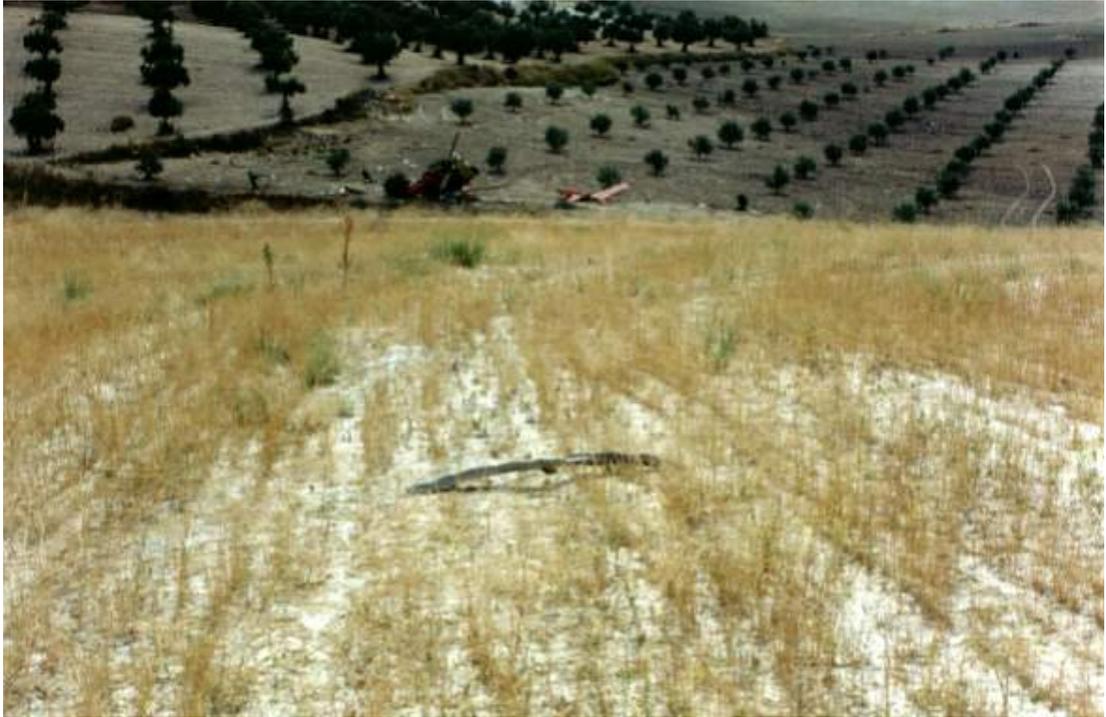
- Leading edge shield of the main rotor (blue blade): One part of this shield was found around 60 m away from the main wreckage site. This part showed a good condition of the spar bonding and the damage was a result of the impact with the ground with the rotor rotating. Therefore, the part had not become detached during flight.

Photo 5.- Blade leading edge shield (blue blade) located 60 m away from the wreckage.

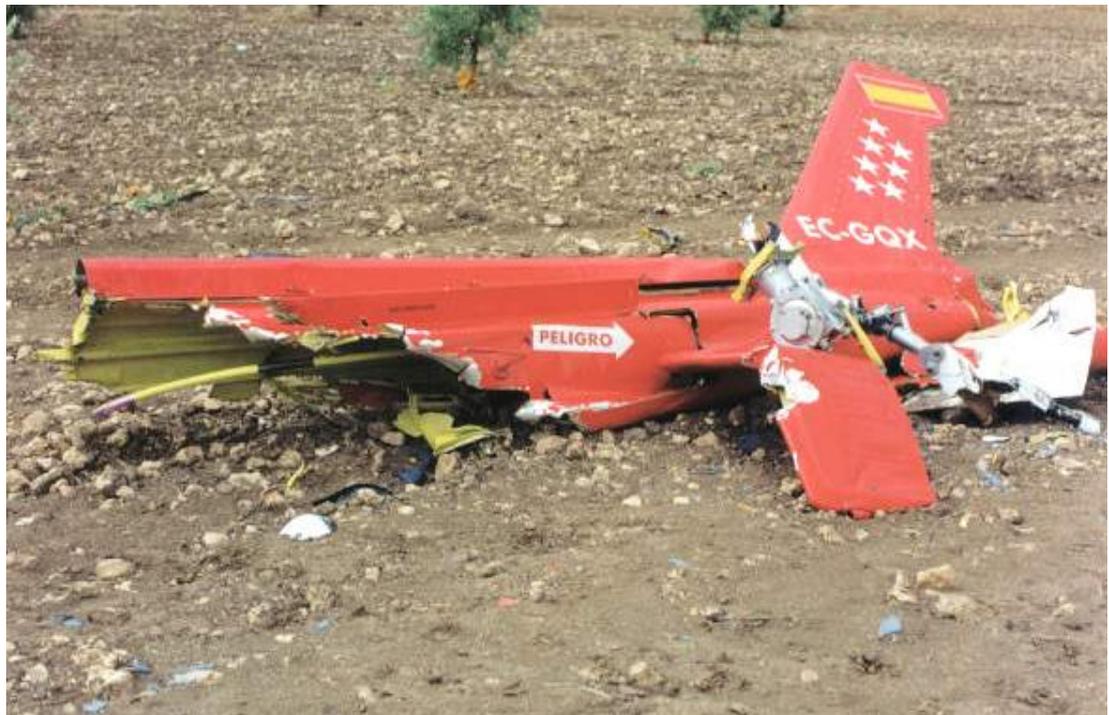
The tail boom had been cut by the main rotor blades during the impact and was left 6 m behind the fuselage. The tail rotor had come loose and ended up near the cone. The two blades of the tail rotor were present and highly damaged.

Photo 6.- Tail boom.

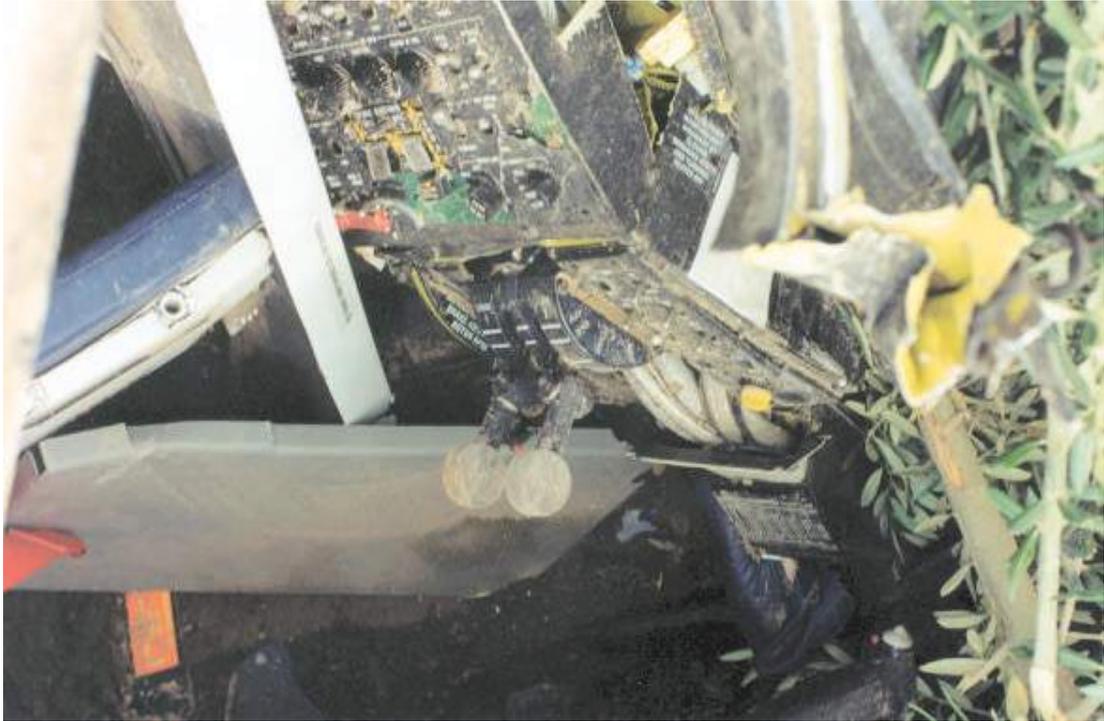
- Engine operating control switches located in the ceiling panel: It was observed that the position of these switches was not the normal flying position. The switch of engine 1 was in "IDLE" and engine 2 in "OFF". The gas levers, used only for manual control of the governor of each engine, were both in the flying position.

The roof panel was highly damaged and other switches were damaged or deformed due to the crash. Nevertheless, the OFF position may only be reached after pushing and rotating the switch, while the IDLE position simply needs to be rotated.

This position of the switch of engine 2 was the only sign of any engine malfunctioning, whilst the marks of the rotating parts indicated that the main and tail rotors were rotating rapidly during the crash. An engine failure would have required, according to the flight manual, the gas lever to be put into OFF and shut off the fuel, whilst both were found in a position consistent with a normal engine condition.

Photo 7.- Detail of the position of the power levers and engine switches on the ceiling panel. Right hand switch is in the "OFF" position.

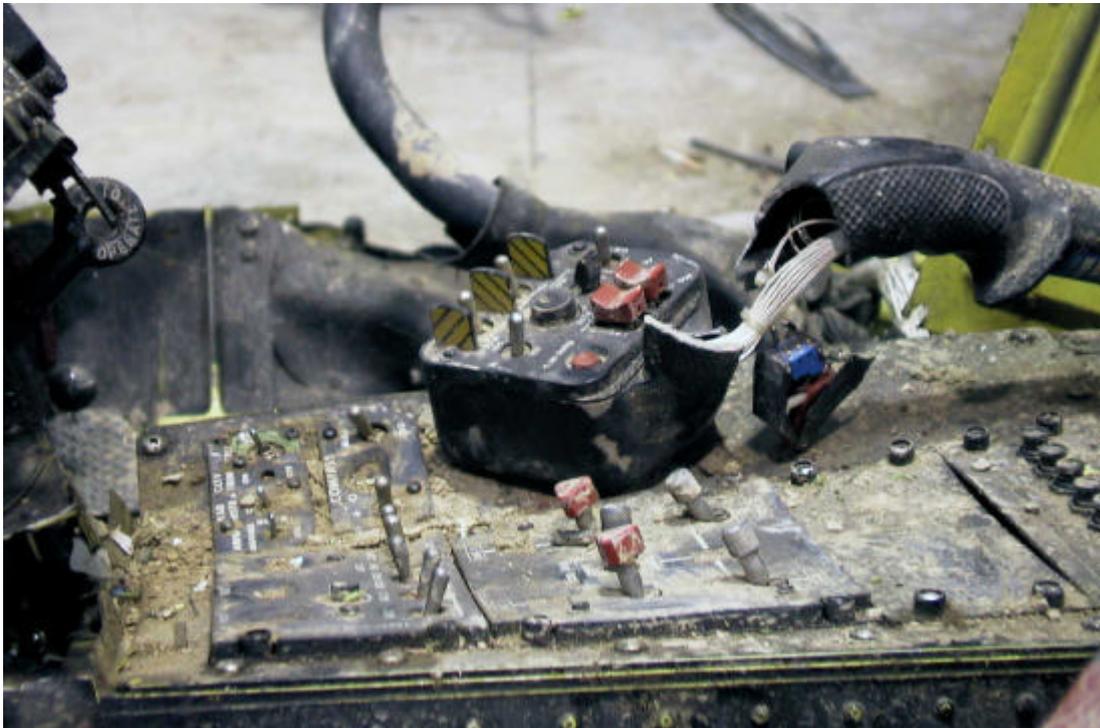
Photo 8.- Switches on the collective lever grip switch box.

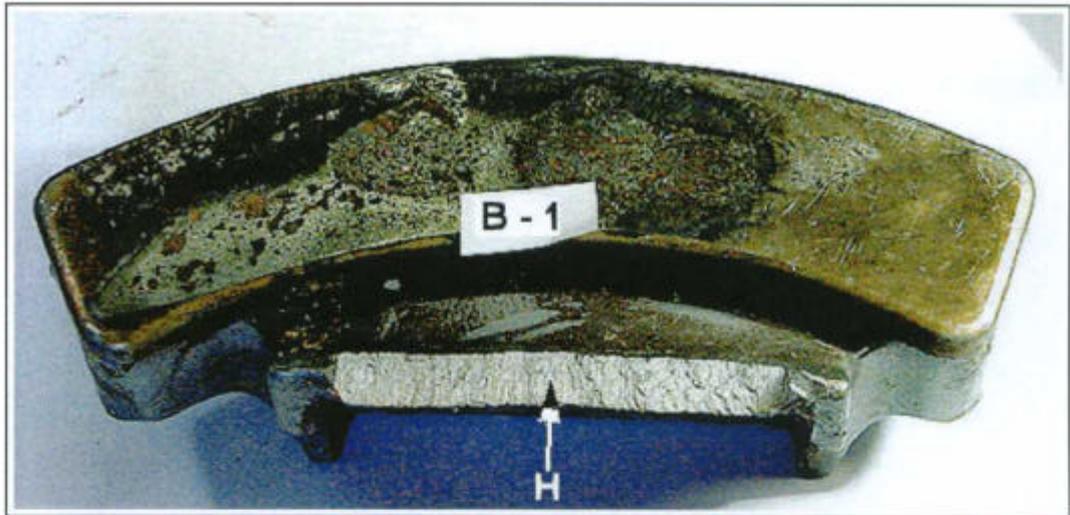
- Grip lower static stop of the main rotor: The four stops had come away from the grips. They showed static failure due to a stroke against the floating ring as a result of an excessive flapping movement.

Fig. 5.- *Tope de posición límite de las palas con rotor parado (rotor principal)*

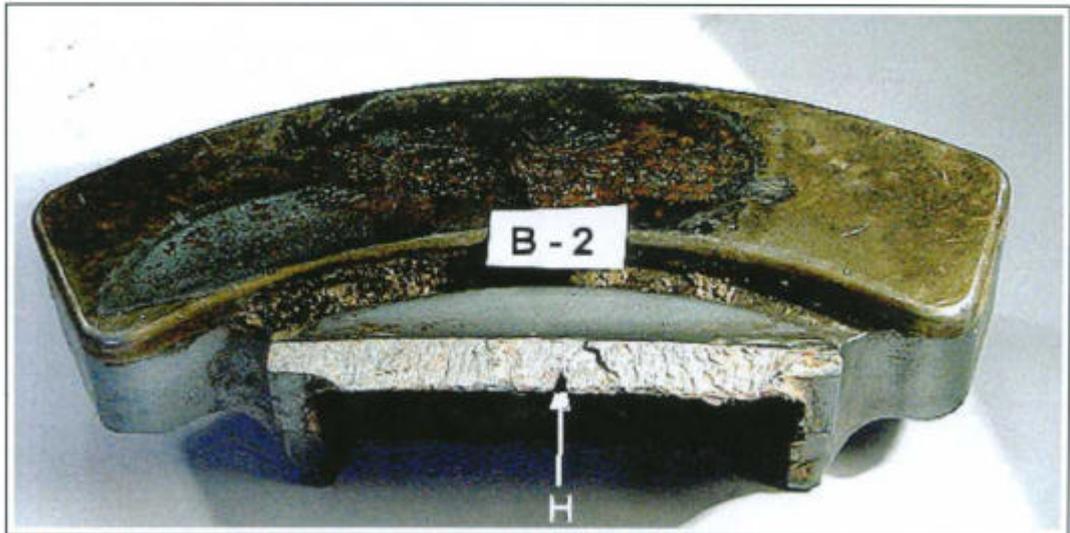
Fig. 6.- *Tope de posición límite de las palas con rotor parado (rotor principal)*

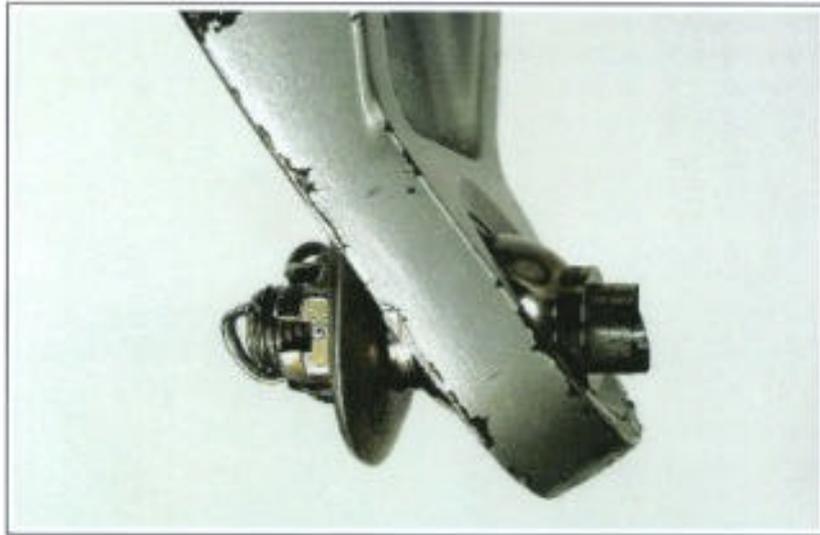
Fig. III.30.- Espacio entre la rotula y la rotura del bulón en el que probablemente estuvieron colocadas las arandelas

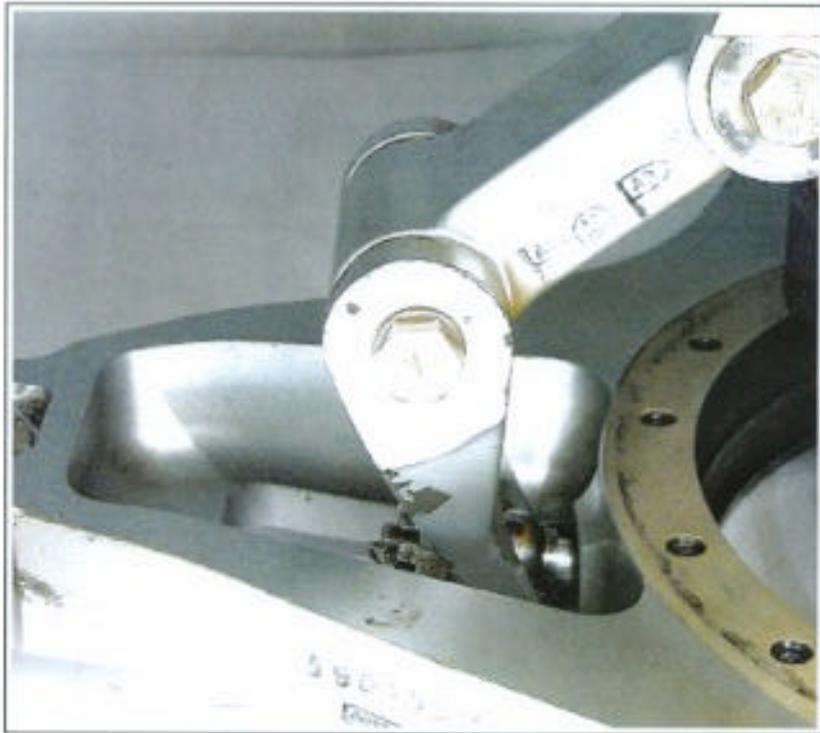
Fig. III.31.- Disposición relativa entre tijera y plato giratorio en las condiciones de montaje

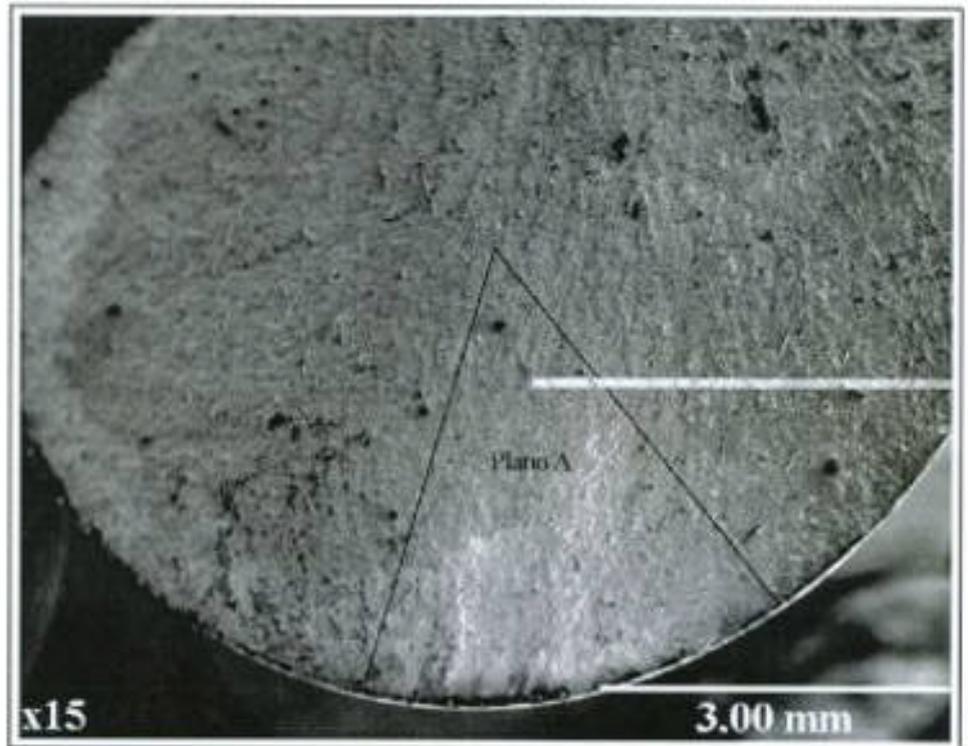
Fig. III.16.- Detalle de la zona A de la superficie de fractura

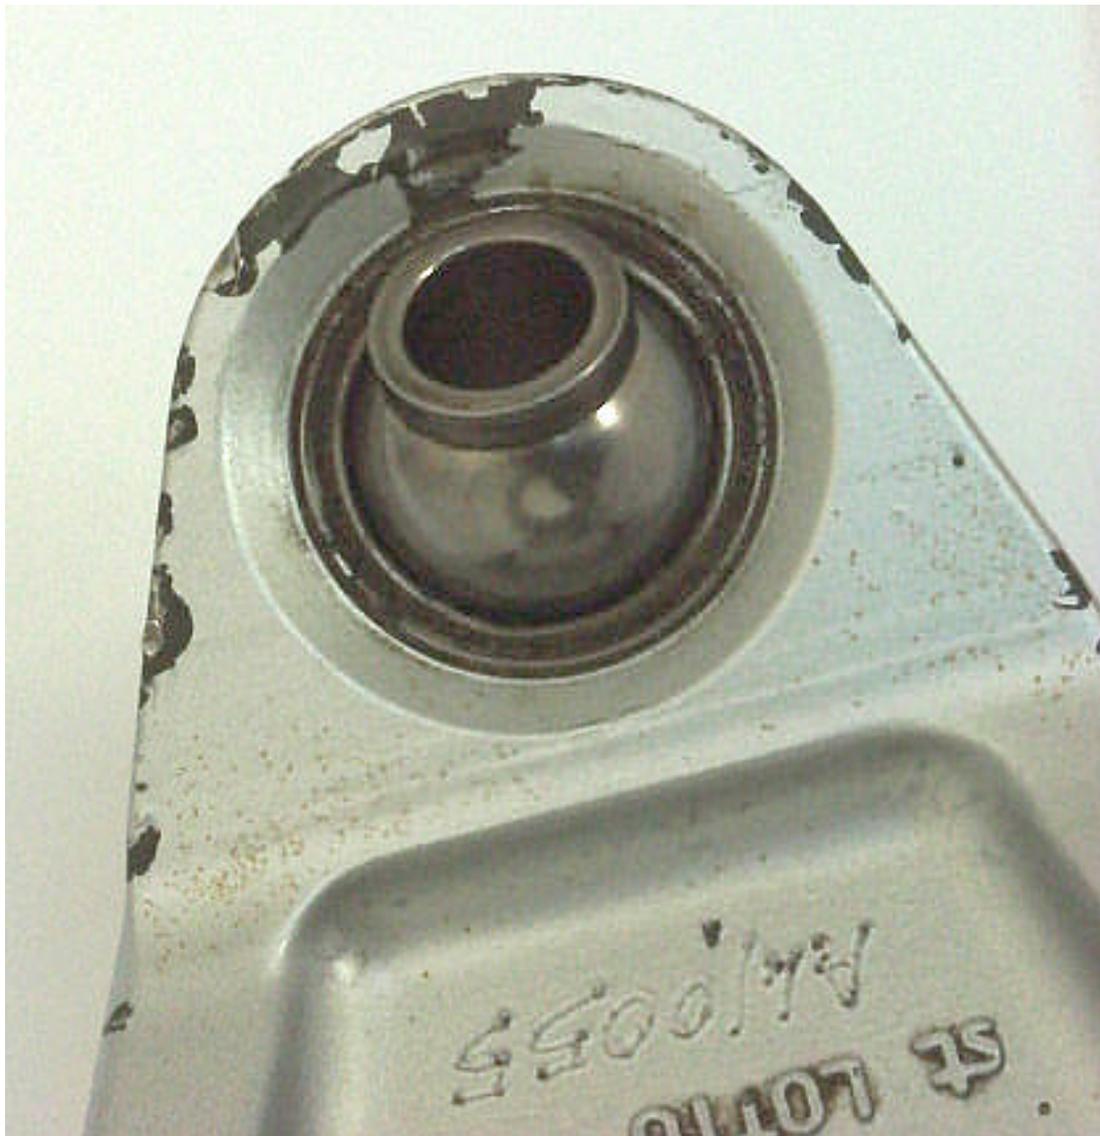
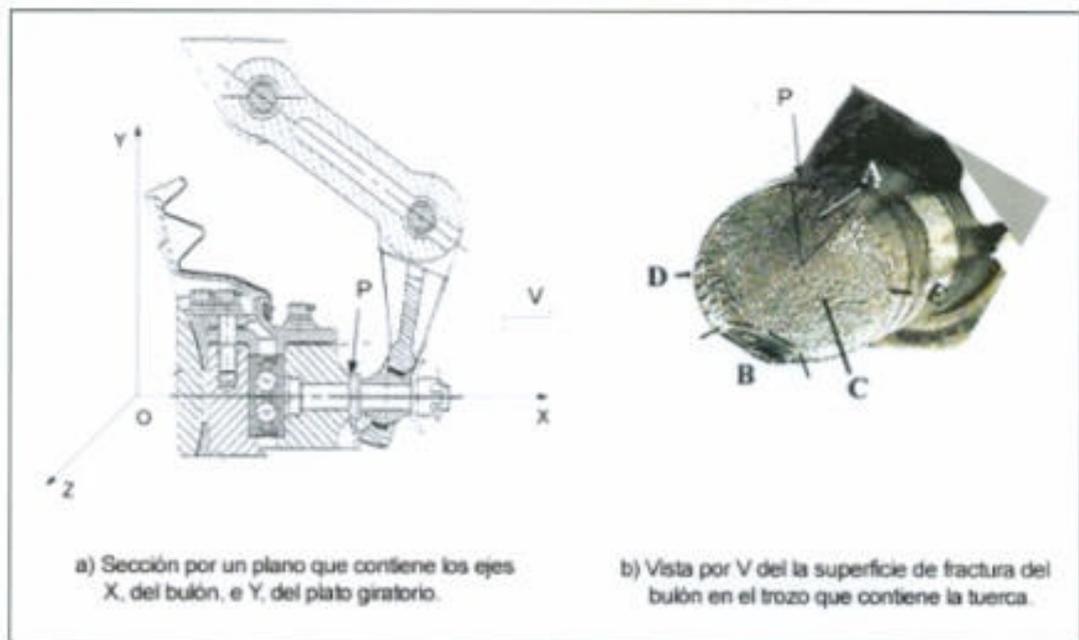
- Lower rotating scissors bolt: It was believed that the failure in this bolt was static caused by excessive shear loads and, therefore, seemed to be a consequence of the crash.

Fig. III.15.- Situación del bulón roto y superficie de fractura del bulón

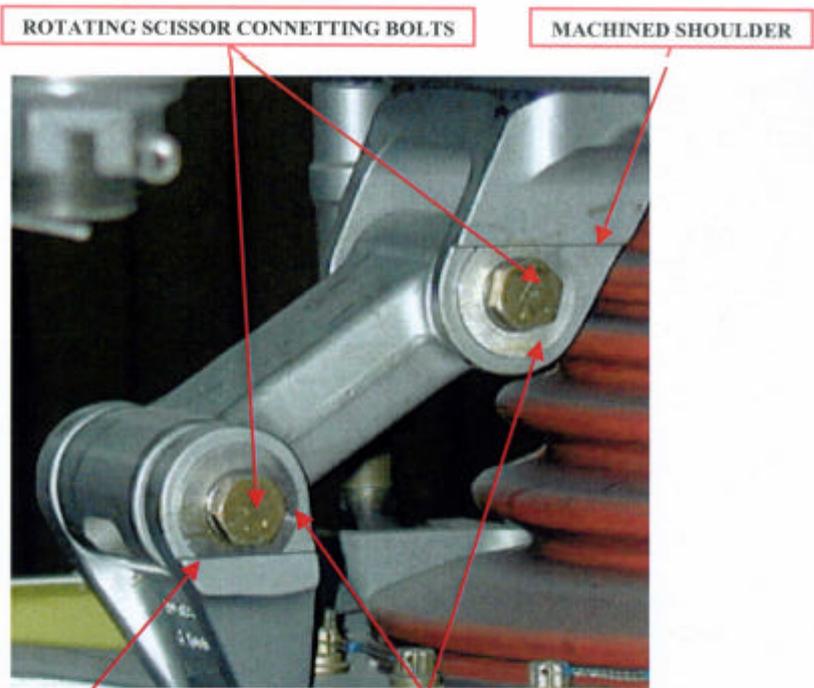
CUT SHAPED FLANGED SLEEVES TO MATCH THE MACHINED SHOULDER. FLANGE SLEEVES POSITIONED AT THE SAME SIDE

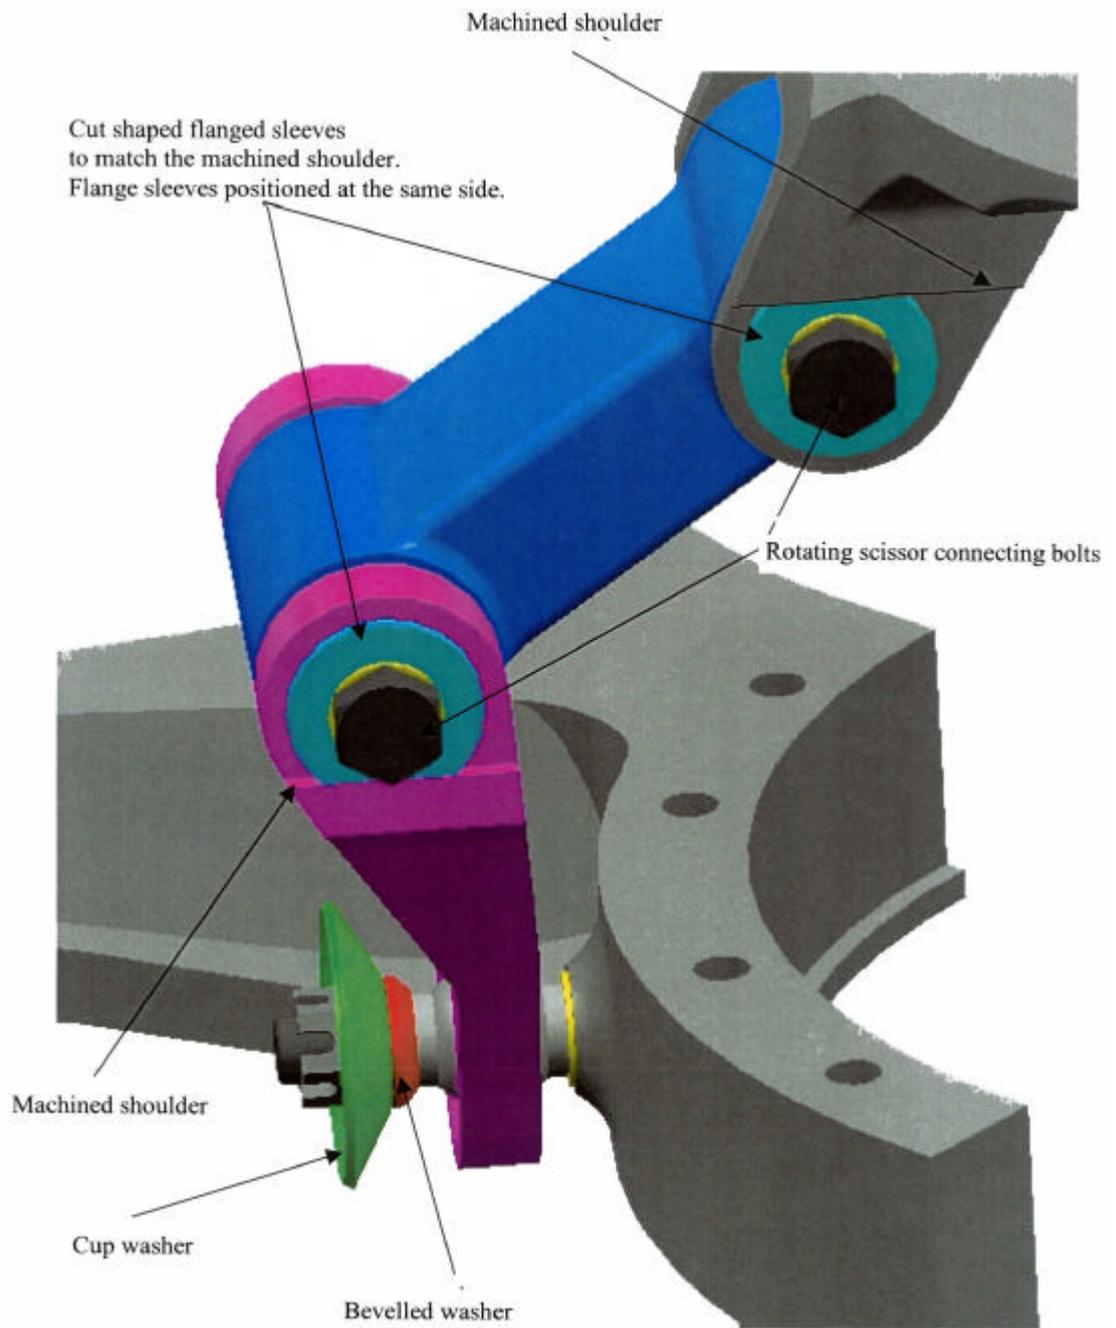
CORRECT INSTALLATION

The following three dimension figures clearly show as appear a correct installation in respect to the wrong one. It is evident that a correct positioning of the two flanged sleeves preclude an incorrect installation of the scissors.

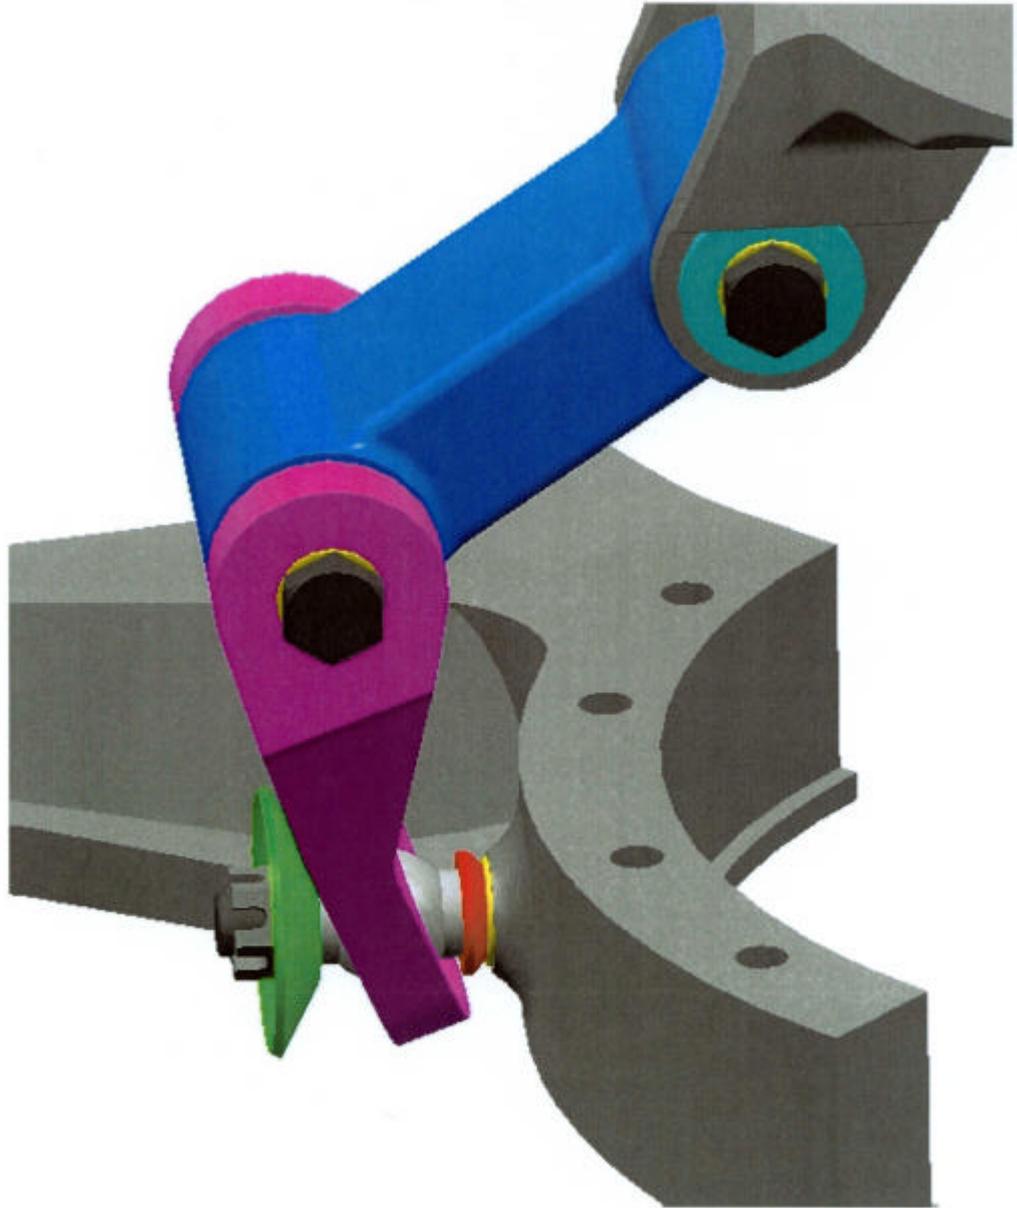
WRONG INSTALLATION

The operator installing the lower link in the reverse position (back to front) have consequently assembled also the flanged sleeve in the opposite direction. So doing it was realized an installation clearly not consistent with the indication of the figure 62-27 A.
