DATA SUMMARY

Registration	RA44543
Type and model	SUKHOI Su-26
Operator	N/A

1.1. History of the flight

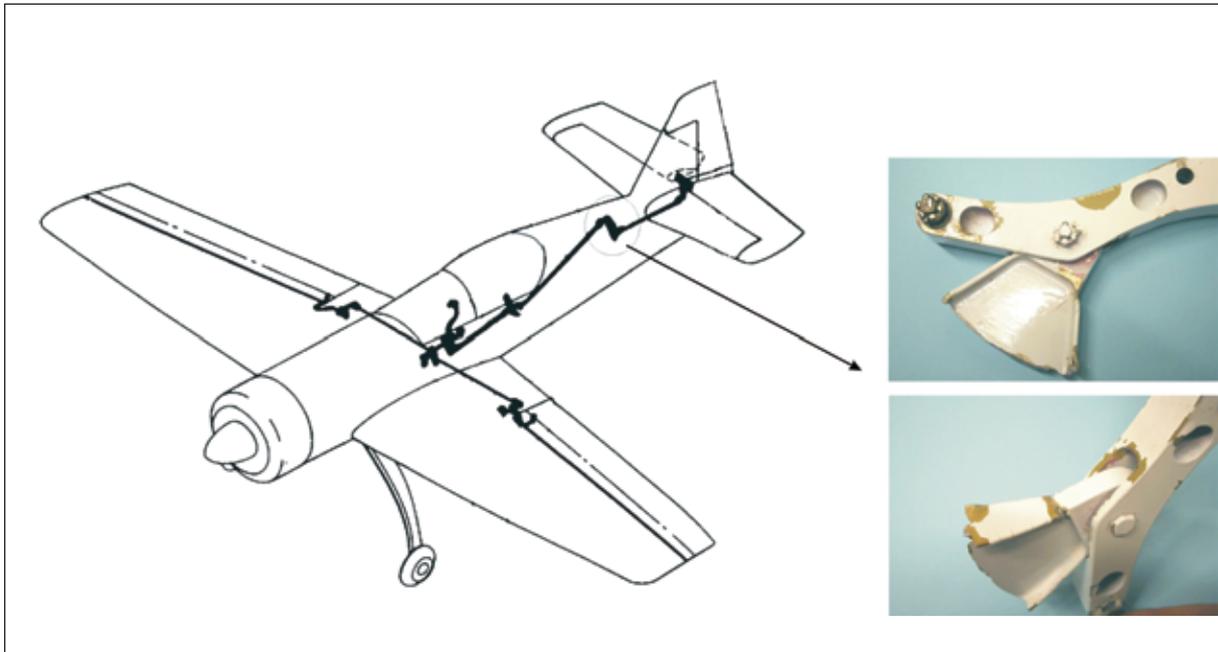
The aircraft's tail structure was still intact after the impact. The movement of the rudder did not interfere with that of the elevator, and vice versa. The elevator is controlled by an articulated bar mechanism; on the bar closest to the control surfaces, marks and deformations were found caused by the cable located among the wreckage.

Figure 1. Situation of and damage to the elevator mechanism

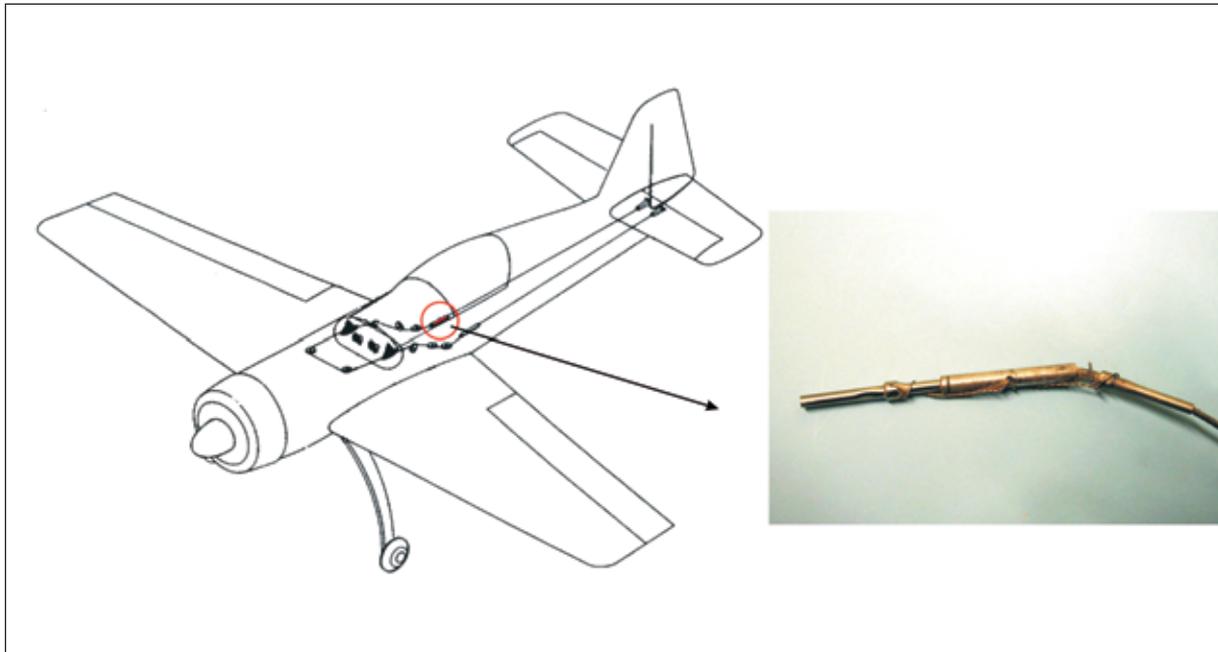
The rudder control cable had different types of fixture at each end: the rudder end was coupled to a terminal with an orifice of the eye terminal type. At the other end there was a tensor joining two terminals; one of them had lost the cable and its shape and appearance were different from the other.

The components of the tensor were studied to determine the characteristics of the terminals fastened to it. The terminal that lost the control cable displayed a step 9 mm from the end of the orifice, caused by defective machining, which prevented the cable from penetrating to the end of its housing. Moreover, during the fitting of the cable to the terminal, it was not tightened sufficiently, as is demonstrated by the small dimensions of the traces made in the inner walls of the orifice. The outer crushing of the terminal had no effect on the inner part of the orifice.

At the other terminal of the tensor, the cable had been inserted to the end of the orifice, and the tightening between the two elements reduced its cross-section by around 20%, in such a way that the fixture would cause the breakage of the cable before it broke away from its housing.

Figure 2. Situation and condition of the control cable tensor at the rudder end

It has been determined that the separation of the cable from one of the two terminals of the tensor was due to a manufacturing defect of the terminal and incorrect assembly between the cable and the tensor.

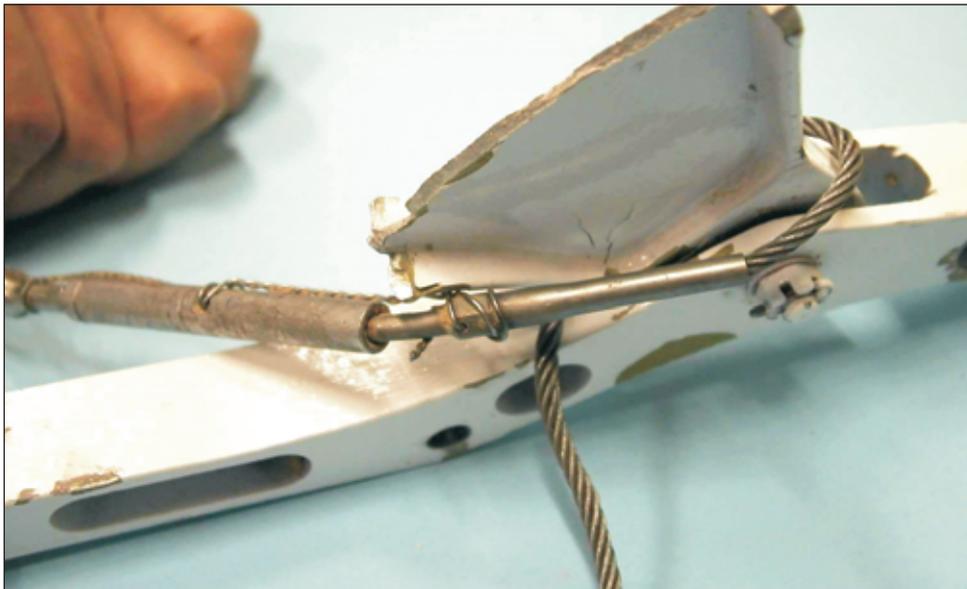
Figure 3. Lock of the elevator

The Sukhoi Su-26 aircraft had arrived in Spain from Lithuania, where it had been subjected to a series of modifications affecting the engine, propeller, avionics, tail, etc. In the course of its first familiarisation flight in Spain, during the execution of an aerobatic manoeuvre, it suffered the breakage of one of the tensors of the rudder control system, which, on moving towards the tail, jammed an element of the elevator control system, preventing it from moving.
