DATA SUMMARY

| Site | Valencia Airport |

| Registration | EC-FCC |
| Type and model | CESSNA 402-B |

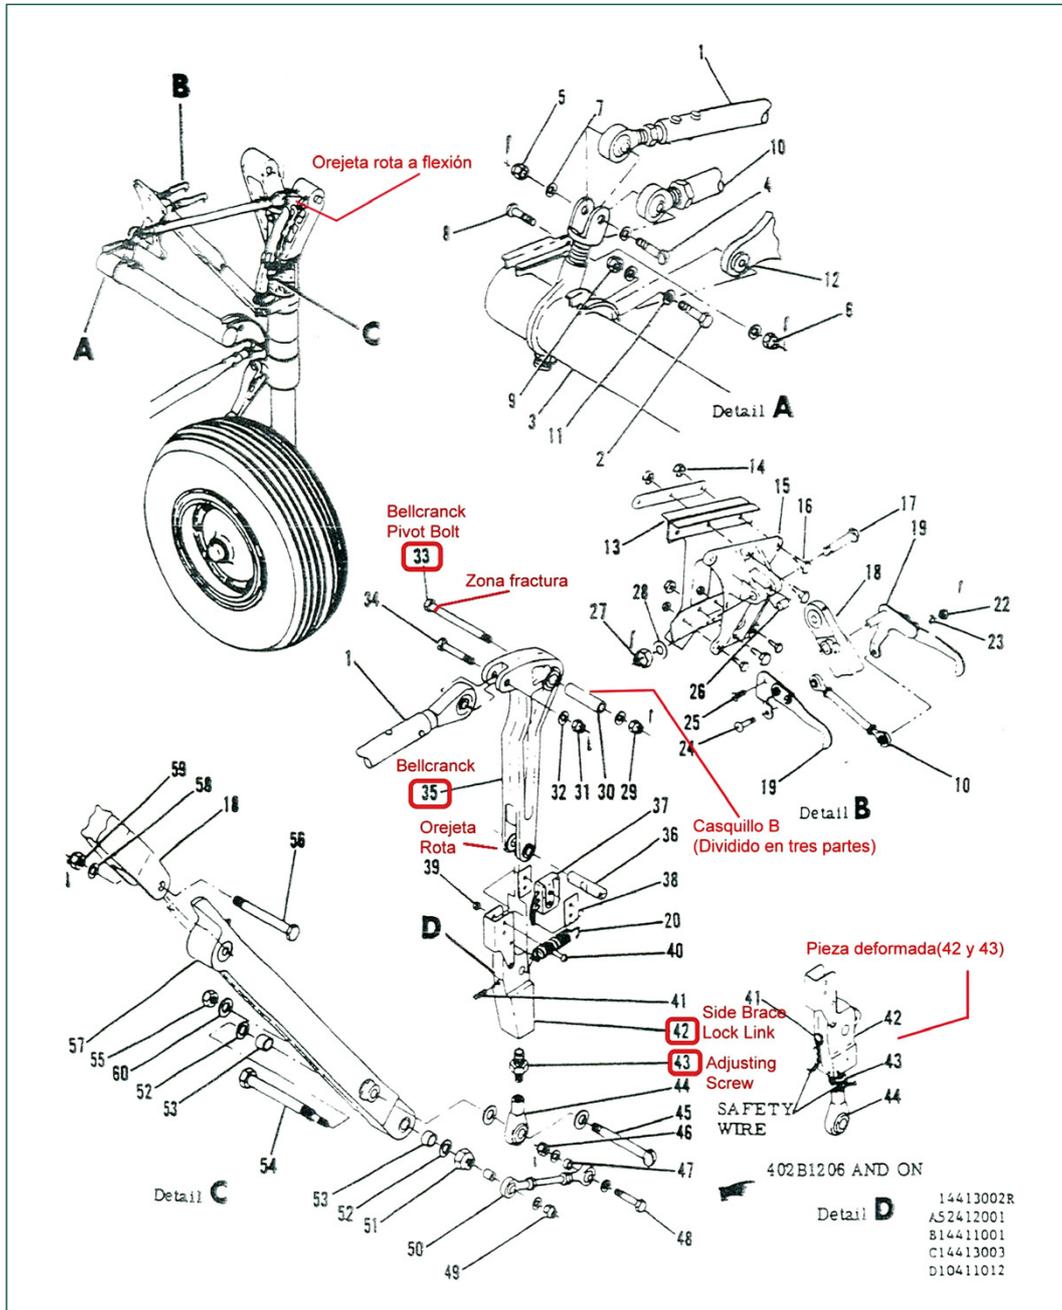
Figure 1. Schematics of the breakdown of the main landing gear leg

It was noticed the breakage of the bellcrank pivot bolt (see attached Drawing 1, item 33) that fits the bellcrank (35) to the leg of the gear through two fittings welded to that leg. One of those fittings (the rearmost when looking in the sense of the flight) was still attached to the leg together with the head of the broken bolt. The forward fitting was broken due to bending and remained partially held by the nut of the bolt (33).

Additionally, one of the two lower fittings of the bellcrank (35) was torn by bending.

The adjusting screw (43) was also deformed.

- a) The sequence of the breakages started with the fracture of the bellcrank pivot bolt (item 33 of Drawing 1 above) because, otherwise, the rear fitting (when looking in the sense of flight) of the left leg of the main landing gear would not have remained undamaged with the head of the bolt still inside.
- b) The front fitting then bent and broke due to bending moments, as happened to one of the lower fittings of the bellcrank (35) that was joined to the side brace lock link (42). The adjusting screw (43) was also deformed.
- c) From that moment on, the geometry of the mechanical assembly of the overcenter (that maintains locked the landing gear) was disturbed, and the leg retracted on its door and produced a series of breaks and deformations in several components of the left landing gear.

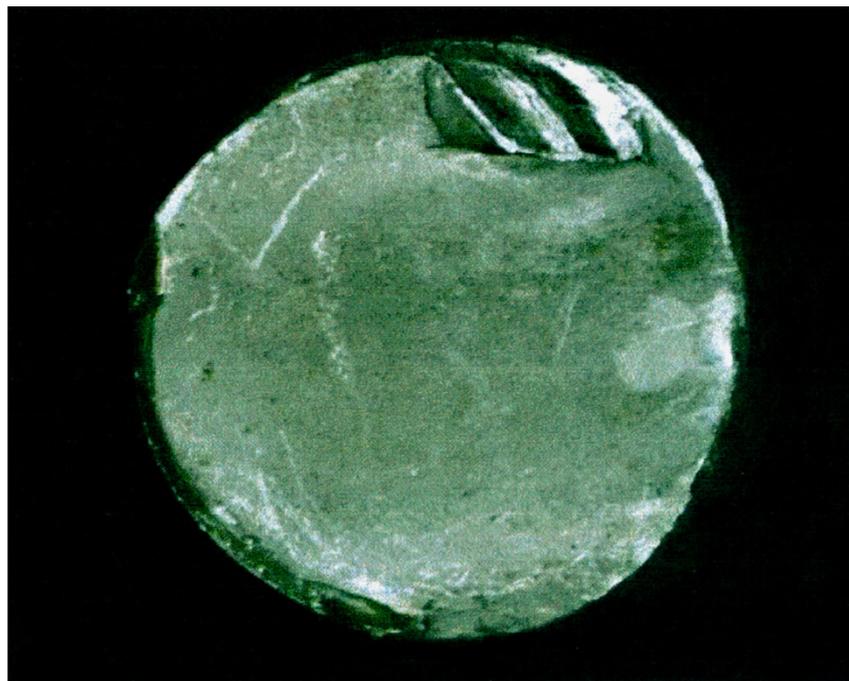
Photo 1. Macroscopic view of the fracture surface

The fractographic evaluation carried out on the fracture surface of the bolt concluded, at a macrofractographic level, that there had been a static failure mainly due to shear loads, which was later confirmed at microfractographic level when domes were detected representing the fracture effects of shear loads.

By means of optical emission spectrometry it was determined that the chemical composition of the bolt corresponded to a low-alloy steel of type AISI 8740, with a medium level of strength as obtained by Rockwell-C hardness measures of 142 KSI (kilo pounds per square inch).

The specification NAS464 establishes that the strength level must be between 160 KSI and 180 KSI.

The bolt evaluated had an actual strength of 142 KSI, which is a 11,25% lower than the minimum required by that specification.

This incident was caused by the shearing of the bellcrank pivot bolt of the left main landing gear leg. This failure was probably due to the fact that the strength of the bolt was lower than the minimum required by the specification.

REC 11/06. It is recommended that Cessna Aircraft Company requires Honeywell TPG/Tristar to review their quality control systems of the elements and components provided as spare parts to be assembled in aircraft manufactured by Cessna Aircraft Company to further ensure that those parts comply with the specifications of the type design.
