Technical report IN-005/2005

Serious incident of aircraft
Tupolev 154M, registration
RA-85644, operated by
Aeroflot, at Barcelona Airport
(Spain), on 27 February 2005

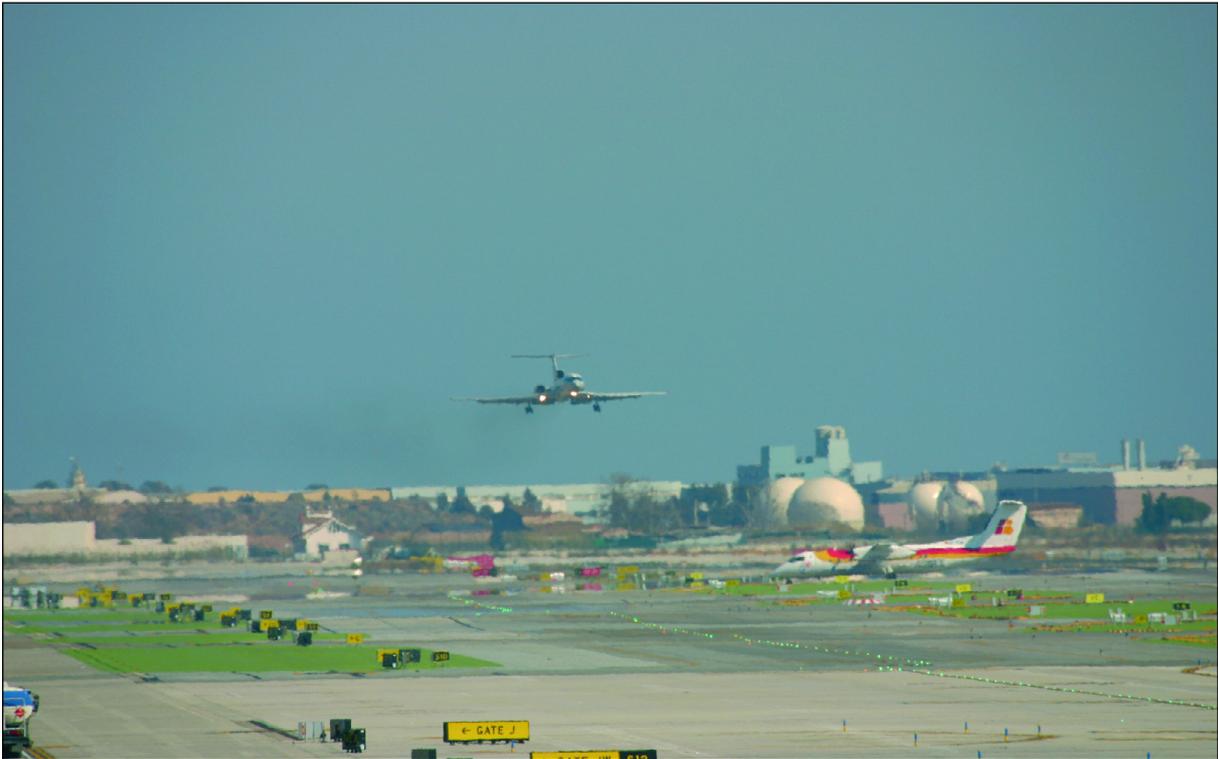
Photo 1. Aircraft approaching to taxiway T at the time a Dash-8 is leaving the taxiway T (photo by a private observer outside the airport premises)

From the information above it is deduced that Tupolev 154 tried to land on taxiway T but the taxiway was occupied and it performed a go around. After the first failed attempt it finally landed on that taxiway T.

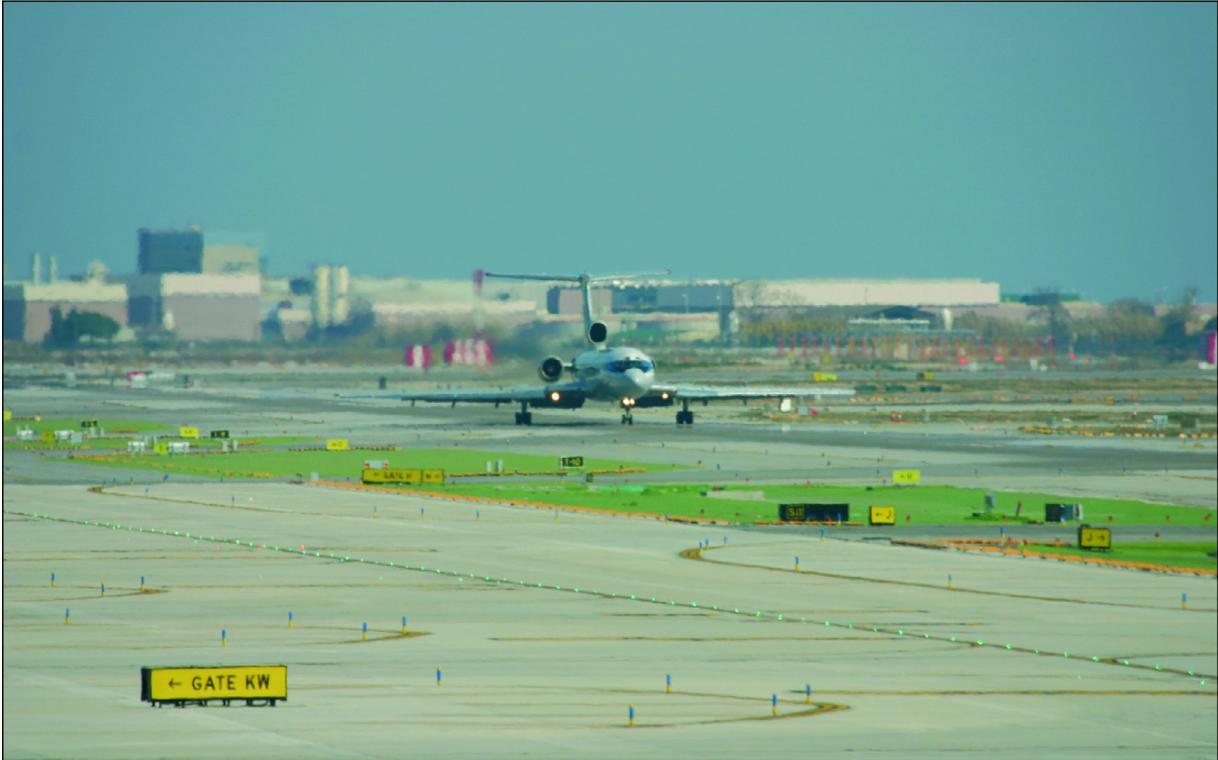
At 12:45:04 the aircraft was cleared again to land on runway 25R. At 12:46:30 the aircraft was informed it had landed on taxiway «T». There were no aircraft on taxiway «T». Taxiway «T» is parallel and on the right of runway 25R.

Photo 2. Aircraft landing on taxiway T (photo by a private observer outside the airport premises)

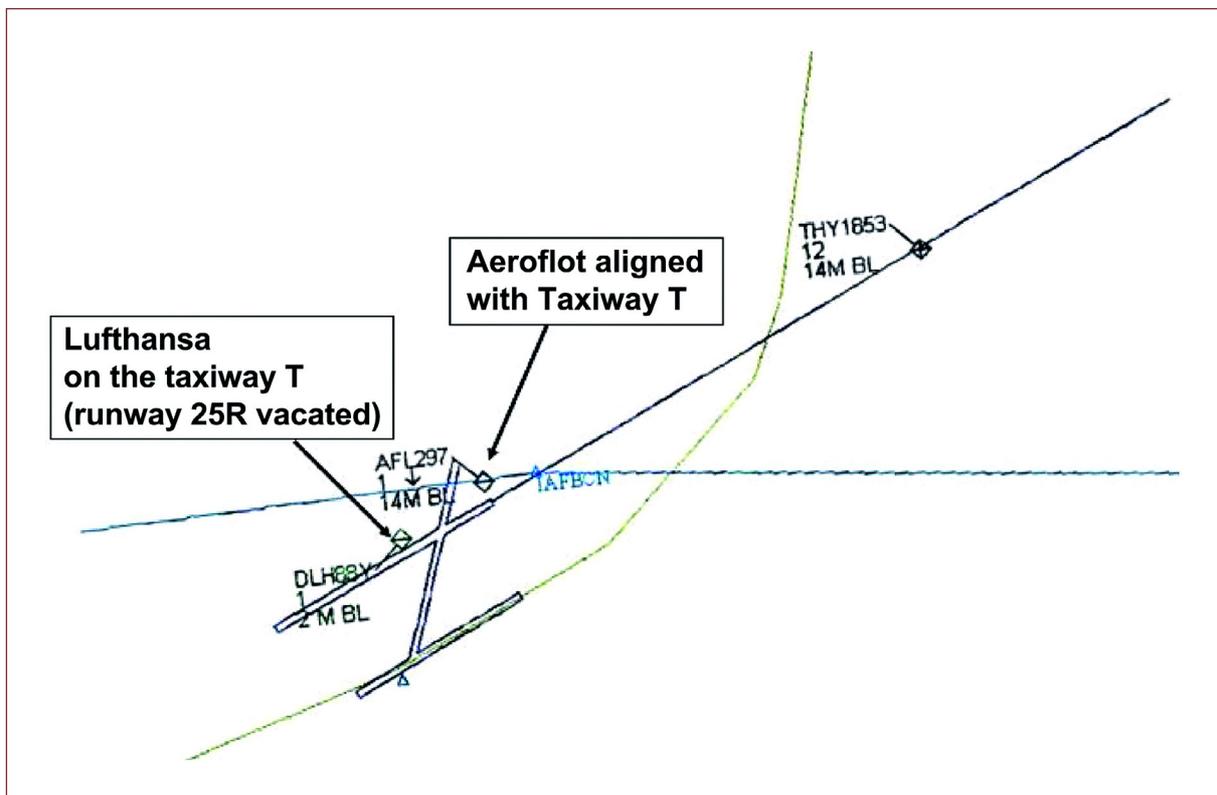
According to radar information provided by the ACC the runway was vacated by the Lufthansa aircraft just when the Tupolev 154 was initiating the go around.

Photo 3. Radar information at 12:31:43 when the Aeroflot was initiating the go around

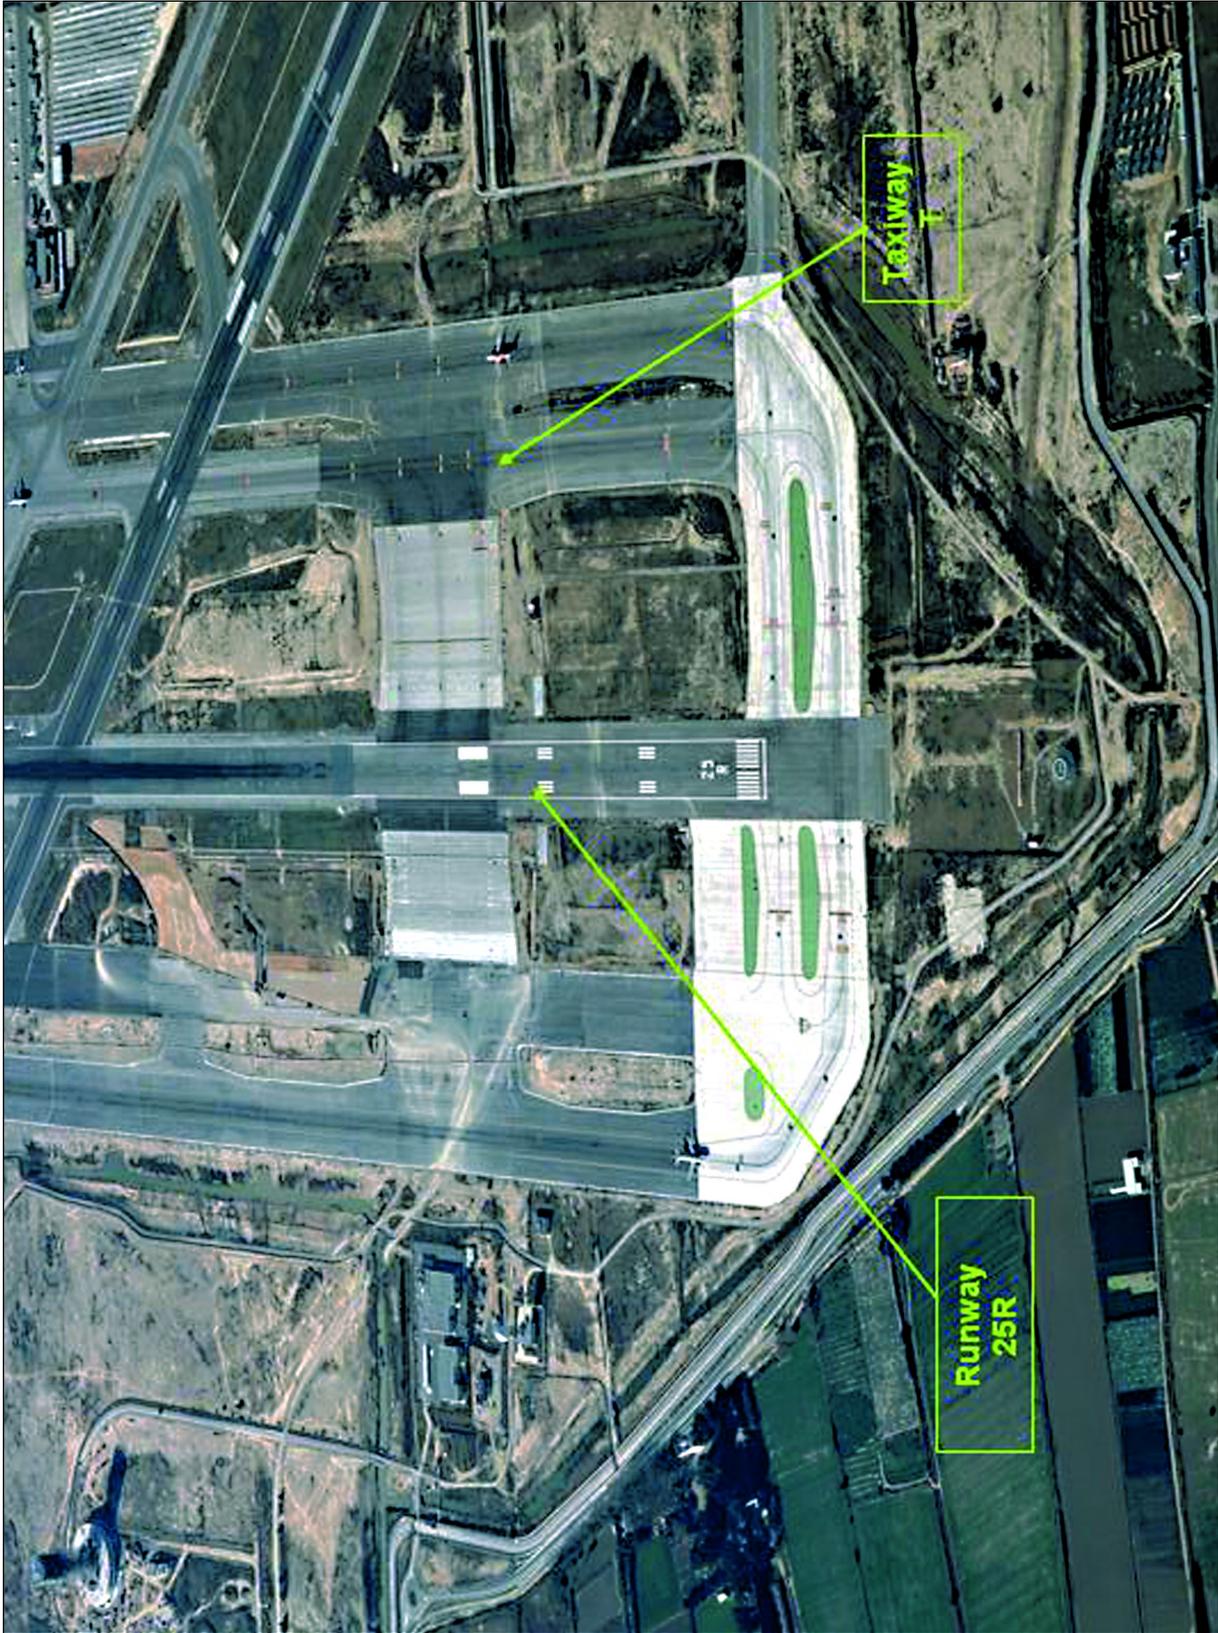
- Designation or number markings.
- Threshold marking.
- Center line marking (as can be seen in the picture n° 3 these markings are not easily appreciated).
- Aiming point marking.
- Touch-down zone marking.
- Side stripe marking.

The distance between the taxiway and runway centrelines is 250 meters. Photo 4 (taken in March 2005) shows the appearance of runway 25R and taxiway T.

Photo 4. Runway 25R and taxiway T
