CIAIAC

Report A-064/2006

Accident involving a PIPER
PA-34-220T, registration
EC-HOL, on approach to
runway 02 at Jerez Airport
(Cadiz – Spain), on 15
December 2006

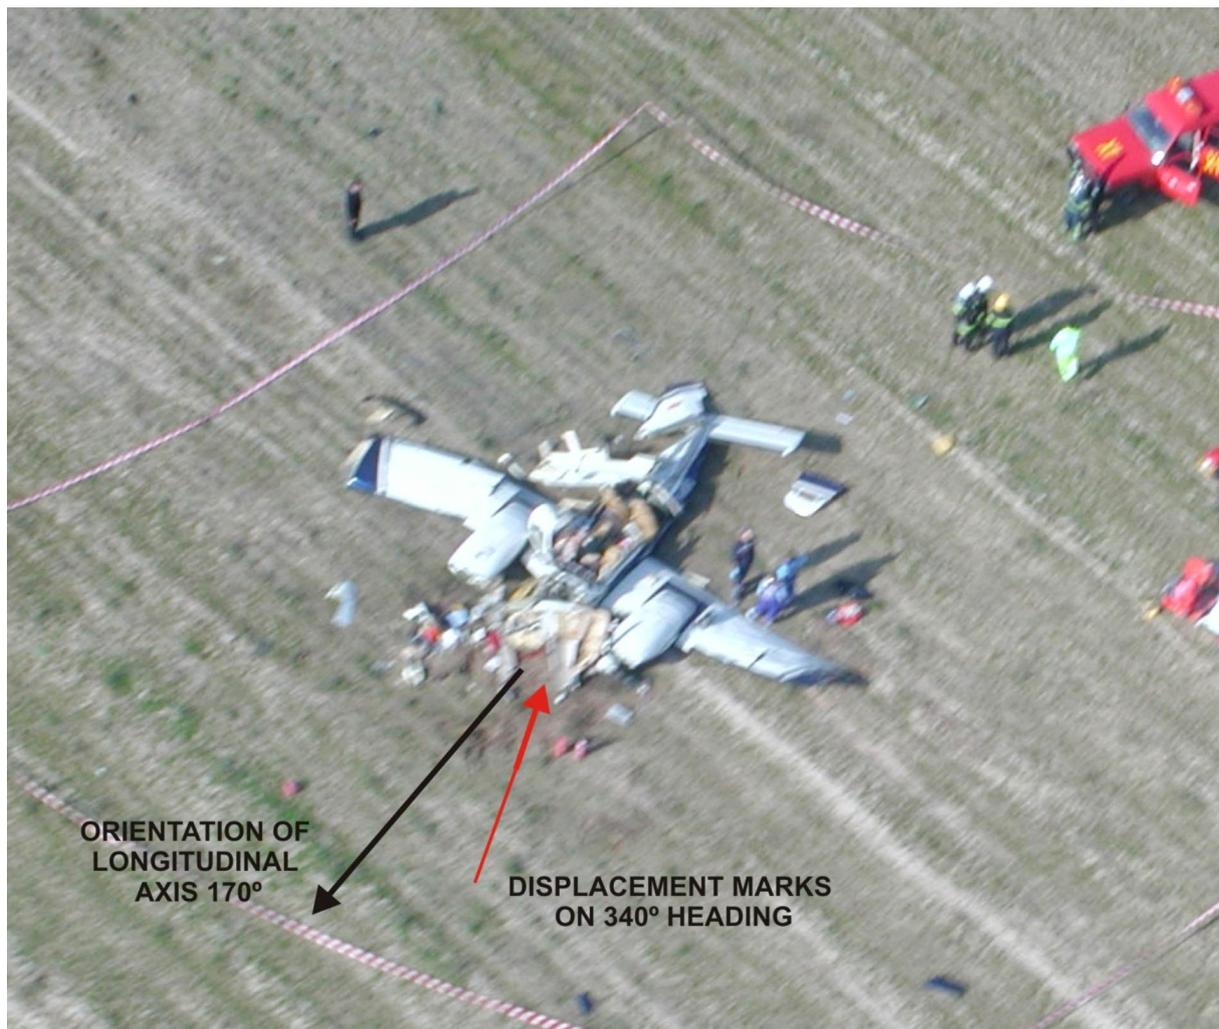
Figure 1. Overhead photograph of the area

An overhead photograph (see figure 1) of the area shows that after impact, the aircraft, which at that moment was on an approximate heading of 170°, slid backwards only a couple of meters on an approximate heading of 340°.

The debris field was confined, with the nose and front legs destroyed. The wing was resting on its lower surface and remained attached to the fuselage. The tail section evidenced less damage, though the vertical stabilizer had detached and fallen to the ground to the right of the airplane.

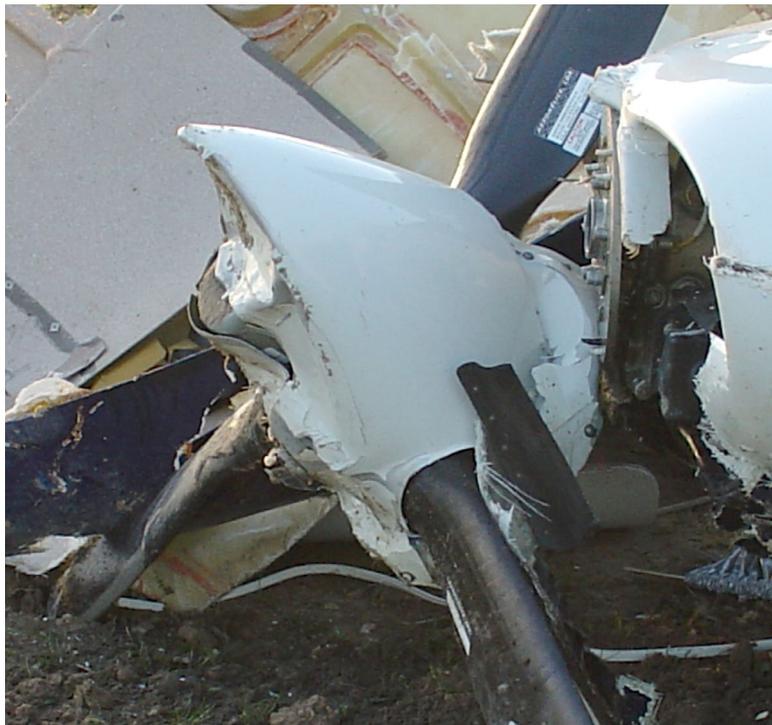
Figure 2. Left propeller cone

A check of the wreckage revealed that the landing gear was down, the flaps were at 10° and the right propeller was at full power. Its three blades were completely twisted and there was damage to the periphery of its cone, which proves that it was rotating to the left, as seen from behind, and at power when it contacted the ground. The landing gear wheels, which were lowered, sunk in the mud.

The damage to the nose, the left propeller cone and the left wingtip suggested that the airplane was falling at a 40° nose-down angle and banking left. It was also moving backwards on a heading of 340° when its nose was pointed toward 170°. These indications confirm that the aircraft was in a spin as it maintained its momentum from the approach glide slope.

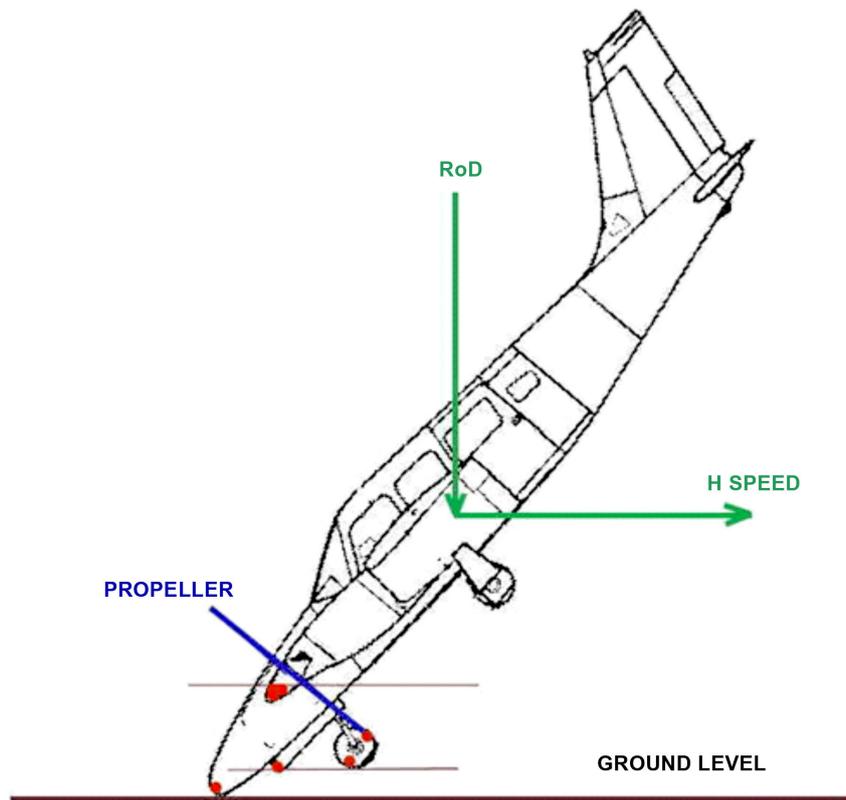
Figure 3. EC-HOL impact diagram

Given the damage observed and the slim chances of surviving an accident with acceleration forces in excess of 20 g's, it was estimated that prior to the spin, the aircraft was flying below the 3° glide slope and that it fell from a height of 40 m. It is calculated that some three seconds went by between the start of the spin and the impact of the aircraft with the ground.

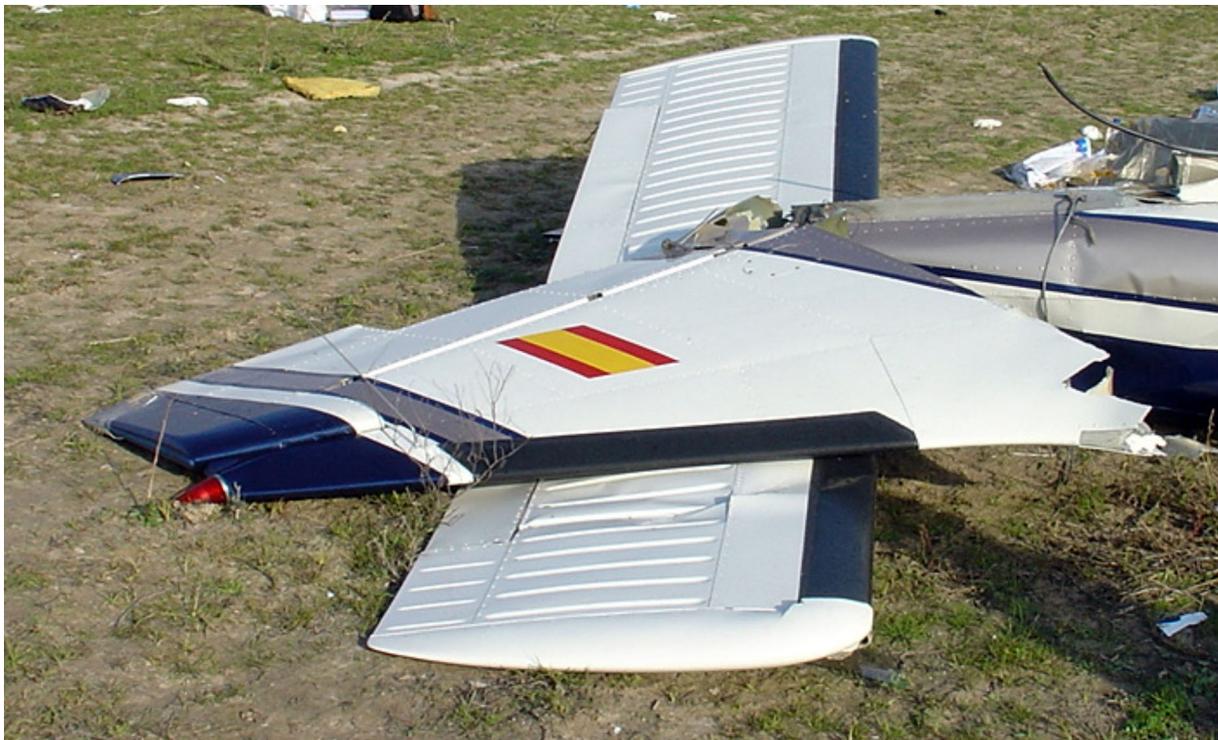
Figure 4. Tail section of EC-HOL

The right wing flexed downward, as did the rear of the fuselage which, under the ground loads, bent and fell to the ground with little force. It was noted that the tail section did not drag on the ground and barely suffered any local damage.
