INCIDENT

Aircraft Type and Registration:	Airbus A320-A1, EC-GRF	
No & Type of Engines:	2 CFM 56-5A1 turbofan engines	
Year of Manufacture:	1991	
Date & Time (UTC):	4 April 2006 at 0802 hrs	
Location:	Stand 203, Terminal 2, London Heathrow Airport	
Type of Flight:	Public Transport (Passenger)	
Persons on Board:	Crew - 6	Passengers - 110
Injuries:	Crew - None	Passengers - None
Nature of Damage:	Damage to left engine inlet cowl and airbridge protective railings	
Commander's Licence:	Airline Transport Pilot's Licence	
Commander's Age:	50 years	
Commander's Flying Experience:	13,256 hours (of which 3,875 were on type) Last 90 days - 157 hours Last 28 days - 49 hours	
Information Source:	Aircraft Accident Report Forms submitted by pilot and subsequent enquires by the AAIB

Synopsis

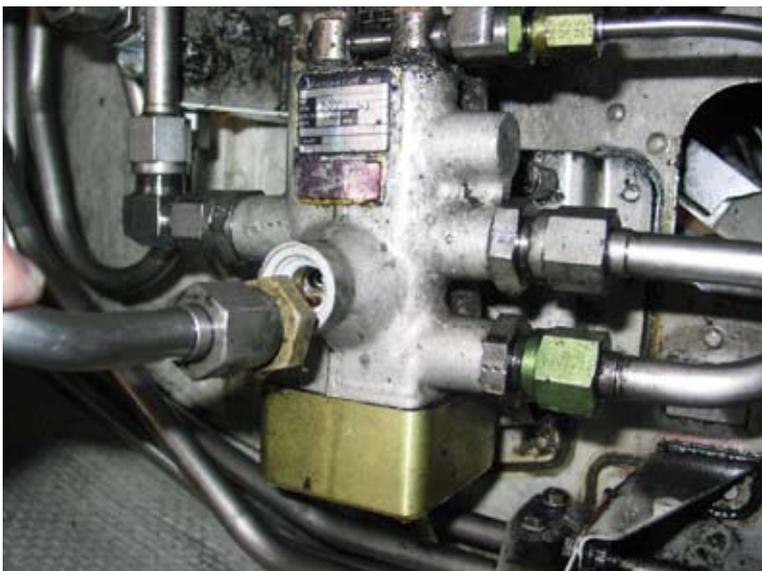
Figure 1

Fractured hydraulic union on the BDDV

Inspection of the aircraft revealed that a hydraulic reducer union on the brake dual distribution valve (BDDV) had fractured, Figure 1, allowing fluid to leak from the Yellow hydraulic system.

The failed union, which is of an aluminium alloy material, was located in the Yellow hydraulic system supply port to the BDDV. The part number of the union is MS21902D8 and it is identified as item 070 of Figure 2D in Chapter 32-43-03 of the A319/320/321 Illustrated Parts Catalogue.

The hydraulic union had fractured in the region of the last full thread before the run-out, on the threaded end to which the hydraulic pipe attaches. The fracture was the result of a fatigue crack initiation at the thread root, which propagated to a relatively small crack under low magnitude cyclic stress. Given the small crack advance, the large area of overload was possibly due to the presence of a high static load on the fitting, over which the cyclic loading was superimposed. This was possibly due to separate periods of vibration, or other excitation, as indicated by the presence of wider beach marks between the closely spaced striations. Crack initiation had occurred at multiple sites around the thread root, precluding a defect induced failure. There was no evidence of corrosion on the fitting. The final separation was essentially axial, and therefore unlikely to have been due to an attempt to over-tighten the fitting, which might be expected to produce a torsional separation. The results of the metallographic examination, hardness determinations and chemical analysis, indicated that the fitting had been correctly manufactured from an Al 2024 alloy in the fully heat treated condition.

The cause of the fatigue cracking in the failed hydraulic union was not established; however, no evidence was found of pre-existing defects, corrosion, or of an incorrect material specification.
