**INCIDENT**

<b>Aircraft Type and Registration:</b>	Boeing 737-300, EC-JUC	
<b>No &amp; type of Engines:</b>	2 CFM 56-3C1 turbofan engines	
<b>Year of Manufacture:</b>	1990	
<b>Date &amp; Time (UTC):</b>	18 July 2006 at 1425 hrs	
<b>Location:</b>	Near Aldergrove Airport, Belfast	
<b>Type of Flight:</b>	Public Transport (Passenger)	
<b>Persons on Board:</b>	Crew - 6	Passengers - 142
<b>Injuries:</b>	Crew - None	Passengers - None
<b>Nature of Damage:</b>	None	
<b>Commander's Licence:</b>	Airline Transport Pilot's Licence	
<b>Commander's Age:</b>	39 years	
<b>Commander's Flying Experience:</b>	7400 hours (of which 5800 were on type) Last 90 days - 210 hours Last 28 days - 90 hours	
<b>Information Source:</b>	Aircraft Accident Report Form submitted by the pilot, radar data, R/T transcripts and witness information

**Synopsis**

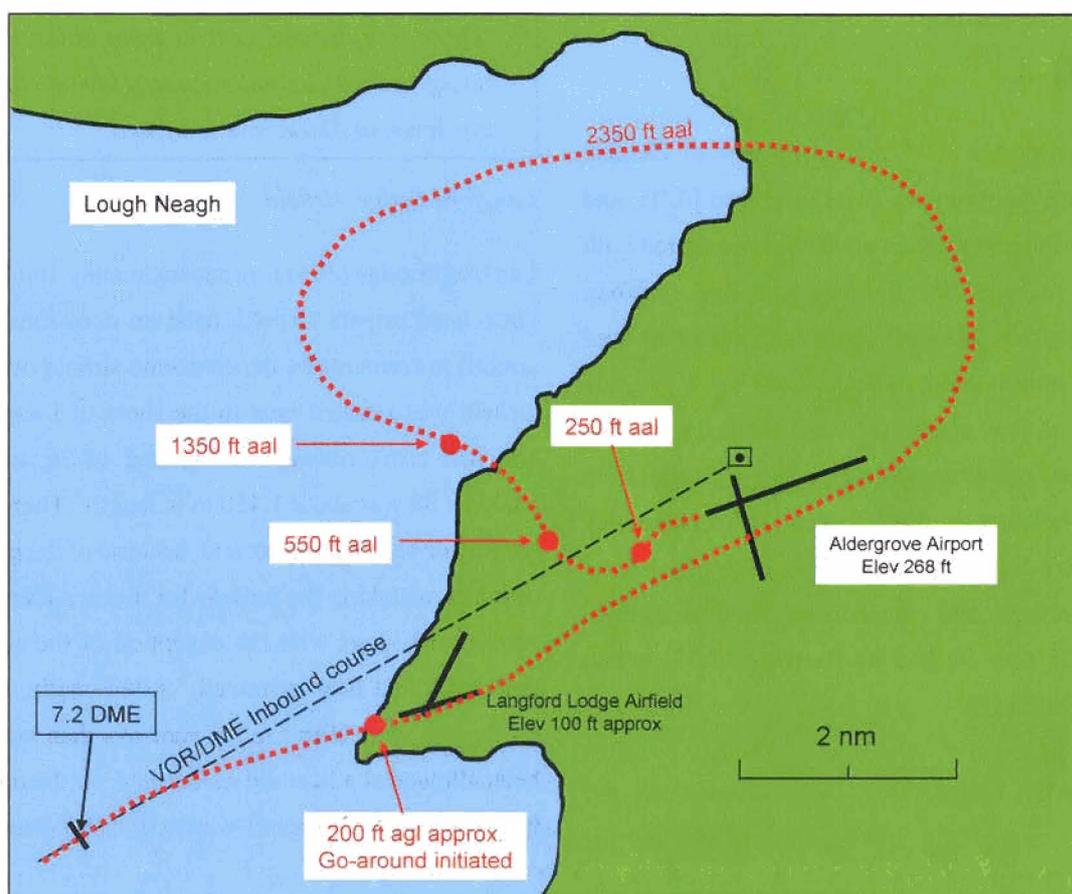
**Figure 1**

Radar data shows that the aircraft began to deviate to the right of the inbound VOR/DME course at about 2.5 nm from Runway 08 at Langford Lodge, or about 6.5 DME from the VOR/DME (Figure 1). Descent from 2,400 ft had begun at 7.2 DME, which was the correct descent point for the procedure. Mode C information showed the average descent rate to the point of go-around to be about 1,700 ft/min. The vertical profile also showed a gradually increasing rate of descent, with the lower 1,000 ft being flown at an average of approximately 2,000 ft/min. The aircraft took 74 seconds to travel from the final descent point at 7.2 DME to the point of go-around, just short of the runway at Langford Lodge. There are two returns at a minimum altitude of 300 ft amsl, about 200 ft above the airfield level, before the aircraft Mode C indicated a climb.

Radar-derived track and height information
