Final Report No. 2063

concerning the serious incident

to the PC-12-45-type aircraft, registration EC-JFO

on 24 October 2007

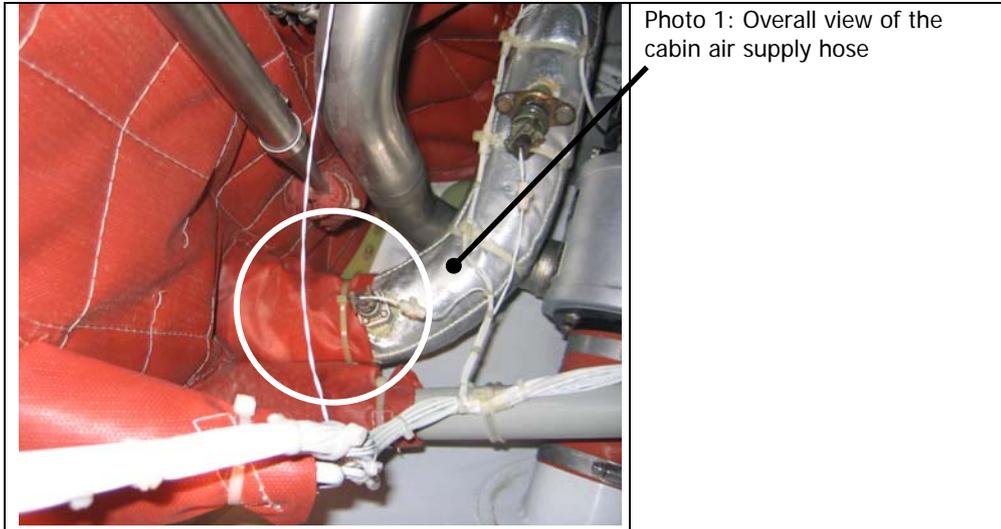
At the time of the troubleshooting for the causes of this malfunction, it was found that the cabin air supply hose (P/N 917.97.28.141 IPC 21-40-00 Page 1/3 item 50 – see Annex 1) was not properly fitted at the pressurised cabin bulkhead. The hose was then connected correctly. The tests subsequently carried out demonstrated that the system was again functioning correctly and the aircraft was brought back into service.

The pressurised cabin passed the pressure test. No leak was found. Apart from a relay which malfunctioned during the ground test, the environmental control system was functioning perfectly. Since the air supply hose was not properly fitted, the cabin could not be supplied with sufficient compressed air. One indication was the reduced airflow out of the panel outlets. It is possible that at the time of the annual inspection at the aircraft manufacturer's works, this hose was accidentally separated from the cabin bulkhead. The connection is covered by an insulation mat and is therefore not visible.

12-A-05-00-01-00A-010A, Task No. 21-20/221

| ECS and bleed air ducts, pipelines, associated clamps and equipment in the engine compartment | Examine |

12-A-21-40-02-00A-920A-A, Water Separator, Removal/Installation

New task 2.9

Check all ECS clamps for correct installation and tightness
