Interim Report A-019/2008

Accident involving
a PILATUS PC-6A
TURBO-PORTER aircraft,
registration EC-JXH,
in Lillo (Toledo)
on 30 May 2008

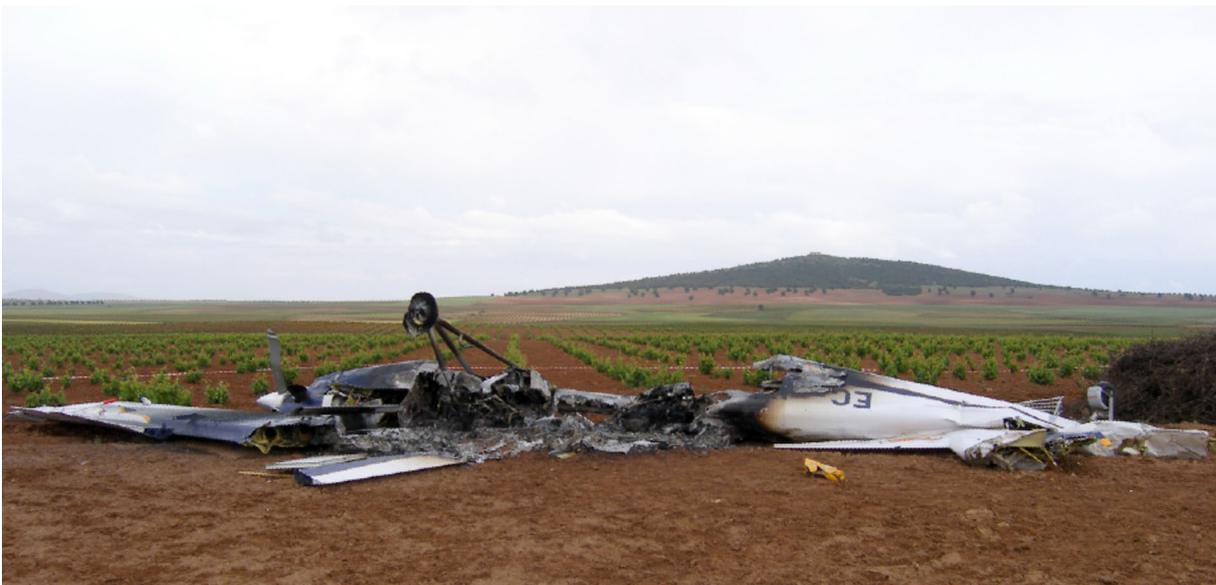
Figure 1. Photograph of aircraft at crash site

The airplane was destroyed as a result of the impact and subsequent fire. The right wing broke in two places upon impacting the ground. The part closer to the root remained attached to the airplane, along with the inboard flap, and was affected by the fire. The other part, to which were attached the ailerons and the outboard flap, detached and fell to the left of the main wreckage, where it was unaffected by the fire. The left wing broke up in flight into two pieces. The one closest to the root also remained attached to the fuselage along with the inboard flap and was affected by the fire after impact. The other piece separated in flight and was found 1.5 km to the northeast of the main wreckage. The outboard flap and the aileron were found separate from the wing, 2 km and 2.5 km away, respectively, also northeast of the main wreckage.

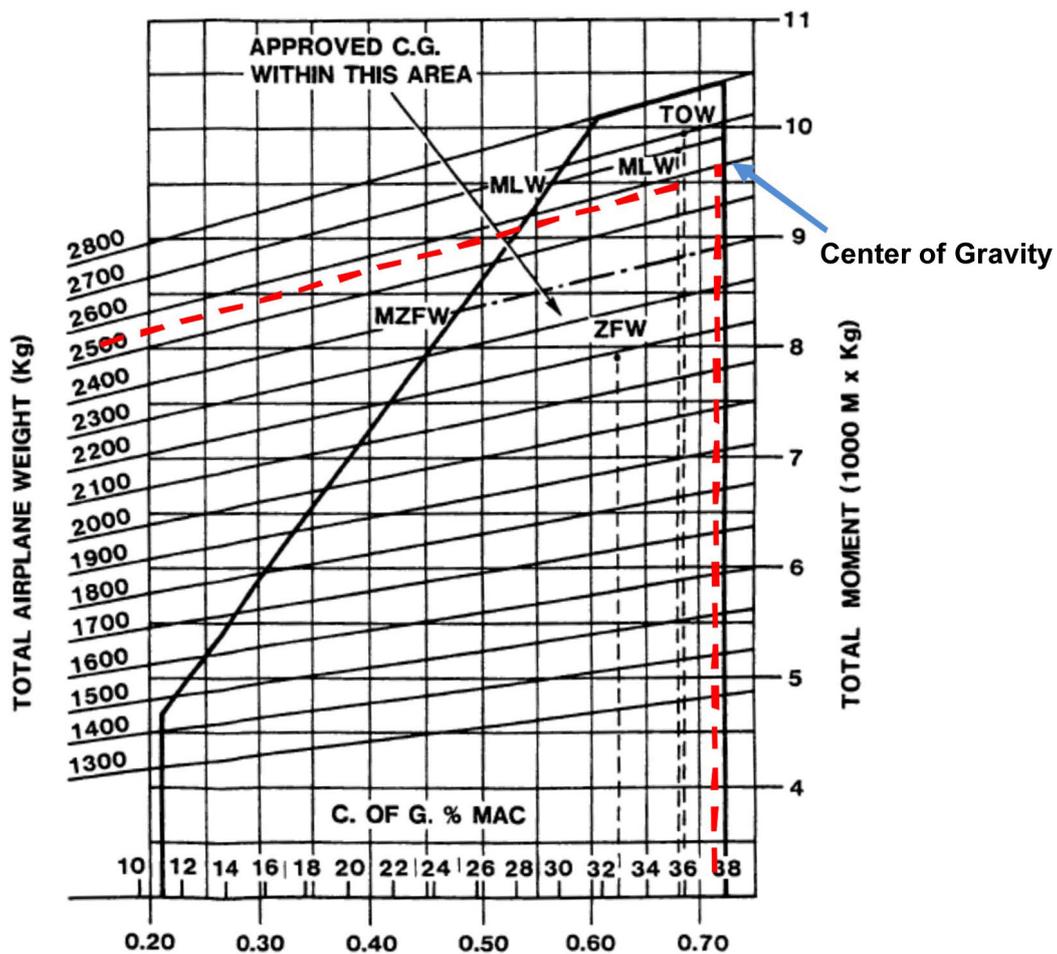
According to the above table, the center of gravity would be 3.47 m away³ from the reference line, that is, at 37.8% M.A.C.⁴, and therefore within the approved area on the weight and balance diagram (see Figure 5).

Figure 5. Diagram for calculating position of Center of Gravity

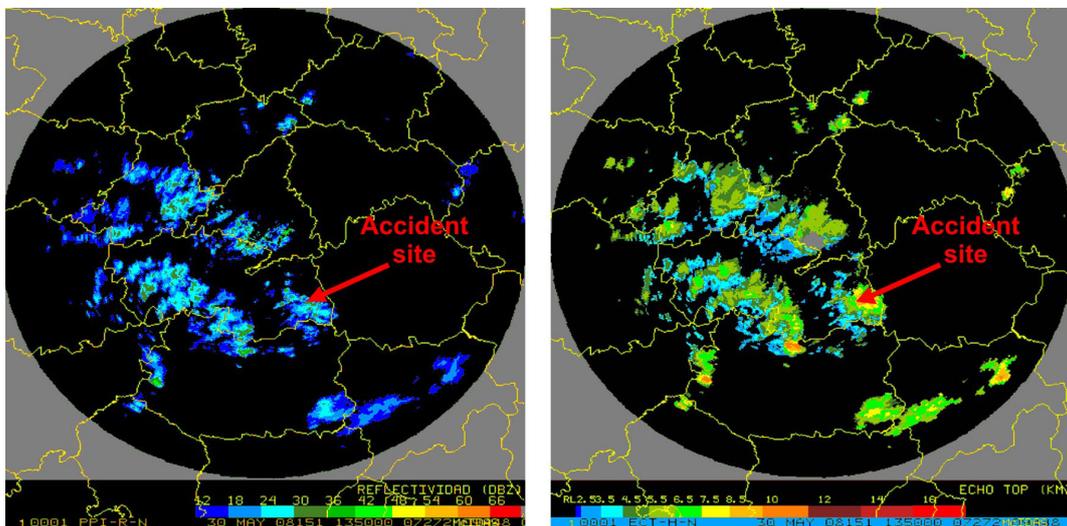
In light of this situation, moderate to strong vertical drafts could have been present in the area, along with precipitation of a convective nature (rain and thunderstorms). The temperature in the area at the time was probably around -10°C .

The reflectivity and Eco Top images in Figure 3 show, respectively, the type of precipitation in the area at the time of the accident (light) and the altitude of the clouds (between 5 and 10 km).

Figure 6. Reflectivity and Eco Top images at 15:50

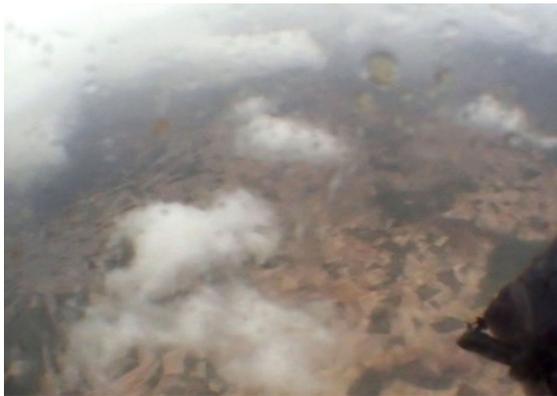
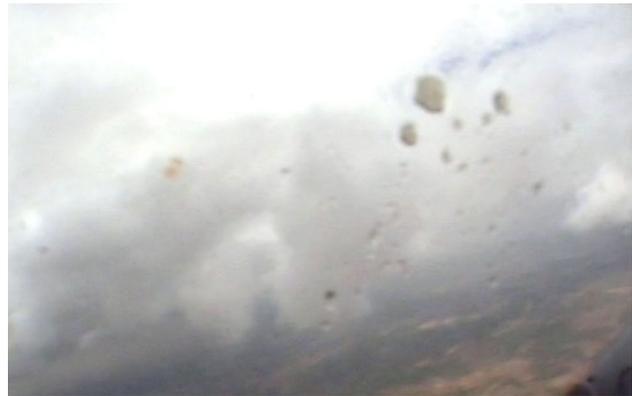
One of the parachutists was recording during the climb on a camera mounted on his helmet (Figure 7). Later, during the fall, the camera turned on inadvertently when he hit his head as he was ejected from the airplane, so part of the fall was recorded (Figures 8 and 9). The footage shows the atmospheric situation described above, with abundant clouds and precipitation.

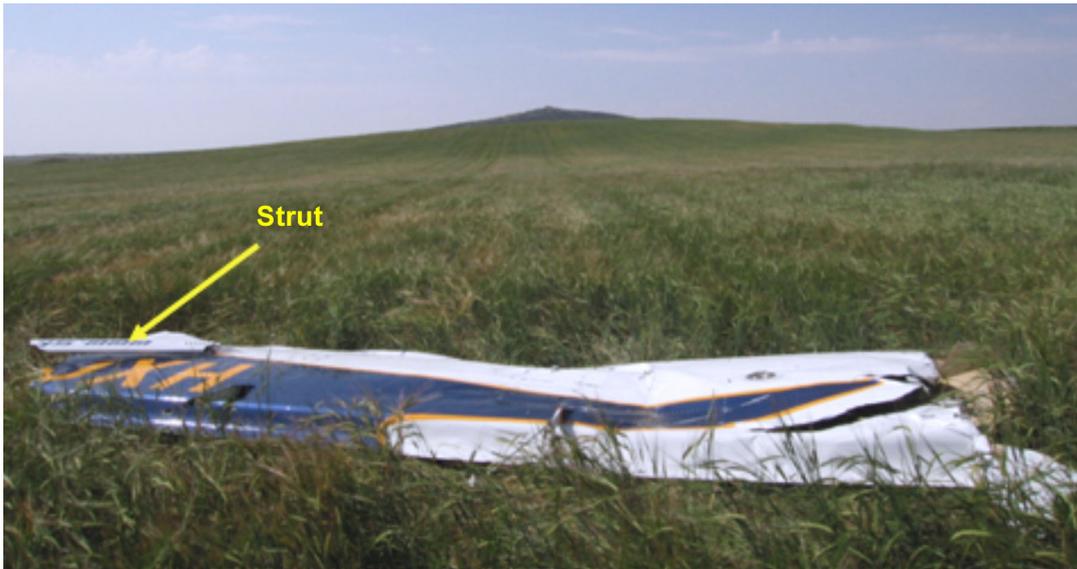
The part that detached from the left wing was found alongside the Lillo-Villatobas road, in the segment that is known as the Cerrotraviesa trail, at coordinates 39° 46' 0.18" N – 3° 17' 10.8" W and an elevation of 680 m. It was oriented from east (part near the tip) to west (part near the root), and resting on its top surface. It was 5.75-m long measured along the spar closest to the leading edge. A 0.85-m long segment of the strut was still attached to it. The force of the impact had caused it to bend along its length such that it was convex along the top and concave along the bottom.

The rivets had pulled out of the top skin closest to the root.

There were two dents on the leading edge. The wing tip was torn and a portion of the trailing edge had detached and come to rest in a separate area from the rest of the wing. Three of the four control surfaces were found. The outboard aileron was not recovered. The inboard aileron, which was only slightly damaged, was the one component that was farthest away from the main airplane wreckage. Specifically, it was found alongside the road that goes from Lillo to Santa Cruz de la Zarza, at coordinates 39° 46' 33.38" N – 3° 17' 17.67" W and an elevation of 692 m. Its fittings were bent. The outboard flap was found on the same road as the wing, at coordinates 39° 46' 6,36" N – 3° 17' 29.58" W and an elevation of 682 m. There were dents at either end of the leading edge.

Figure 10. Photograph of left wing

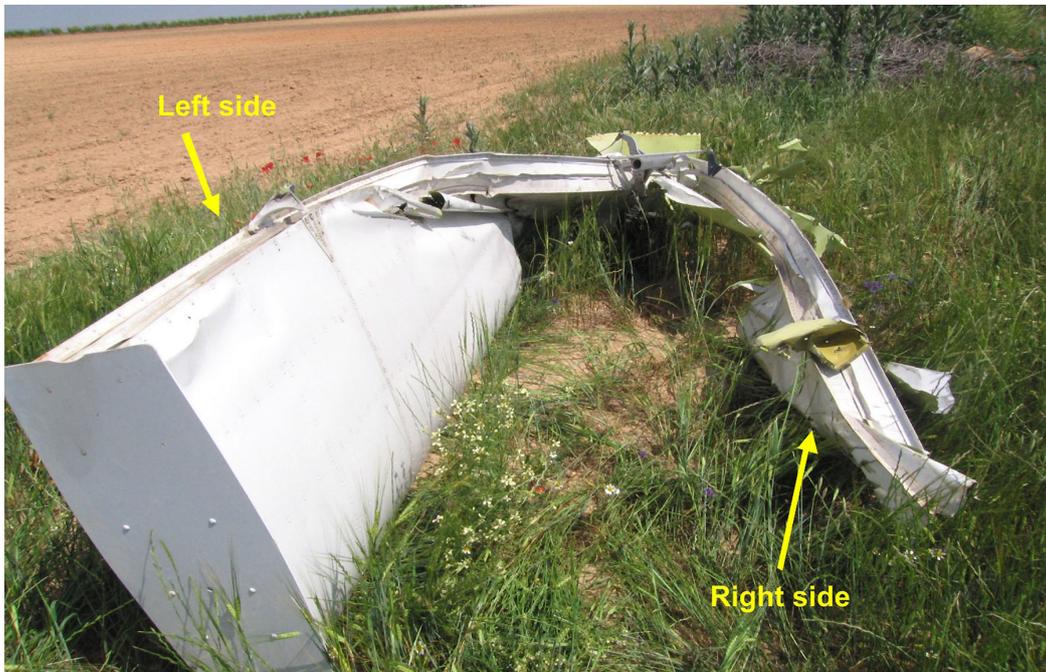
Like the left wing, the horizontal stabilizer was also found near the Cerrotraviesa trail, at coordinates $39^{\circ} 45' 48.66''$ N – $3^{\circ} 17' 47.58''$ W and an elevation of 700 m. It was bent at the center in a U-shape (see Figure 11) and ripped from its fittings at the center. The left side was heavily damaged. It was missing the piece that had remained

Figure 11. Photograph of the horizontal stabilizer

attached to the main wreckage. A part of the right side of the leading edge was found alongside the La Guardia-Corral de Almaguer road, at coordinates 39° 46' 16.2" N – 3° 17' 26.64" W and an elevation of 690 m.
