**LIETUVOS RESPUBLIKOS SUSISIEKIMO MINISTERIJOS
ORLAIVIŲ AVARIJŲ BEI INCIDENTŲ TYRIMŲ VADOVAS**
**MINISTRY OF TRANSPORT AND COMMUNICATIONS OF THE REPUBLIC OF LITHUANIA
CHIEF INVESTIGATOR OF AIRCRAFT ACCIDENT AND INCIDENT**

No B02-08

**ACCIDENT TO THE SU-29, EC-HPX AIRCRAFT
AT ROJŪNAI AERODROME ON 18 JUNE 2008**

FINAL REPORT

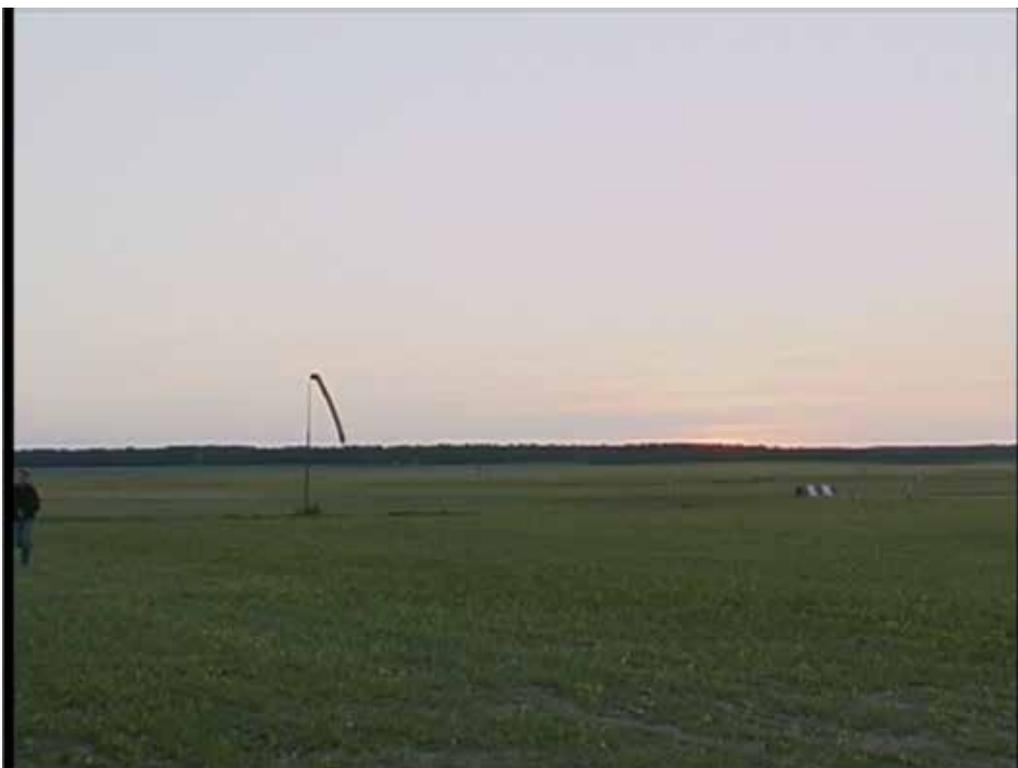
The video recording shows that factual weather conditions at the time of SU-29 approaches for landing were good: no clouds above the aerodrome area, visibility approximately 8-10 km. Aerodrome windsock installed at the right safety strip near the beginning of RWY 09, indicated a light stable 3-5 m/s southerly wind. The accident occurred just after the sunset, at dusk (Picture 1).

Picture 1. Meteorological conditions at the aerodrome during the SU-29 landing

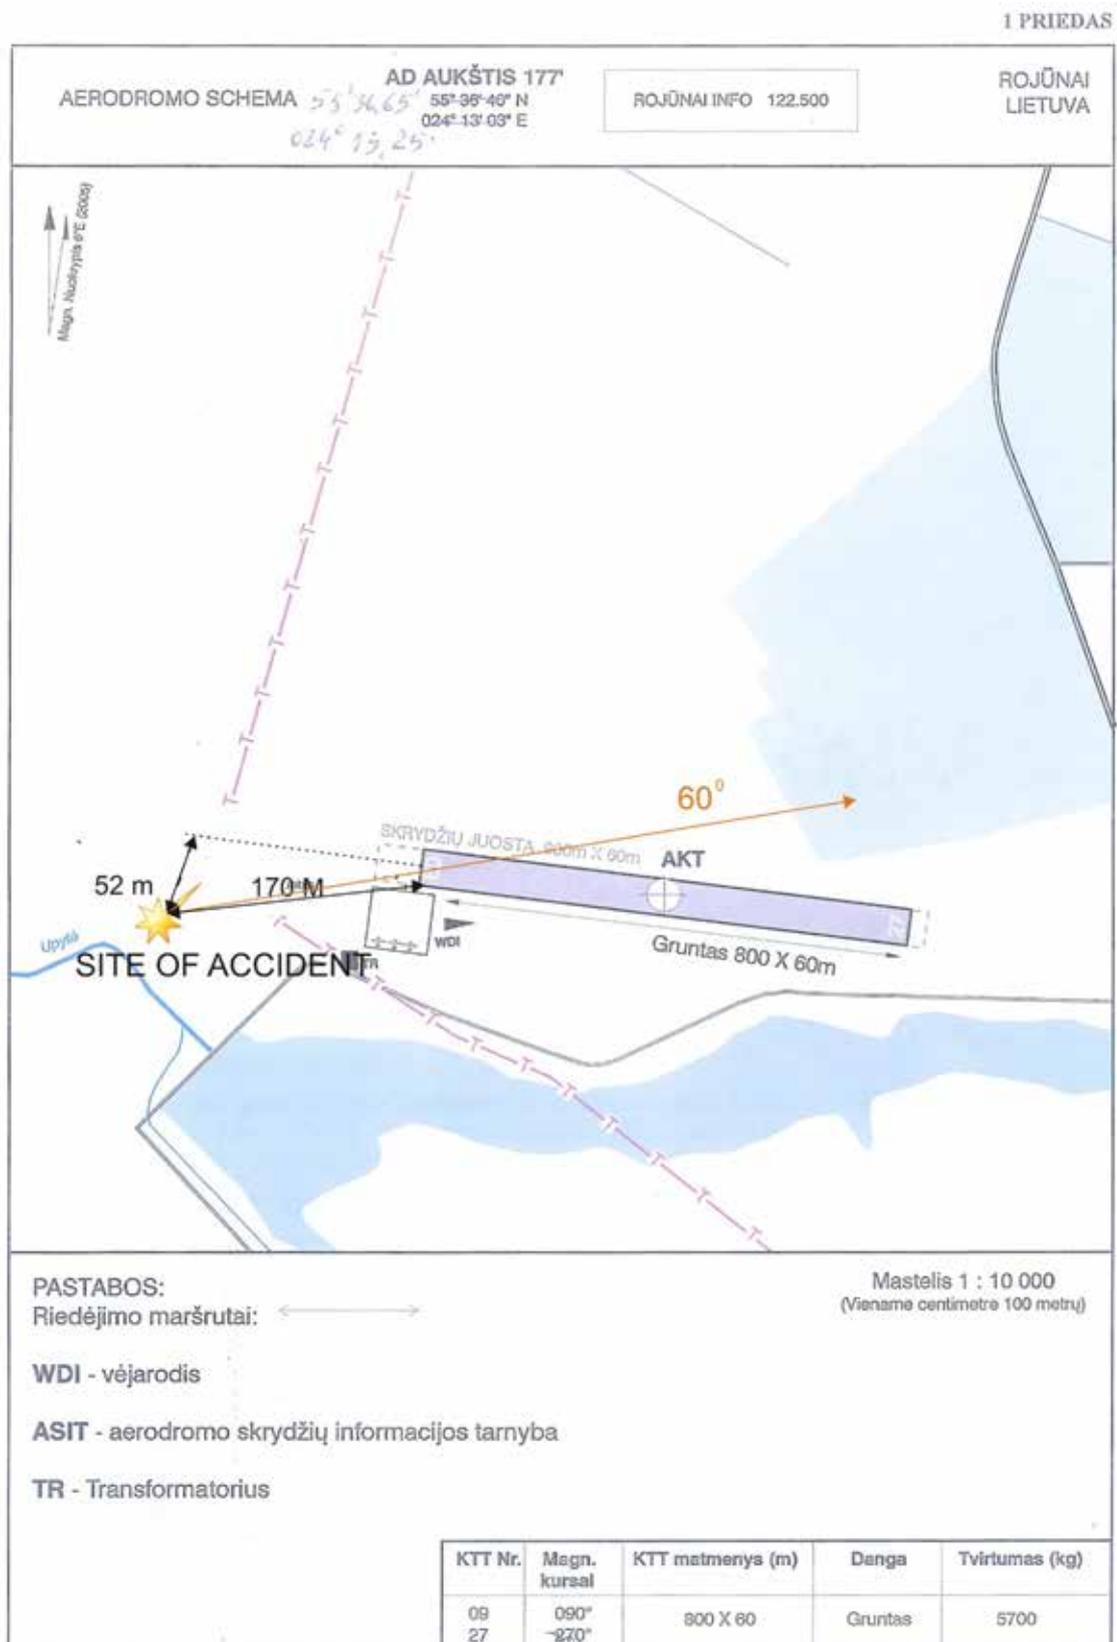
Rojūnai Aerodrome (Picture 2) is 16 km from the Panevėžys city centre. Coordinates: 55°36.65'N, 024°13.25'E. The aerodrome is the property of a private person. Aerodrome elevation 54 m. Runway directions: MK 090° x 270°, dimensions: 800 x 60 m. RWY surface – grass. The group of aircrafts were to land on runway 90°, the wind was light, southerly crosswind.

Picture 2. Site of the accident as shown in the chart of the Rojūnai Aerodrome

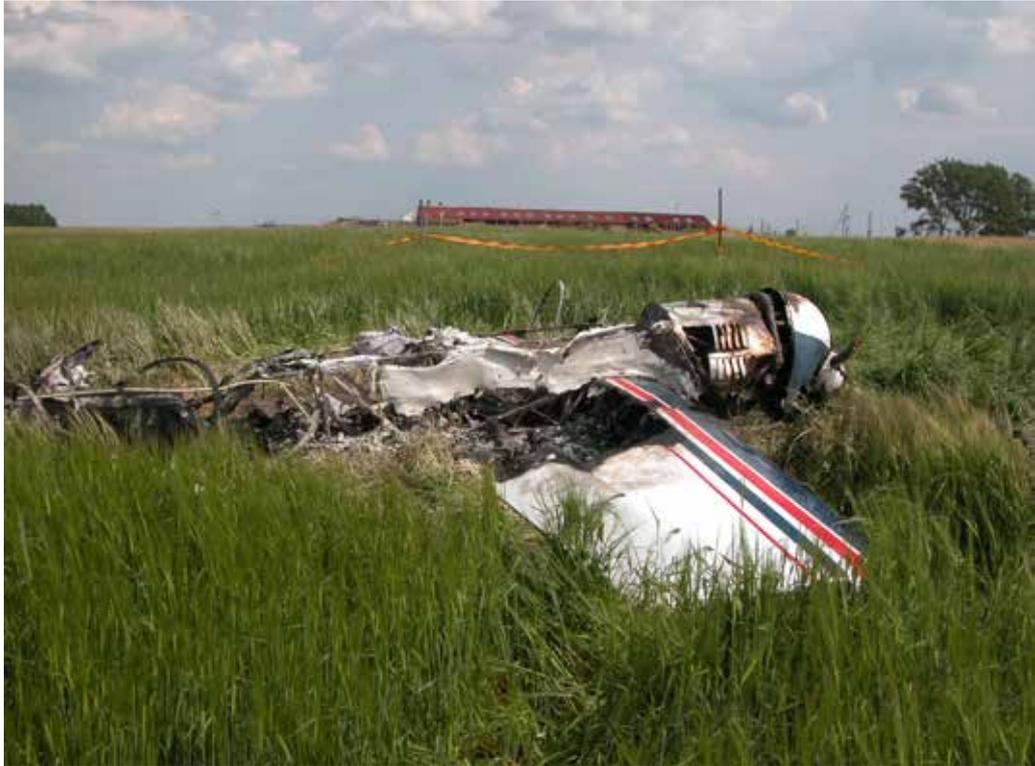
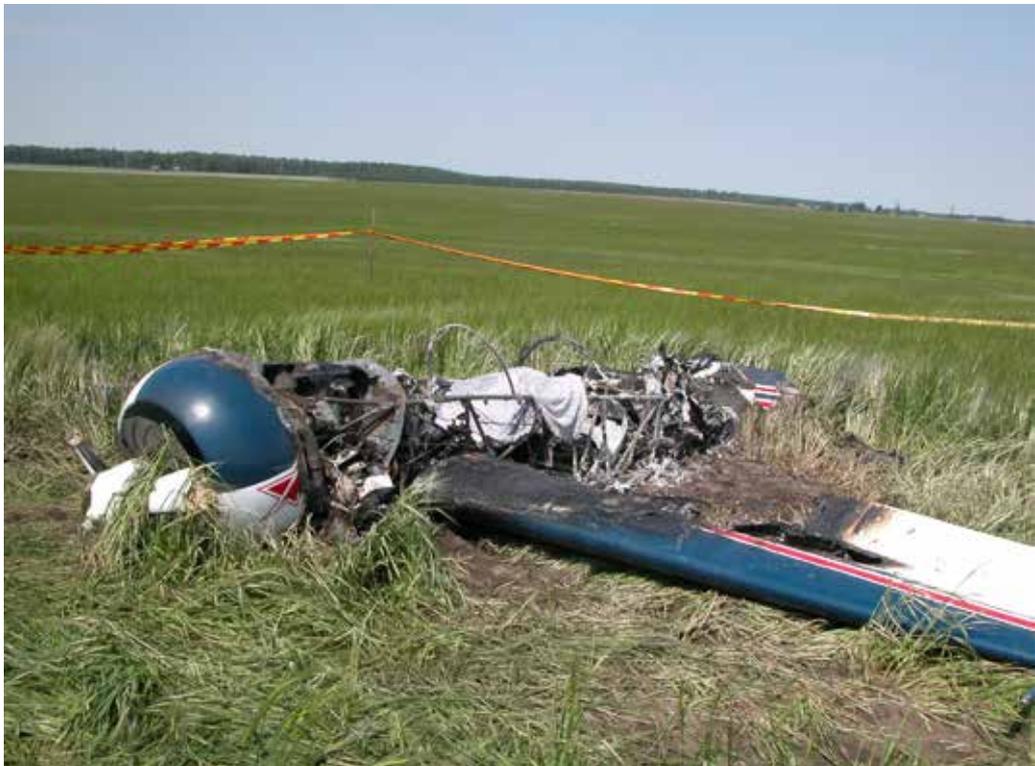
The aircraft was destroyed during the impact with the ground and a fire that followed the impact (See Pictures 3 and 4).

The aircraft flatly impacted the ground near the aerodrome on the right-hand side of RWY 09. According to a witness, nose of the aircraft was raised during the impact. The aircraft slid the grass for 28 metres and came to a stand at the distance of 170 m from RWY 09 and 52 m to the right of its centerline facing south (Picture 3). The fire that commenced during the first impact rapidly flared up and destroyed the aircraft completely (Pictures 3 and 4).

The aircraft caught fire due to the impact with the ground. The main flashpoints were petrol tanks of the aircraft: wing tanks in the left and in the right wings and the main tank located between the engine and front cockpit. The most damaged parts during the fire were the cabin, fuselage, stabilizer, fin and wing parts near fuselage (Pictures 3 and 4). The fire was extinguished by four manually operated fire-extinguishers and the fire truck that arrived to the site of the accident after 20 minutes.

Picture 3. Aircraft SU-29 after the accident

Picture 4. Aircraft SU-29 after the accident

- 4.1. The owners of the Rojūnai aerodrome should provide more effective fire fighting facilities at the aerodrome while preparing for competitions and during the competitions.

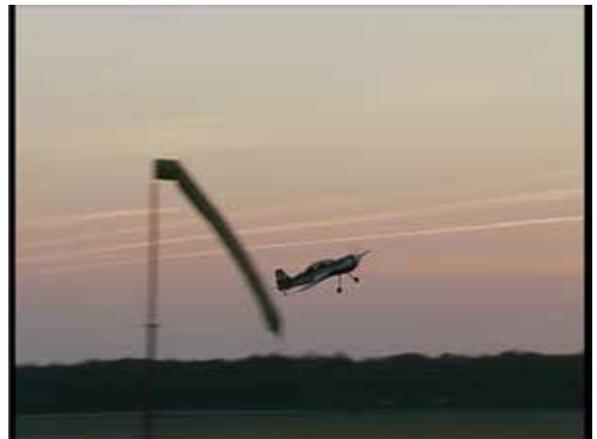
Picture 8. SU-29 EC 1st approach for landing

The video records show that the aircraft SU-29 twice approached the runway with a course that was less than the runway heading. According to witnesses, the difference between the heading of runway 09 and the aircraft flight course was approximately 30-40 degrees. During the second approach on final the aircraft, flying right of the track, descended too early. The video records also show that the aircraft was closing the runway at a high angle-of-attack that was comparable with the angle during missed approach. All interviewed witnesses confirmed that the aircraft descended to the runway with a high angle-of-attack at a low speed. One of the witnesses claimed to have been worried by the dangerous manoeuvring of SU-29, thus, he drove to the pilots of the aircraft that had landed previously to have them communicate with SU-29 pilot via radio. Since, according to the witness, the aircrafts made a survey circle prior to landing, it seems that the SU-29 failed to make correct calculations with regard to the approach for landing twice, i.e. the second and base turns that lead to insufficient lateral and longitudinal distances from the runway. Attempting to approach the runway at a shortest distance, the pilot flew at the lowest possible speed with no speed reserve and the descent of the aircraft seemed like a fall being stopped by increasing the engine power. During the third approach, according to the witness, the pilot performed the second turn even earlier. In order to make correction before the base turn, the pilot turned left and then immediately started turning right. Both the location of the third turn and the flight manner, according to the witness, were similar to the ones performed during the first two approaches. The aircraft was very close to the runway. After the base turn the aircraft started an abrupt descent with a high angle-of-attack. During the descent it increased the engine power, slightly lowered the front part of the aircraft and impacted the ground. The evidence suggests that during the third approach the pilot made the same mistakes as in previous: the base turn was performed too close to the threshold of the runway and its centreline, at a low horizontal speed and high angle-of-attack. Prolonged descent downwind at a high vertical speed after the base turn could have been another mistake. It seems, engine power was increased too late. When the pilot saw that the speed is not increasing promptly and tried to lower the angle of attack by lowering the forward part of the aircraft, the height was already insufficient.

- 3.1.6. During all three attempts to land the aircraft flew very narrow aerodrome circuit performing the base turn very close to the runway.
- 3.1.7. During the first two attempts to land the aircraft approached the runway failing to finish the final turn, i.e. with a course less than the landing direction.

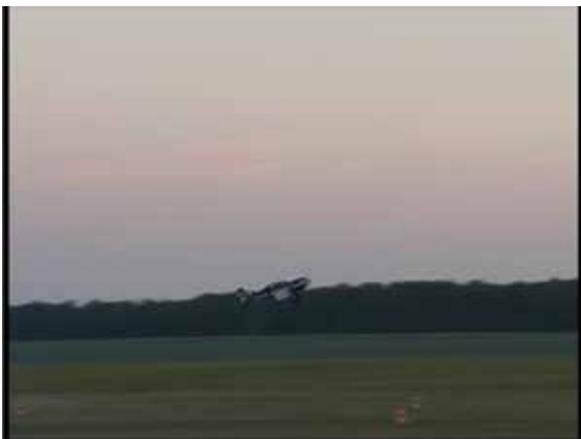
Picture 9. SU-29 EC 2nd approach for landing

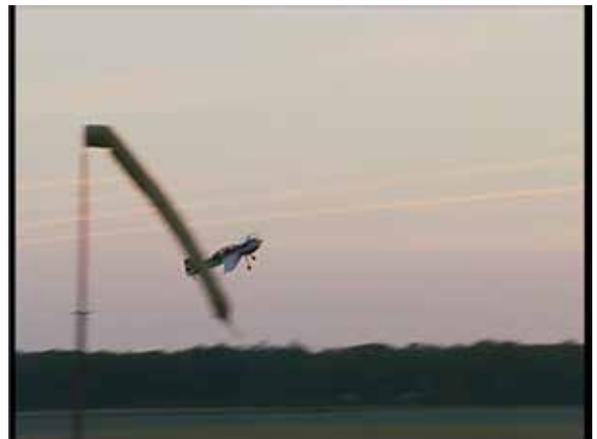
Picture 10. SU-29 EC 2nd missed approach
