FINAL INCIDENT REPORT

Boeing B-737/300F

EC-KDJ

FINAL INCIDENT REPORT Nr. 07/INCID/2008

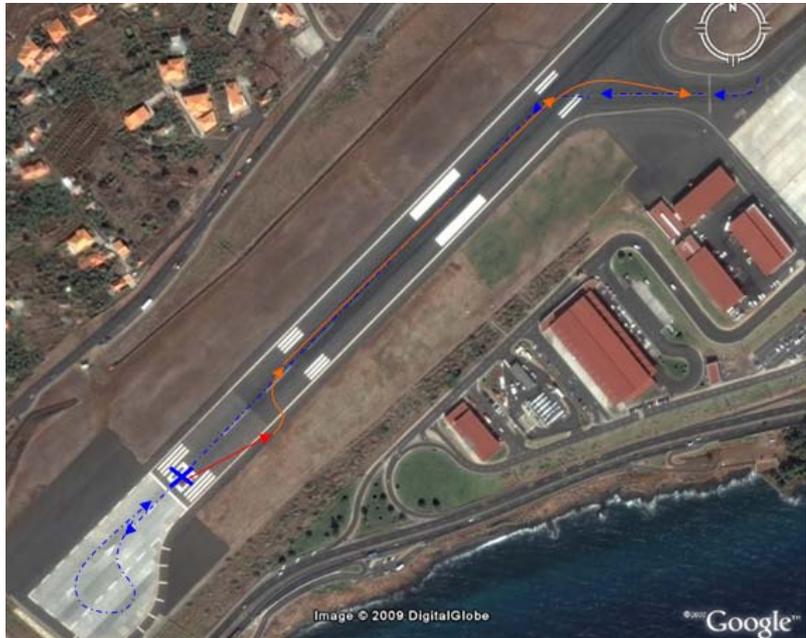
Picture Nr: 1

The aircraft started moving forward, but engines didn't react symmetrically (left engine accelerating more than right one), the aircraft skidding to the right, becoming impossible for the pilot to get control, with normal means, until reaching runway safety shoulder (*picture nr. 1*), after power reduction and A/T was disconnected by the pilot flying.

When leaving runway, the external left main wheel hit a runway edge light and broke it.

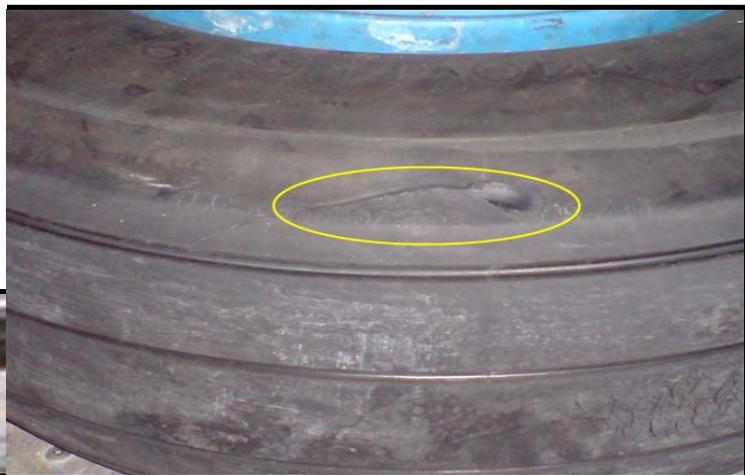
Picture Nr. 2

An external inspection revealed a scratch on outboard left main wheel tire and that wheel was changed before new departure was attempted.

There was no reported damage to the aircraft. Only the outboard left main tire was punctured and it was changed before new departure (*picture nr. 2*).

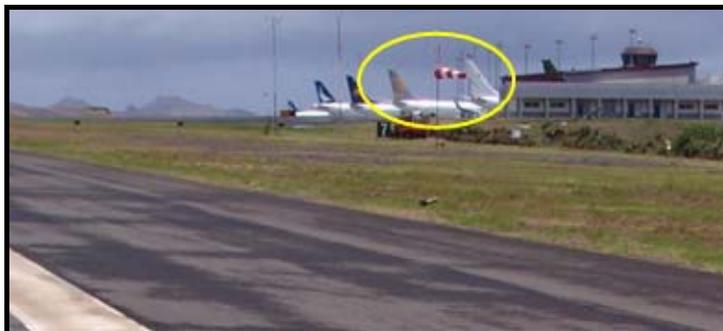
Picture Nr. 3

Visibility was good, the wind was blowing moderate from NE (12kts) and there were no low clouds or other significant phenomena, after the rain stopped (*picture nr. 3*). When take-off was attempted the runway was wet.

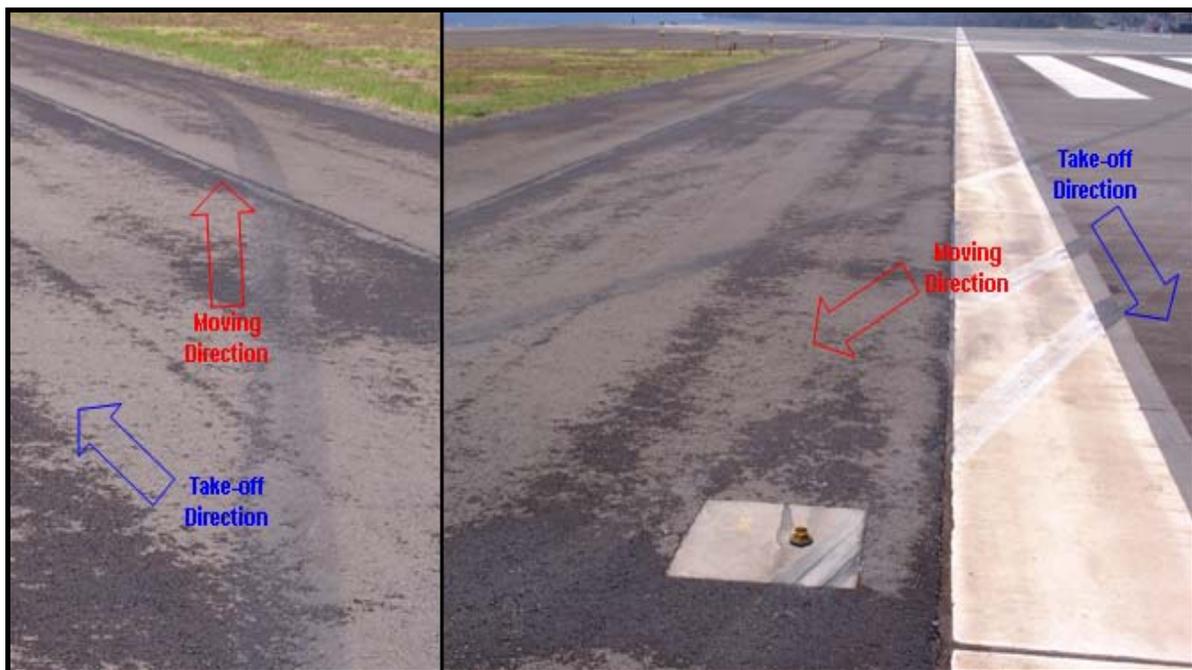
Picture Nr. 5

Aircraft path was well signalled on runway, after the event (*picture nr. 5*).

Marks of skidding started on the beginning of the runway, finishing on right runway safety shoulder, about 80m ahead. Looking for the marks on the runway we could distinguish light colours on painted surfaces and dark ones on asphalt, which may indicate that a cleaning action had occurred, where the tires acted as a broom.

An accurate inspection to the tires showed no signs of wearing or melting rubber, characteristic of dynamic or reverted rubber hydroplaning phenomenon.

EC-KDJ aircraft didn't reach minimum speed for dynamic or reversed rubber hydroplaning. Nevertheless there were visible runway marks of skidding, which confirmed the occurrence of viscous hydroplaning, due the presence of dust on the runway smooth surface, covered by a light wet film.

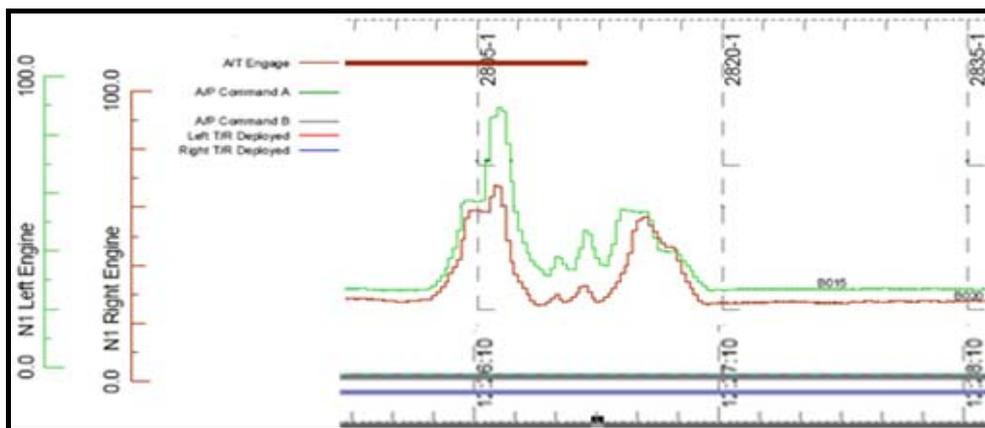
Picture Nr: 6

For take-off, crew elected to use Auto-Throttle (A/T) and FMC computed thrust. Picture nr: 6 represents engines power behaviour, during rejected take-off manoeuvre.

A/T didn't act symmetrically on both engines, #1 accelerating towards 88% N1, while #2 rested at 67% N1 (picture nr. 6).

The pilot tried to bring power to idle but he succeeded only after disconnecting A/T, being idle power established at 12:27:10 (frame 2820).

Primary cause for this incident was the asymmetrical activity of Autothrottle system, which caused engine #1 power increase greater than engine #2, forcing the aircraft to veer to the right.

Considering that primary cause for this incident has been the engine's asymmetrical acceleration, once A/T was engaged for take-off, a comprehensive check should be performed on A/T system, in order to determine the faulty part;

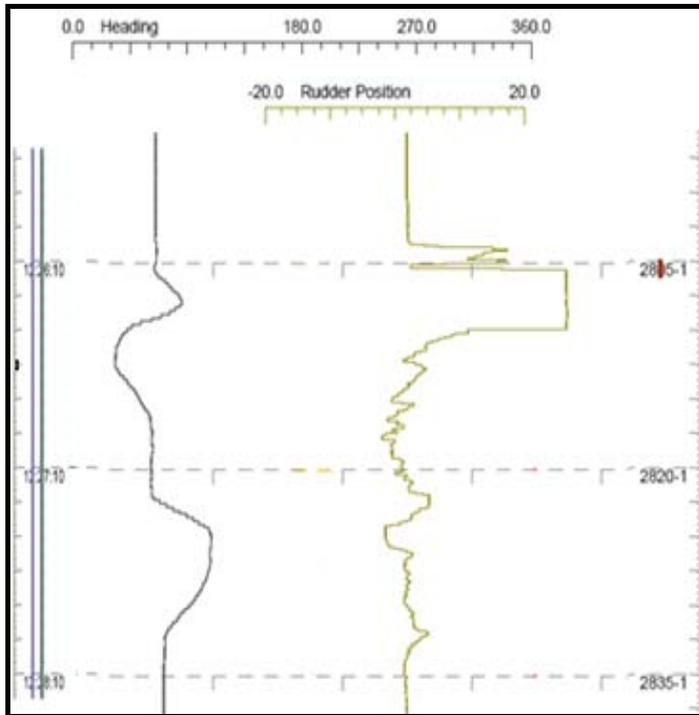
Picture Nr: 7

As soon as take-off was initiated (12:26:00) there was a ruder deflection to the right (17°), returning to neutral and immediately set to maximum right deflection (>20°). Meanwhile aircraft heading increased from 048° to 090° (picture nr. 7). After those 20'' ruder remained more or less neutral but there was heading excursions from 090° to 030°, back to runway heading (045°) and to the right again (110°), before regaining heading 048° at 12:28:00 (frame 2832).

Despite all those heading variation, aircraft track remained more or less straight until the aircraft came to a halt.

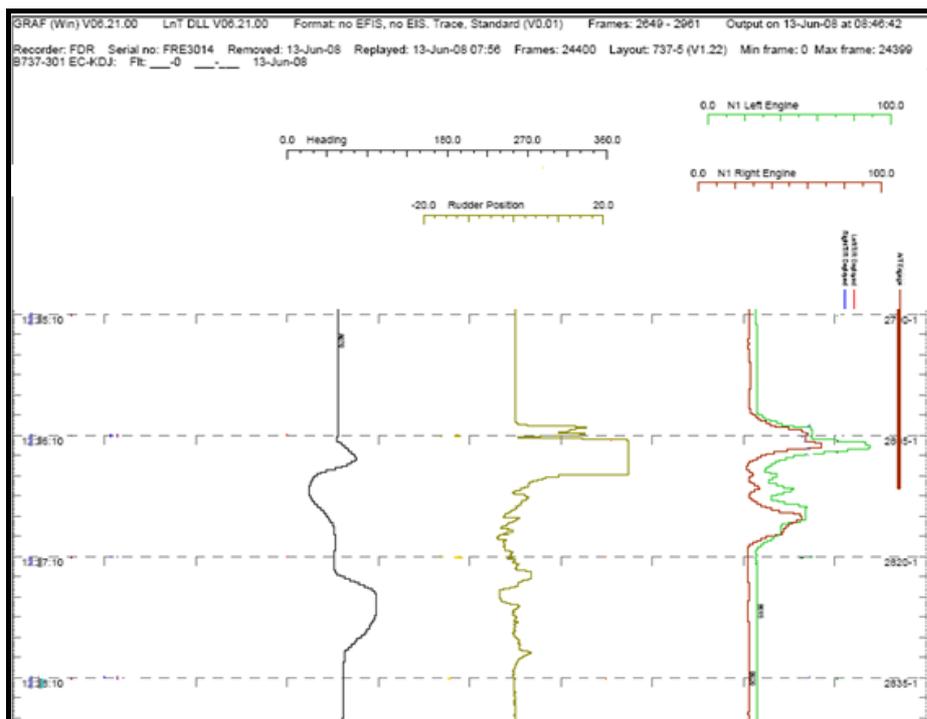
Picture N: 8

Almost simultaneously ruder deflected to the right (17°) and aircraft heading started to increase towards 090°. Pilot reduced engines thrust (20%N1) but A/T remained engaged and power increased again (40%N1) until A/T has been disconnected and thrust levers returned to "idle" (*picture nr. 8*).

At the very moment the aircraft started moving and heading increasing, it initiated a slide that took it on a straight 30° track to the right, leaving the runway, until it stopped on runway safety shoulder. All along that track there were heading significant changes, power variation and assorted ruder actuation. Even if there is no registry of nose wheel steering actuation it is supposed to have been used by the PIC, but without any effect, as the aircraft was skidding.

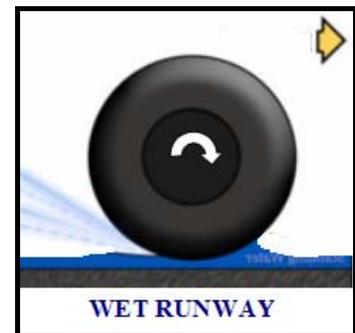
Picture Nr: 14

Rain water, combined with dust, formed a thin mud film on top of a smooth runway, in order to create a highly slippery surface. When asymmetrical engine power forced the aircraft to veer to the right, it started skidding, entering in a viscous hydroplaning situation. Without grooving to stop the hydroplaning phenomenon, the aircraft continued skidding until reaching runway safety shoulder, which was not so smooth, where tires got contact with surface and control was regained.

Considering that skidding was due to the presence of a thin mud film on top of threshold smooth runway surface;
