## **FINAL ACCIDENT REPORT**

**COSTA BLANCA FLIGHT TRAINING CENTRE, S.L.  
BEEHCRAFT 77**

**EC-KNU**

**FINAL ACCIDENT REPORT Nr. 26/ACCID/2009**

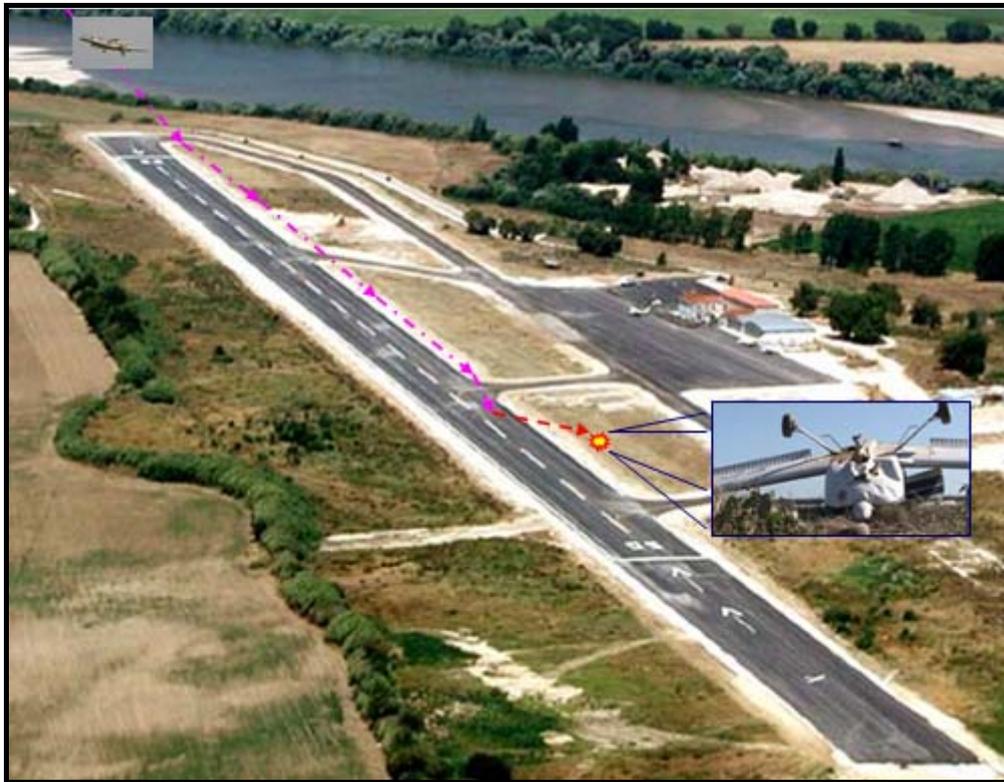
Picture Nr. 1

Touching down after mid-runway, the pilot was unable to control the aircraft along the centre line, it started veering to the left, entered the sandy runway hedge for about 30m, until the nose wheel collapsed and the aircraft became upside-down, coming to an alt about five metres far from the runway margin.

It entered the unpaved area, the nose wheel penetrated in the sandy soil (breaking-up) and the aircraft capsized, resting on its top, about five metres offset of the runway and facing 020° approximately (*picture nr. 1*).

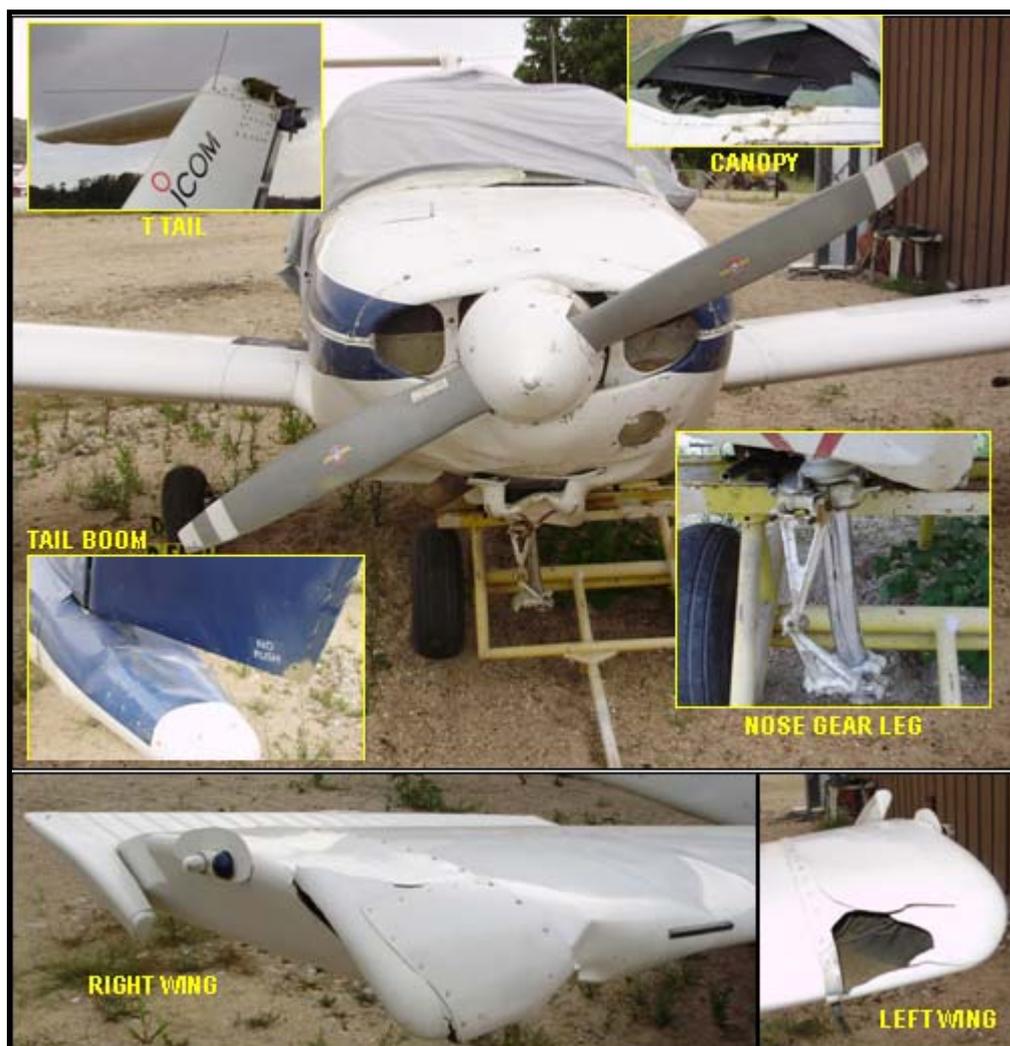
Picture Nr. 2

The aircraft suffered heavy damage on nose gear, canopy & cabin top, right & left wings, tail and propeller (*picture nr. 2*).

Leaving the asphalt surface the aircraft run about 30m prior the nose wheel penetrated in the sandy soil and broke apart. Animated with inertial energy, when the nose hit the ground, the aircraft capsized and became upside-down, with right wing hitting hard the soil and becoming wrinkled, while cabin top crushed and broke the windscreen and canopy. The tail struck the ground and left stabilizer was separated. At same time the impact forced the vertical stabilizer and ruder against tail boom, creasing it.

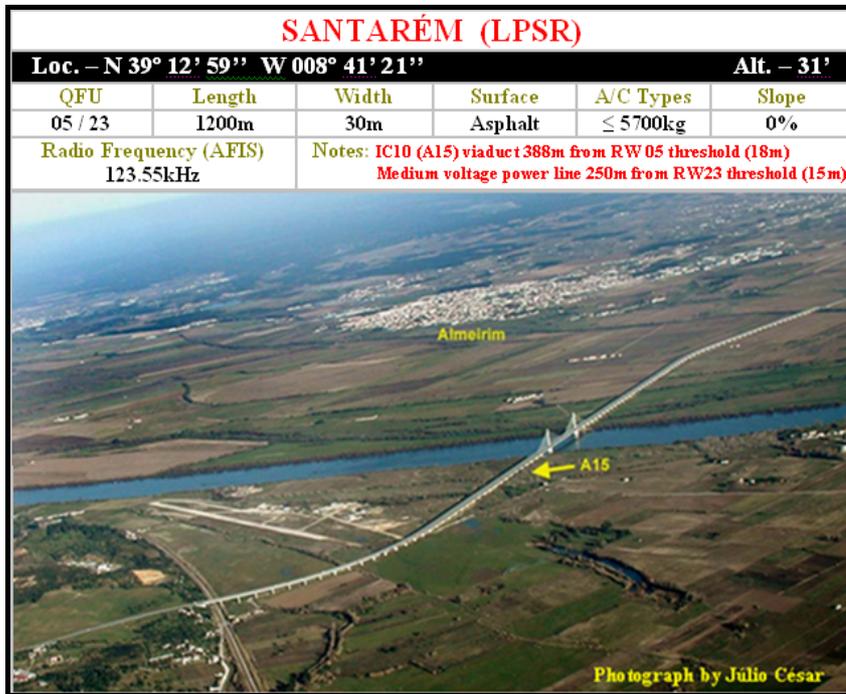
Picture Nr. 3

The privately owned Santarém aerodrome (Cosme Pedrógão) is located near Tagus river, 2NM south of the city and it is served by a single 1205m long runway (*picture nr. 3*).

Due the presence of IC10 (A15) viaduct on the approach path for runway 05, threshold has been displaced in order to give greater clearance over the obstacle, thus reducing landing distance available on RW05 to 980m while maintaining landing distance for RW23 at 1125m.
