DATA SUMMARY

Date and time	Saturday, 24 September 2011; 11:44 h¹
Site	Near Almaraleja (Moura – Portugal)

Registration	EC-CZG
Type and model	CESSNA FR-172-J
Operator	Álamo Aviación

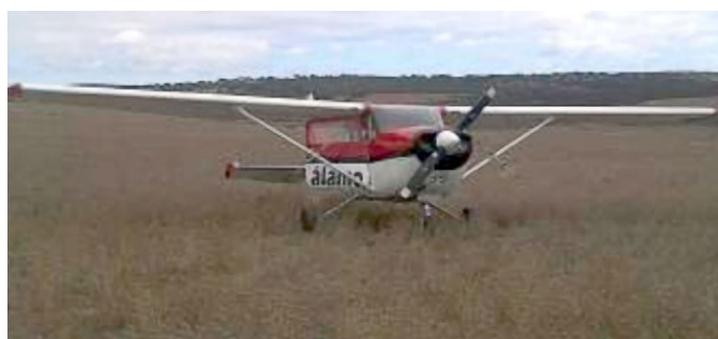
Figure 3. Aircraft at the landing site

The aircraft was undamaged and its three occupants were able to exit it unaided without any injuries.

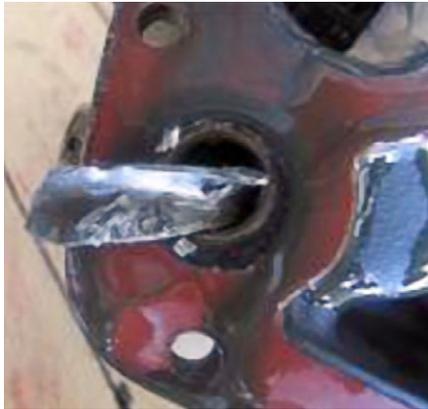
Figure 5. Oil outlet to the filter

There were chips in the oil filter and in the accessory cover. A part from the sleeve on the crankshaft was found in the oil outlet to the filter (see Figure 5).

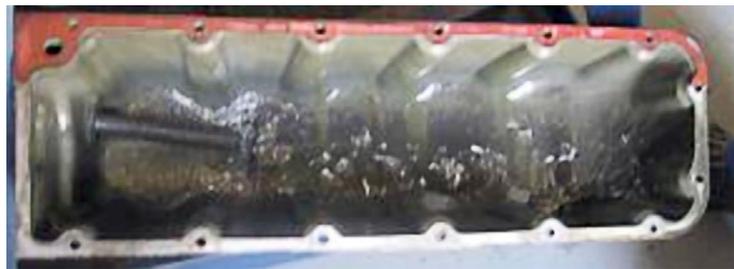
Figure 6. Chips in the lower crankcase

In the lower crankcase there were a large number of metal chips (see Figure 6). When the crankcase was disassembled into two halves, the counterweight on the crankshaft that joins the crankpin on the no. 2 cylinder and the no. 2 support was found to be broken. Also broken was the camshaft in the same area as the crankshaft (see Figures 7 and 8). The break in the crankshaft counterweight led to the fracture of the lubricating line inside the crankshaft counterweight.

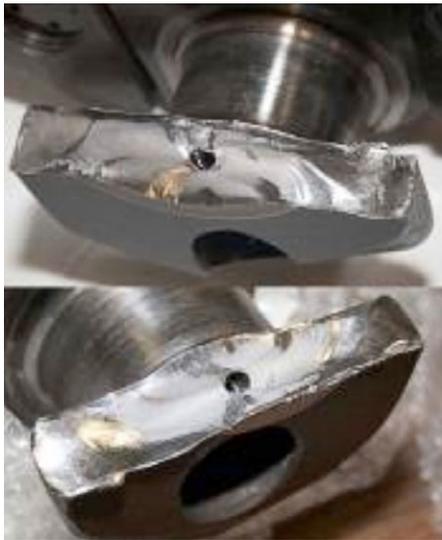
Figure 9. Fracture in the crankshaft

The area of common radius between the counterweight and the crankshaft support revealed the presence of cracks that were parallel to the fracture surface, as well as microcracks in the nitride layer.

The appearance of the fracture profile on the counterweight revealed that the fracture surface had a transcrystalline character.

Based on the macro and microfractographic features, the fracture of the crankshaft's counterweight was caused and propagated due to fatigue, resulting in the final fracture due to static overload.

The fracture originated in the common radius of the counterweight and the support, an area in which various peripheral grooves were observed. The fracture originated in a part of the component where stresses tend to build up.

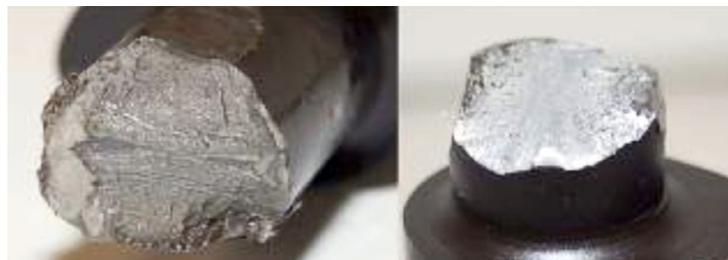
Figura 10. Detalle de la rotura del árbol de levas

Based on the macro and microfractographic features on the fracture surface on the camshaft, the fracture started and propagated along two different fronts due to oligocyclic fatigue, leading to its eventual failure by static overload.

The camshaft fractured due to the presence of an abnormal amount of operating loads. This stress condition is caused by repeated bending loads in two opposite areas of the shaft.

The abnormal loads observed in the fracture area were very likely caused by repeated contact with one of the counterweights on the crankshaft following its fracture.
