DATA SUMMARY

Date and time	Tuesday, 8 May 2012; 07:45 UTC¹
Site	Jerez Airport (LEJR) – Jerez de la Frontera (Cádiz, Spain)

Registration	EC-IOT
Type and model	PIPER PA-28-161 "Warrior"
Operator	Flight Training Europe (FTE) JEREZ

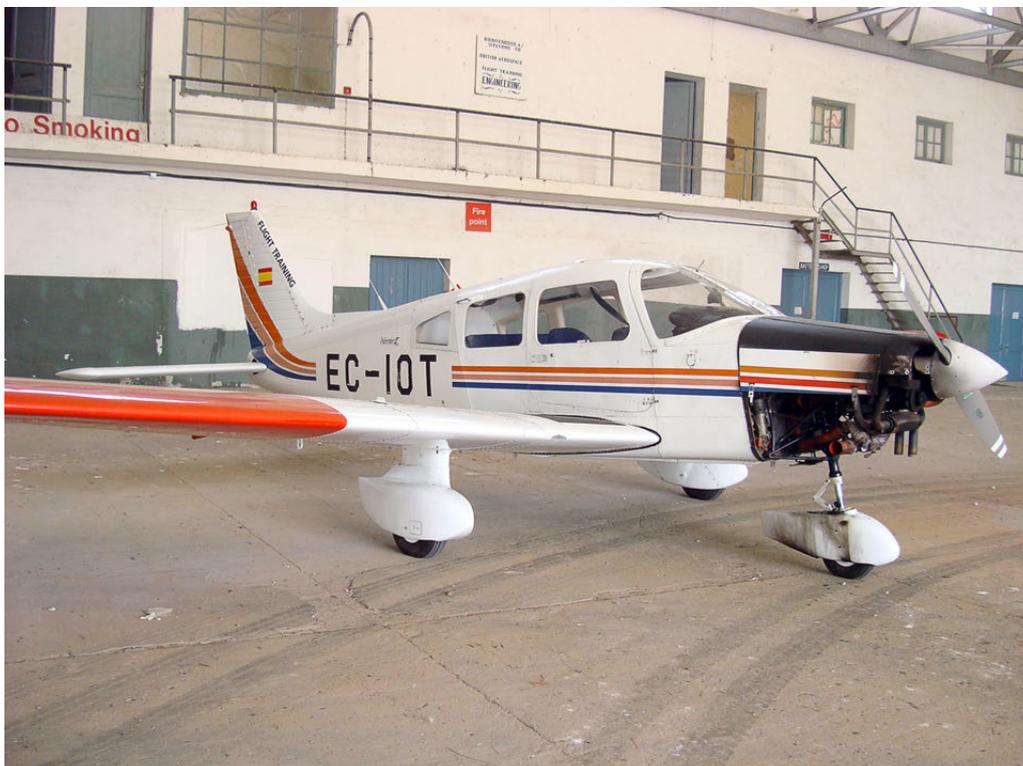
Figure 1. Aircraft after being taken to the hangar

The student was not injured. The damage to the aircraft was confined to the area of the engine and its fairing. The aircraft was towed to a hangar and kept there for a subsequent inspection.

The inspection conducted after the event in the hangar revealed that the hot air intake to the carburetor (from the exhaust pipes) was broken and showed signs of having been subjected to high temperatures. The bottom part of the engine fairing had also been affected by high temperatures. The fuel pipes were checked, along with the area housing the carburetor, but no evidence was found of a loss of fuel or a leak. The fire seemed to have started in the bend in the hot air intake from the exhaust pipes.

The inspection and verification of the aircraft and the study of the Operations Department reports indicated that the fire had most likely started as a result of fuel build-up in the exhaust area, probably due to using the carburetor accelerator pump (fuel pump) to try to start the engine when it was very possibly flooded. It was noted that during each actuation, the fuel pump released about 2cc of fuel, which ended up falling on the lower engine fairing, which showed signs of fuel accumulation.
