**DATA SUMMARY**

Date and time	<b>Sunday, 1 July 2012; 08:45 UTC<sup>1</sup></b>
Site	<b>La Juliana Aerodrome (Seville, Spain)</b>

Registration	<b>HA-NAH</b>
Type and model	<b>SMG-92 Turbo Finist</b>
Operator	<b>Swallow Aviación, S.L.</b>

Operation	<b>Aerial work – Commercial – Parachute drop</b>
Phase of flight	<b>Takeoff – Takeoff run</b>

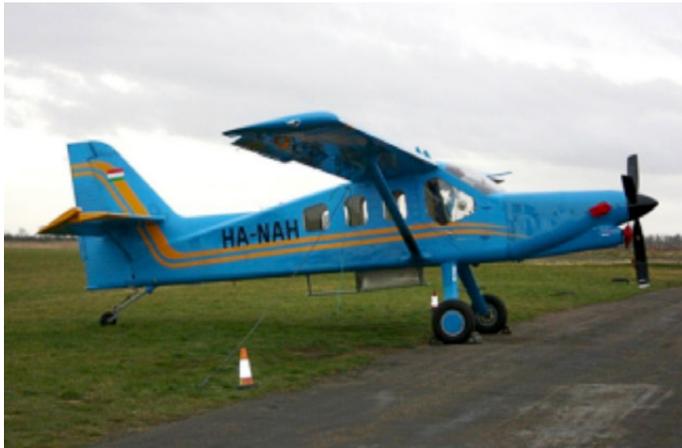
Figure 1. View of the aircraft

The aircraft started taking off from the runway 27 threshold. Upon reaching a speed deemed proper by the pilot for rotation, the pilot noticed that the aircraft was not taking off, so he decided to abort the takeoff. While trying to stop the aircraft, it exited via the left side of the runway near the end, breaking through the fence that surrounds the aerodrome. The damage to the aircraft was mainly limited to the propeller, engine fairing, landing gear, elevator and

wings, which detached when the fuselage impacted some olive trees while the aircraft was outside the airfield.

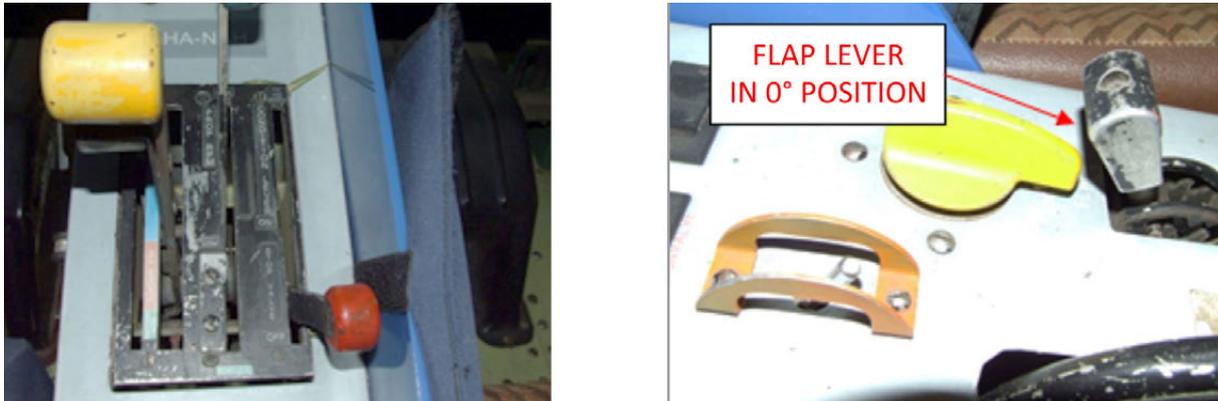
The onsite investigation conducted after the accident revealed that the flaps were in the 0° position, the throttle lever was in an intermediate position, the pitch was full forward and the condition closed.

Figure 3. Powerplant control levers (left) and flap selector (right)

The evidence indicates that the pilot was attempting to take off on runway 27 and forgot to place the flaps in the takeoff position (20°).

Since the flaps were selected to 0° (Up), the aircraft would have needed a speed in excess of 86 kt to take off, instead of the 79 kt corresponding to a flap position of 20°.
