DATA SUMMARY

Date and time	Thursday, 11 October 2012 at 09:44 UTC¹
Site	Sabadell Airport (LELL)

Registration	EC-DMC	M-WINT
Type and model	CESSNA F152	PILATUS PC-12/47E
Operator	Aero Club Barcelona-Sabadell	Privado

REPORT

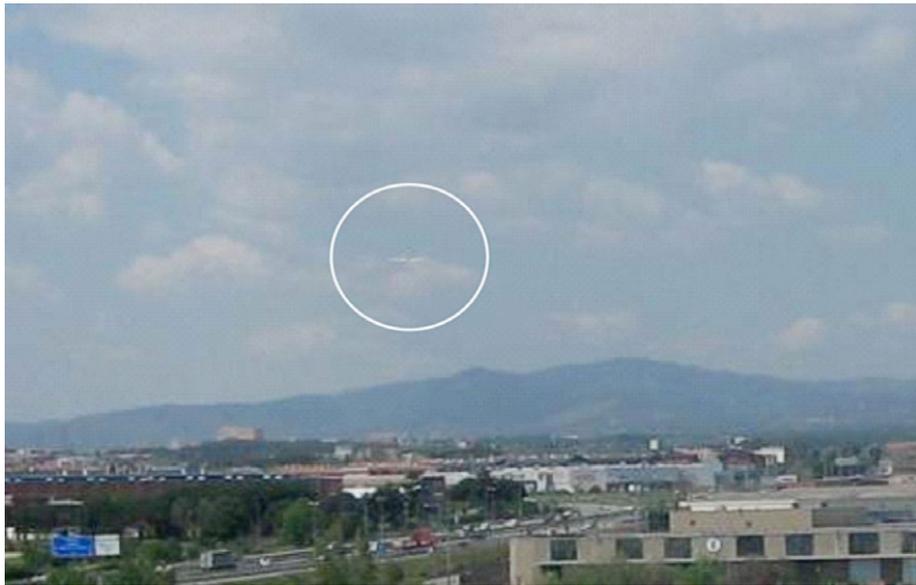
Figure 1. View from the tower of an aircraft in the approximate position as in the incident

Based on radar information, the aircraft crossed at a horizontal distance of 0 NM and a vertical distance of 100 ft.

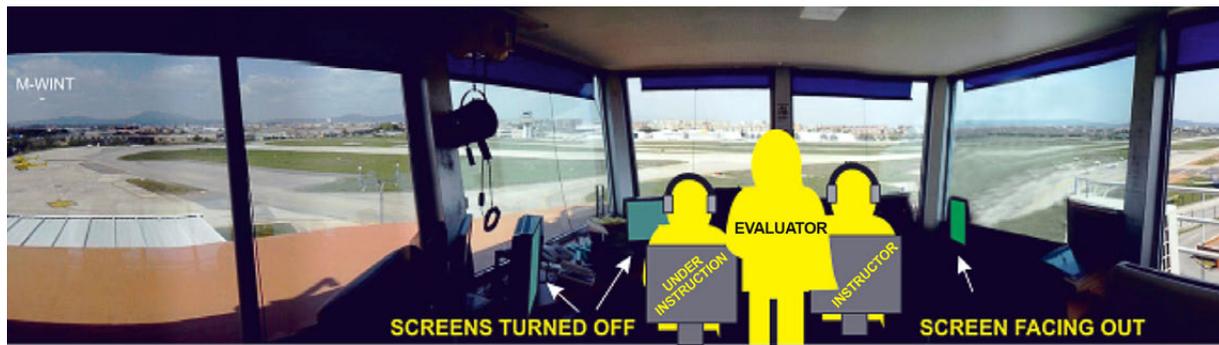
Figure 2. View of the control room with the positions of the controllers

At the time of the incident the student being evaluated was seated in the controller's post (LCL), with the instructor to his right. Behind them was the evaluator and further back the observer.

The instructor stated that from the position of the student being evaluated there was visual access to two radar displays, so one of them was turned off and the closest to his position was turned on but turned around so that the student being observed was unable to see it. He was sitting beside the student controller with his PTT (push-to-talk) unit connected to the number two console and tuned in to the local frequency. He did it this way to avoid audio problems during the evaluation, since on other occasions pilots had experienced problems when both the AENA and ferroNATS headsets were

- REC 32/14.** It is recommended that AENA Air Navigation have the instructor-assistant on the evaluation team make use of all the information at their disposal, specifically that one from the radar display system, as a support to facilitate detecting potential conflicts that jeopardize the safety of aircraft whenever an aerodrome control (visual) evaluation is being conducted.
- REC 33/14.** It is recommended that ferroNATS have the instructor-assistant on the evaluation team make use of all the information at their disposal, specifically that one from the radar display system, as a support to facilitate detecting potential conflicts that jeopardize the safety of aircraft whenever an aerodrome control (visual) evaluation is being conducted.
