Date and time	Tuesday, 13 November 2012; 12:05 h¹
Site	San Javier Airport (Murcia)

Registration	EC-JYC
Type and model	FAIRCHILD SA-226-TC
Operator	Zorex

Operation	Commercial air transport – Non-revenue operations – Ferry
Phase of flight	Takeoff run

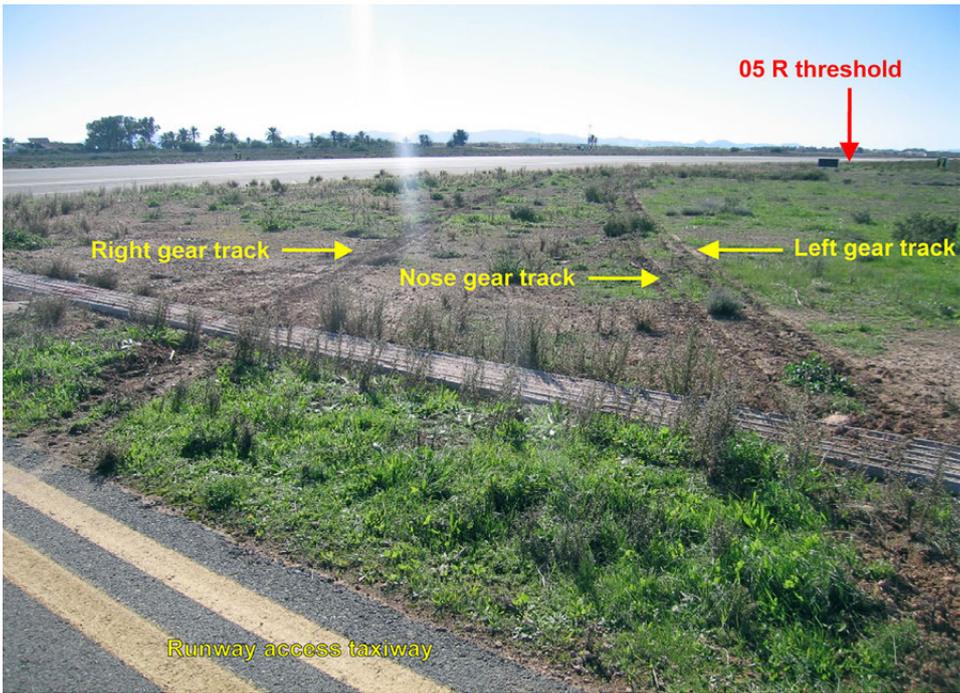
Figure 1. Gear tracks

The tracks found at the accident site during the investigation indicated that the airplane started to deviate approximately 15 m before the aiming point marking; from that moment on both front gear wheels were skidding while turning left. The airplane then struck the edge of the access taxiway and crossed it, at which point the wheels returned to their normal position, with the airplane stopping a short distance further ahead (see figure in Appendix A).

As Figure 1 shows, during the portion of the run that the airplane was skidding (approximately 47 m), the tracks left by the front gear wheels came within 60 cm of those left by the left main gear wheels, whereas the normal distance between them is about 2.25 m (half of the wheel track).

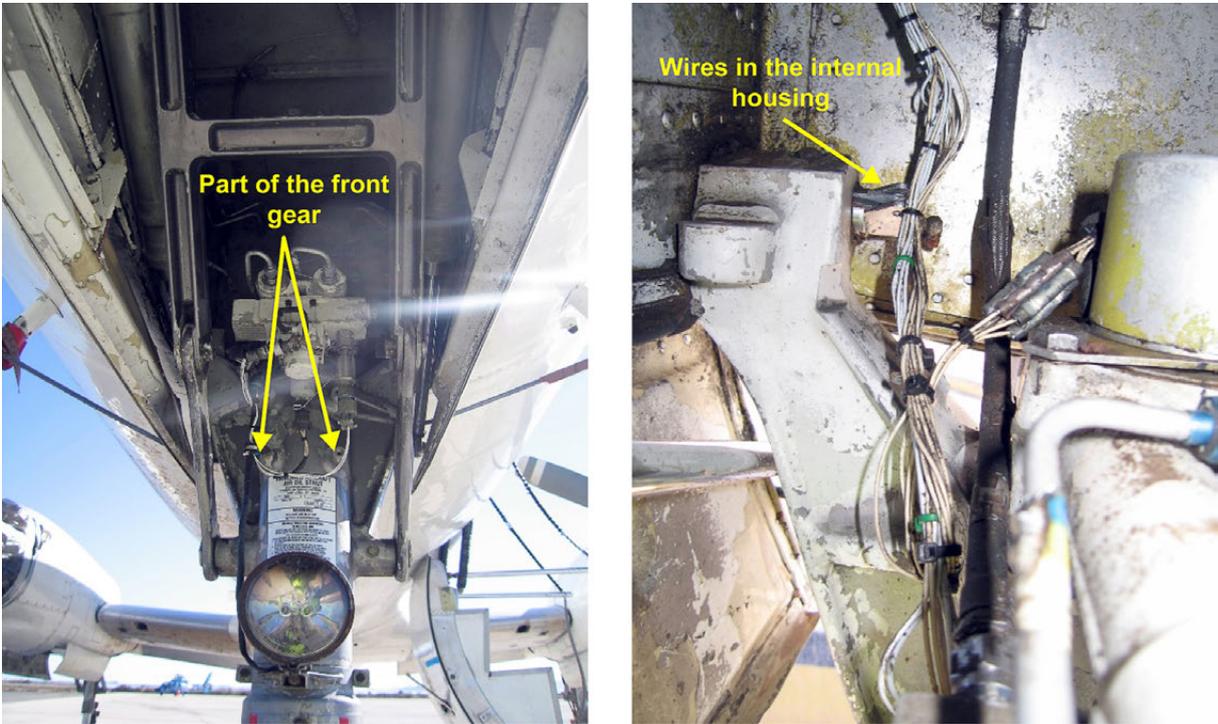
Figure 2. Nose gear housing

An inspection of the landing gear did not reveal any mechanical faults aside from the damage caused by the runway departure. It was noted, however, that the electrical

wires that actuate the gear components lacked any type of protection against moisture and other external agents (see photographs in Figure 2) beyond the insulation present on each wire.

It is possible, however, that the lack of protection for the wires, beyond that provided by the insulation, along with the adverse moisture conditions and a possible contaminated runway, could have caused an instantaneous failure of some component in the electrical system resulting in an improper contact that was corrected during the

REC 46/2013. It is recommended to M7 Aerospace to generate appropriate documentation and in the form considered the most suitable (Service Bulletin, Service Letter, etc.) with specific instructions for the maintenance of Nose Wheel Steering electrical system wiring of the FAIRCHILD SA-226-TC METRO II aircraft, ensuring effective protection of the system from a humid environment.
