FINAL ACCIDENT REPORT

AIR TRACTOR - 802A

EC-JLB

FINAL ACCIDENT REPORT Nr. 12/ACCID/2012

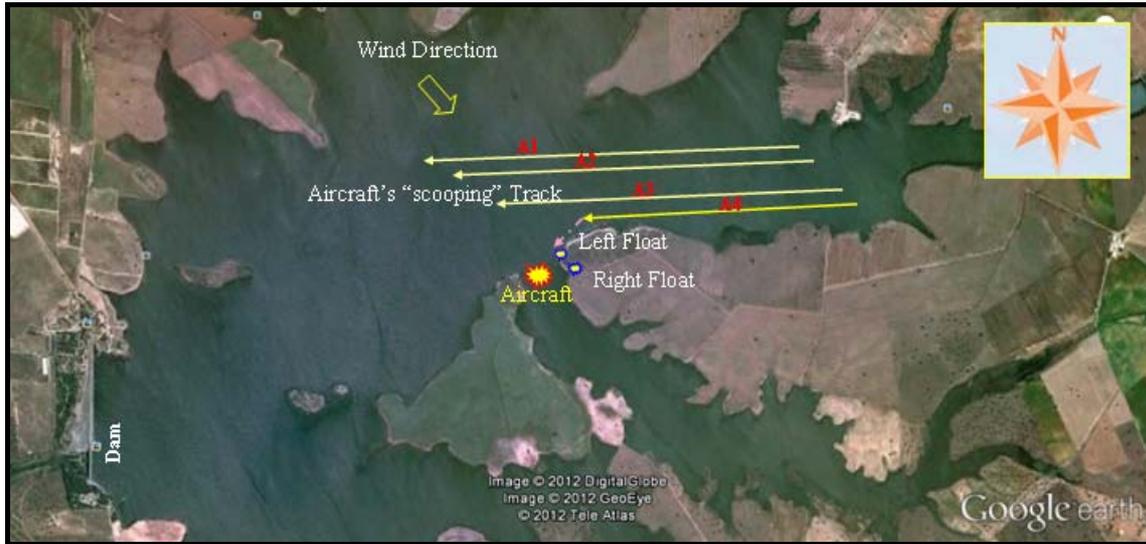
Picture Nr 2

neck of land and crashed, nose down, some meters ahead in another inlet, right float broke up (becoming afloat and drift) and the aircraft sunk, almost immediately (*picture nr 2*).

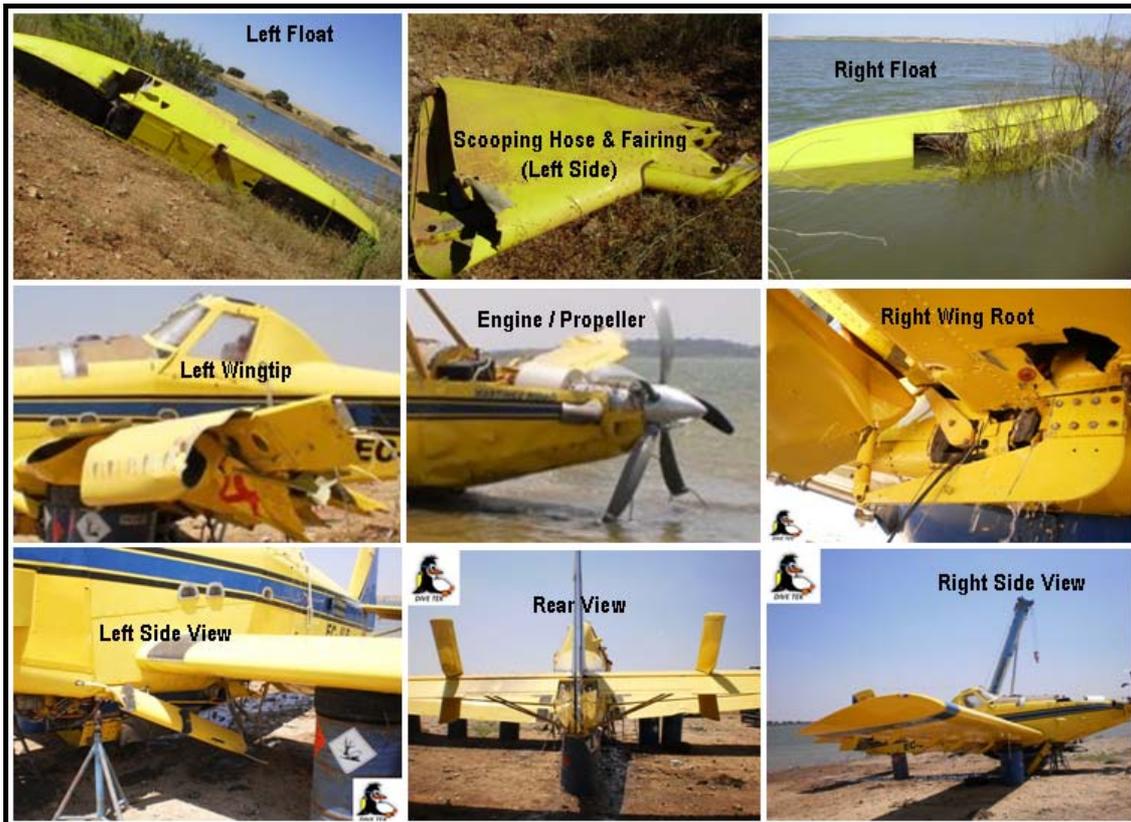
Picture Nr 3

The aircraft suffered substantial damage, which could justify not to be repaired, namely both floats separation and heavy damage to their fixing points and floats themselves, left wing tip and outer wing damage caused by water impact, right wing underwing crack (near its root) with fuel tank leak, bent propeller blade tips and light damage (scratches and dents) on fuselage skin and flight control surfaces (*picture nr 3*).

Being the aircraft immersed in the water it's supposed to have suffered equipment and engine substantial internal & external damage.

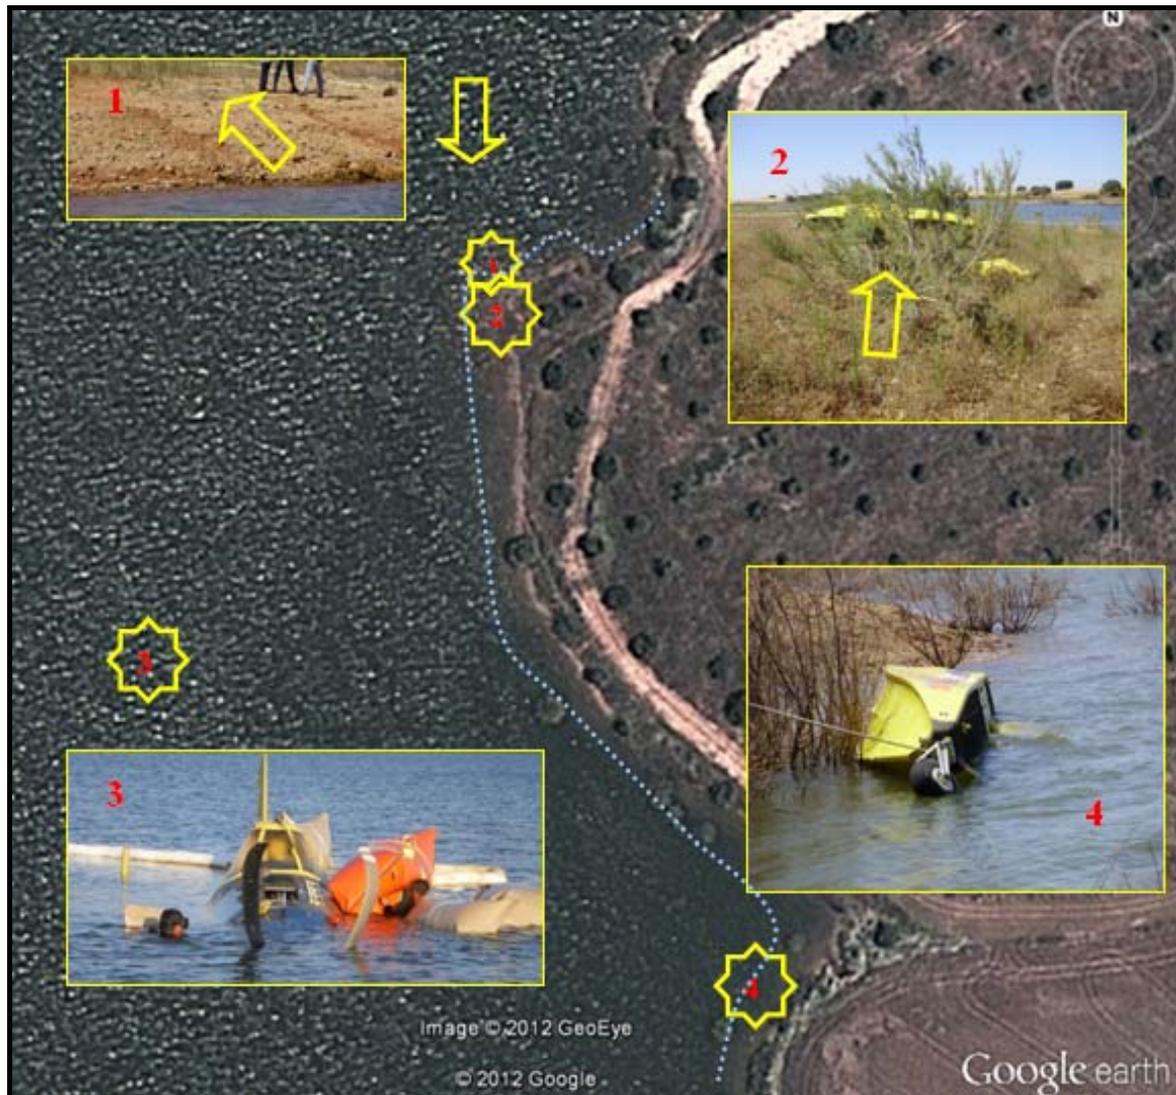
Picture Nr 7

Picture nr 7, bellow, shows ground impact points and wreckage localization, with the arrows pointing on movement direction.

First impact, with both floats, occurred on lagoon water line (1), which was at a bit lower level than the picture shows (more or less by blue dotting line), on a wings levelled and nose up position. Here the left float separated and rested ashore (2), with the aeroplane flying over the neck of land and impacting the water, nose down, a few metres ahead. Without left float, left wing tip impacted the water and outer wing became damaged, while right float broke apart and drift to its final position (4). The aircraft sunk and was later recovered from the bottom (3).

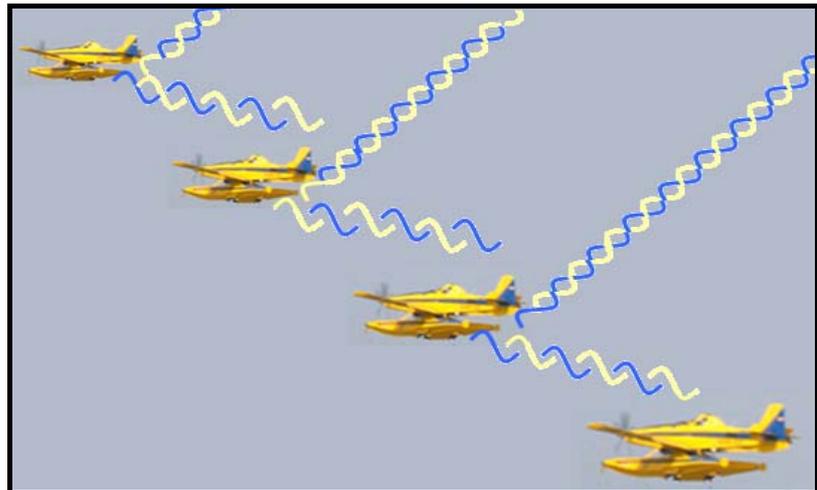
Picture Nr 8

Lateral spacing between aircrafts allowed every aircraft to avoid preceding one (in case of failure and rejected take-off manoeuvre), proceeding in front; while longitudinal spacing kept each aeroplane outside previous aircraft wake, when moving on lake surface (*picture nr 8*).

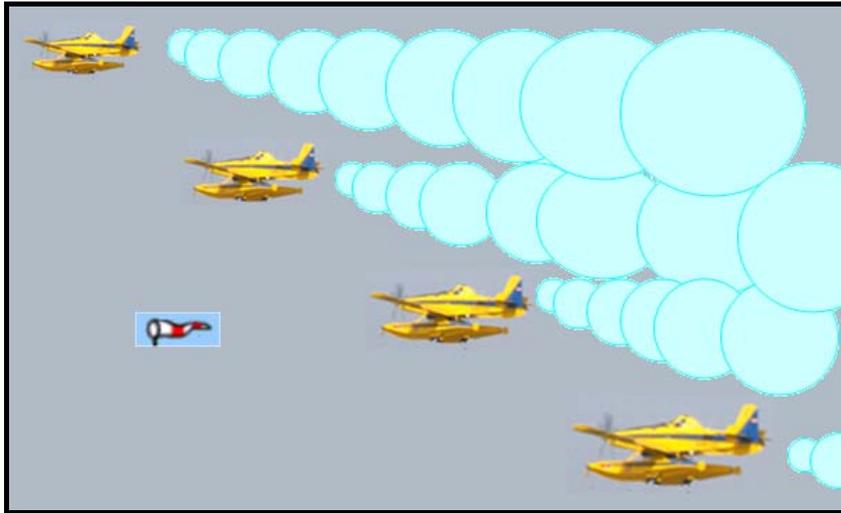
Picture Nr 9

With the planes heading into the wind, wake turbulence waves propagate straight behind and, due lateral separation between aeroplanes, forward aircraft generated turbulence doesn't interfere with following aircraft, which keeps flying undisturbed (*picture nr 9*).

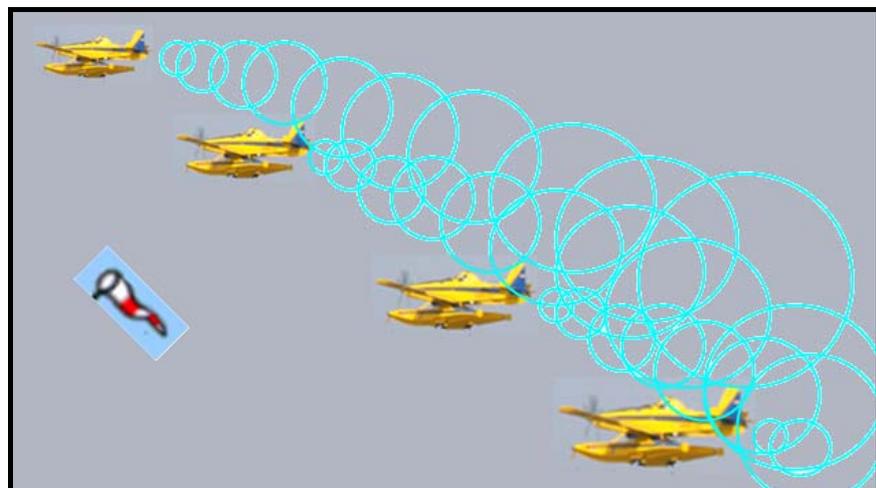
Picture Nr 10

In spite of its low intensity, the wind caused a deviation to the left of wake turbulence waves (*picture nr 10*).

In such a case, wake turbulence generated by preceding aircrafts was interfering with following ones, creating difficulties for its controllability.

If aircrafts 2 and 3 were not too much affected by turbulence and pilots managed to control them without problems, aircraft nr 4 was suffering the influence of all other aircrafts generated turbulence, having its pilot a great difficulty to control the aircraft. In fact, at rotation, after scooping, he lost control of the aircraft and, when he regained it, the aircraft was pointing about 45° to the left, against the margin. He couldn't lift-off before impacting the ground with both floats, lost one of them and crashed a few meters ahead.

If the leader had adopted a right line formation, wake turbulence waves would move outwards of the subsequent aircrafts and the manoeuvre would be facilitated.

“To study the introduction, on his Operations Manual, of more detailed information regarding lateral wind effects on aircraft’s performance and control during group scooping manoeuvres, or other similar operations (like simultaneous take-off and landing manoeuvres) suggesting the use of required procedures, namely different formation layout, in order to minimize or avoid such negative effects” (SR 05/2012)
