## Report IN-015/2014

Incident on 5 July 2014,  
involving an AIRBUS 340-300,  
registration LV-FPV, operated  
by Aerolíneas Argentinas, and  
a BOEING 767-300, registration  
VQ-BSX, operated by Utair, at  
the Barcelona Airport (Spain)

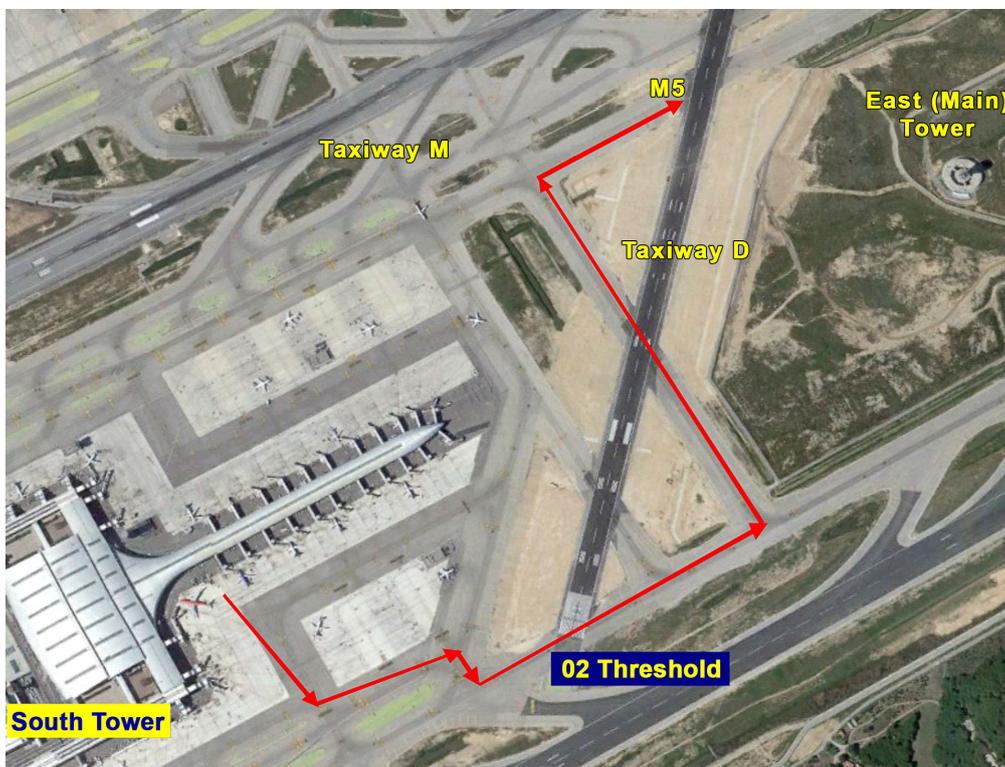
Figure 1. Taxi route of airplane ARG1163

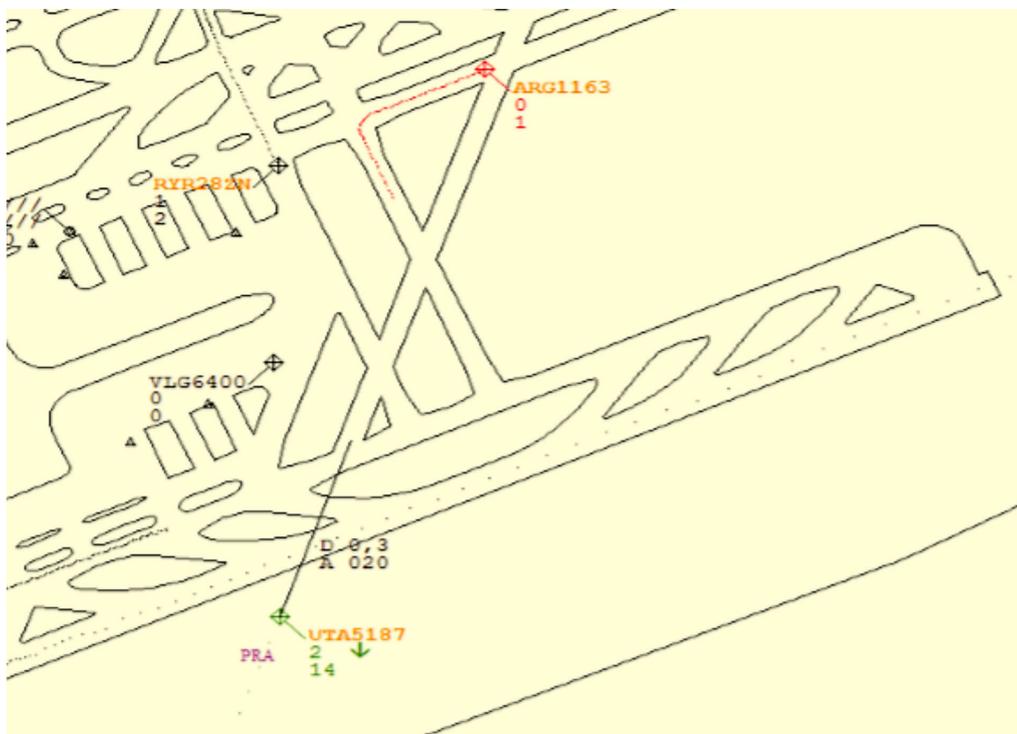
The minimum horizontal distance separating ARG1163 and UTA5187 during the runway incursion was 1.15 NM, and the minimum vertical distance was 200 ft (Figure 2). At that point aircraft BCS6304 was 4 NM behind UTA5187.

Figure 2. Minimum radar separation between the aircraft

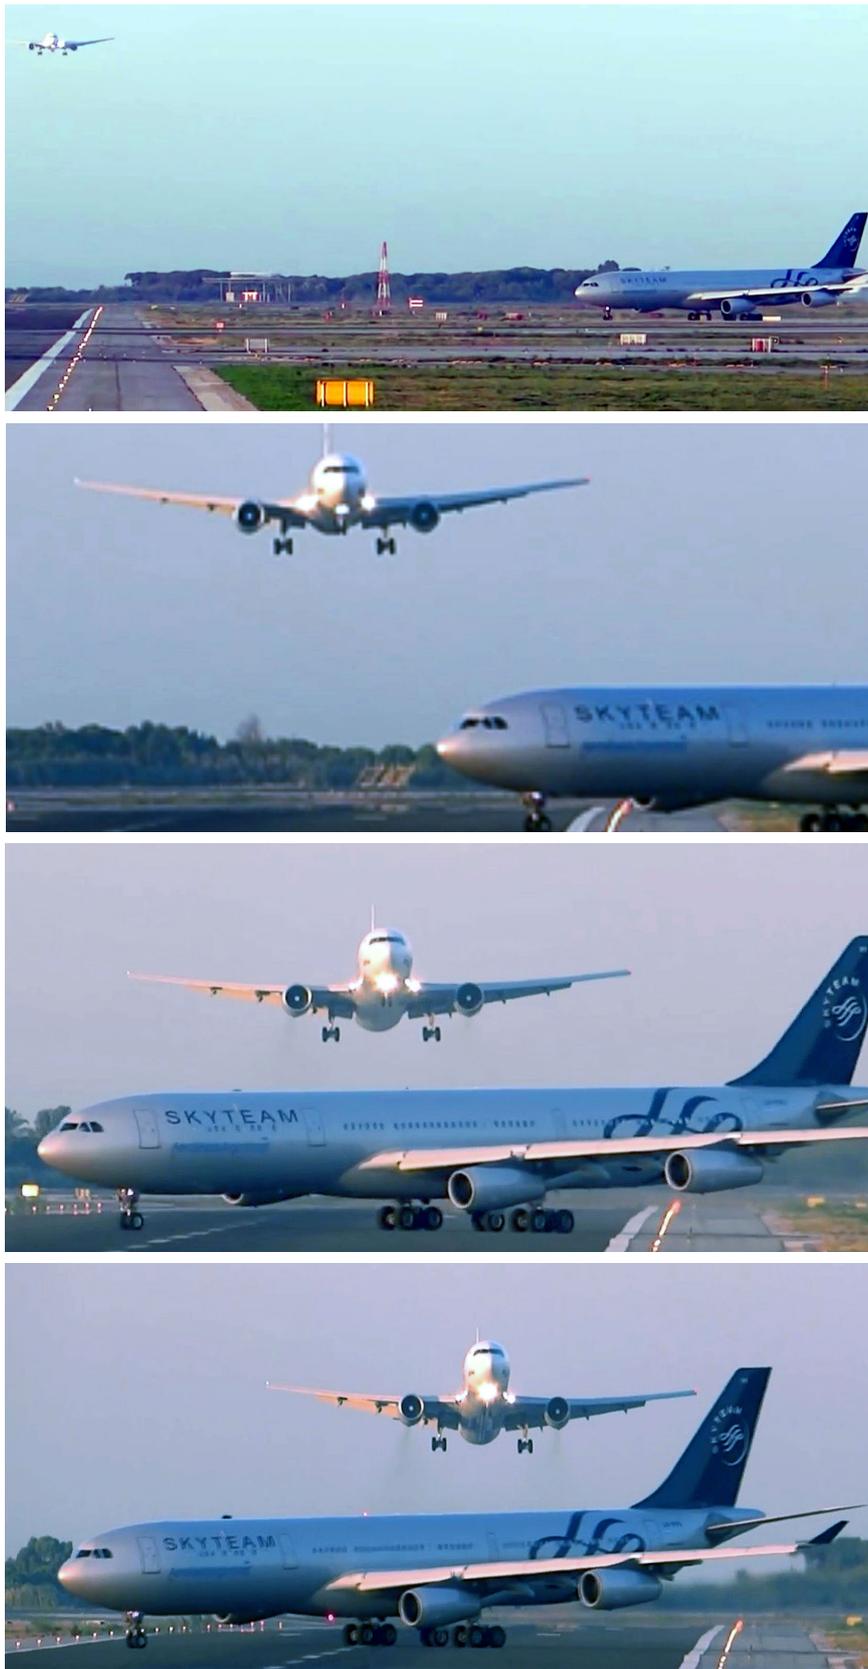
Figure 3. Photographs of the runway incursion sequence

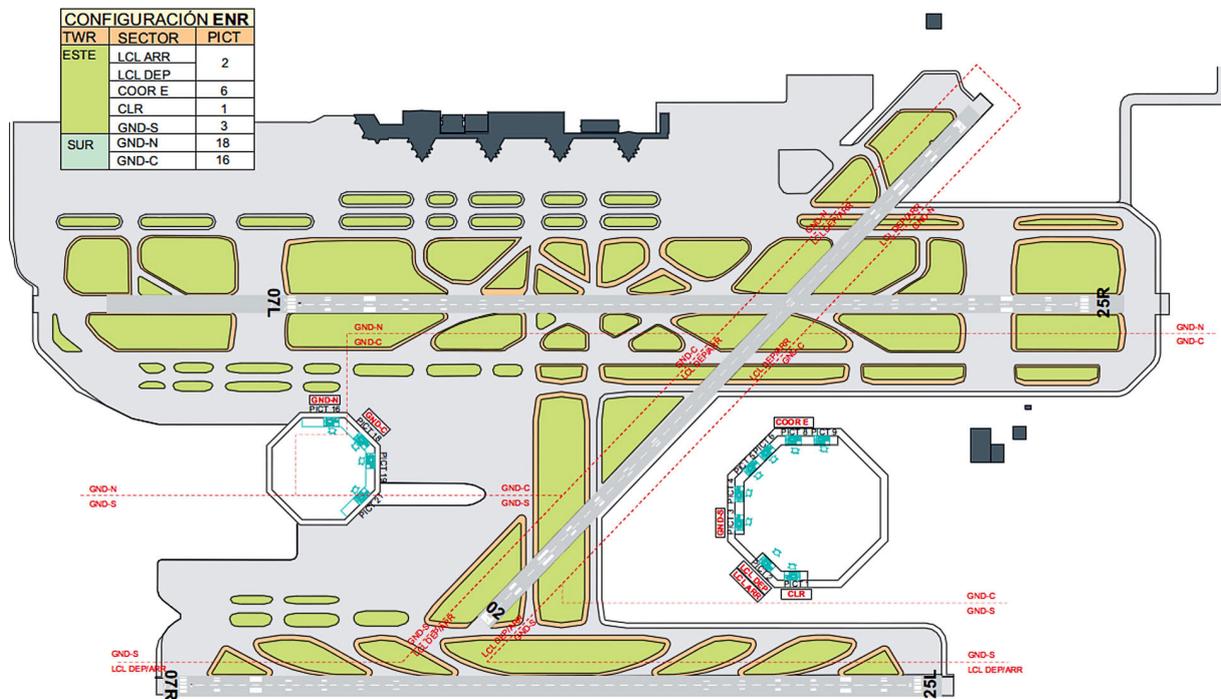
Figure 7. Location of the towers

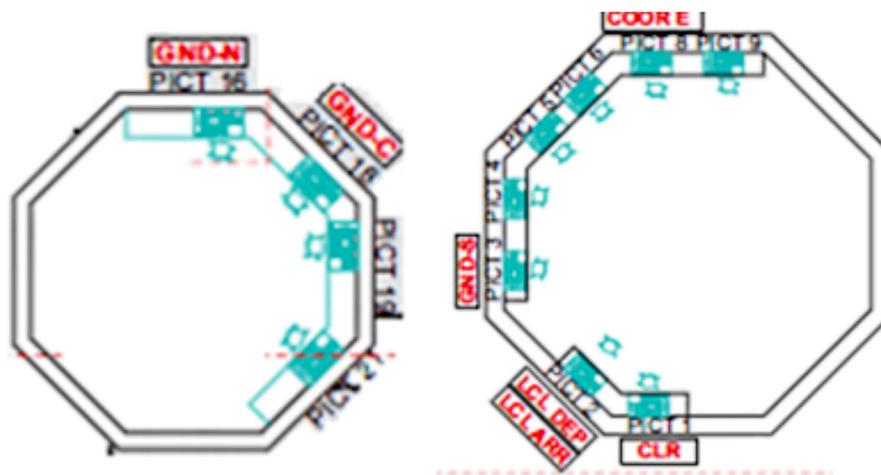
Figure 8. Layout of the posts in the towers

The GND-N and GND-C controller posts face north, meaning that traffic approaching runway 02 is behind them. Moreover, when seated, the GC controller cannot turn and see approaching traffic to 02 as far as the coastline. This controller also has the tower supervisor's tables directly behind, partially blocking their view. The Local controller's (LCL) post faces the intersection of runways 02 and 07R.

- It is recommended that ENAIRE review the location of all the control posts to ensure that the local controller has an unimpeded view of all the intersections where the various taxiways cross the active runway.
