Report A-001/2016

Accident involving a SOCATA TB-20
aircraft, registration EC-ESK, operated
by a private operator, in the Serranía
de Cuenca Natural Park (Spain)
on 16 January 2016

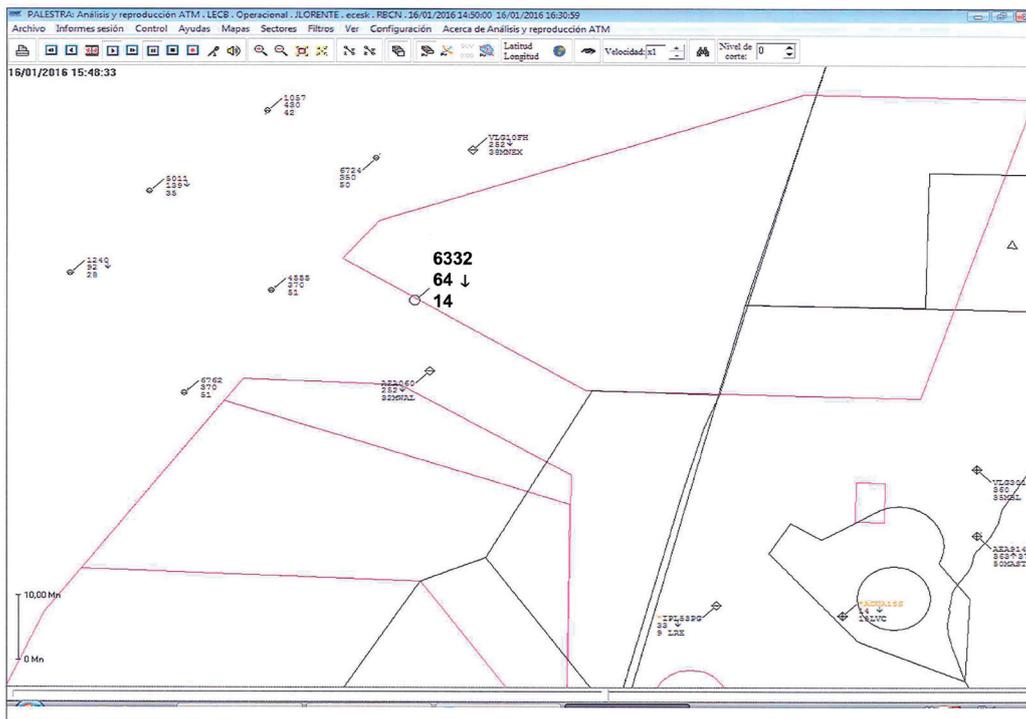
The radar track was lost at 16:48:34. One second earlier, the aircraft's coordinates were 40° 13' 05" N, 1° 53' 12" W and its position was:

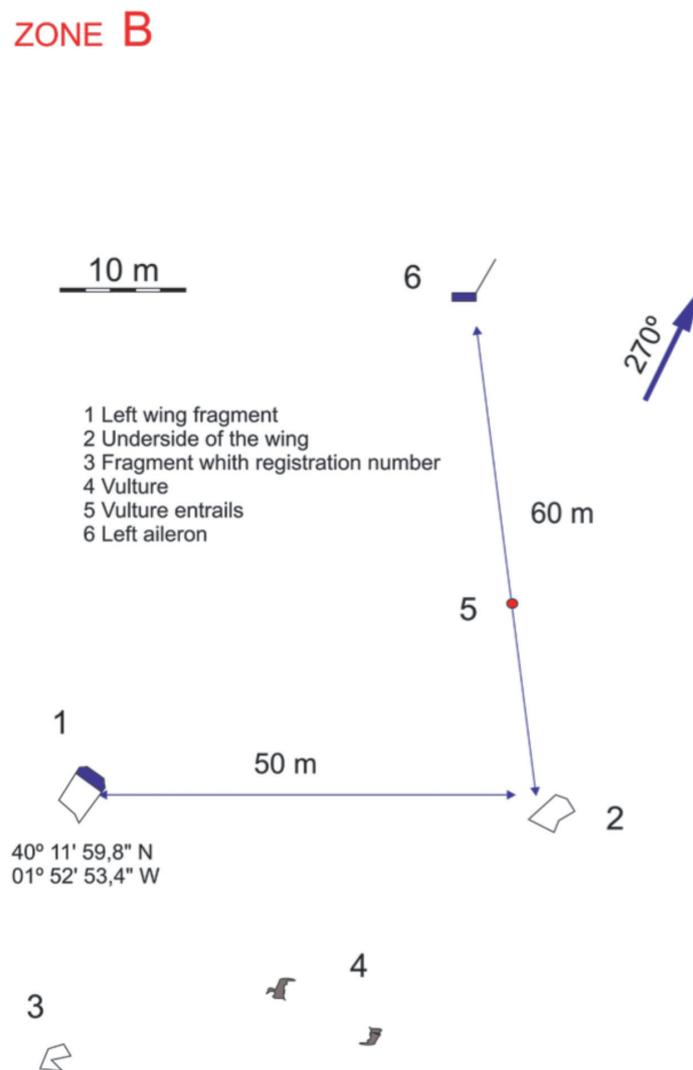
Fig. 1. Positions of the various parts of the left wing and of the vulture

The first area (at coordinates 40.200231 N, -1.872787 W) contained the debris from the left wing along with the body of the vulture. The diagram below shows the relative positions of the various parts of the left wing and of the vulture.

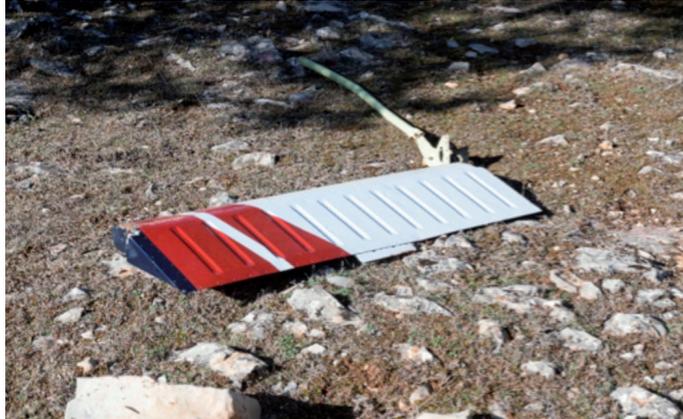
Fig. 2. Left aileron

The photographs below show debris from the left aileron, with part of a control linkage still attached to it, part of the skin from the bottom of the left wing, and the left wingtip, which were found in this area.
