**COMISIÓN DE
INVESTIGACIÓN
DE ACCIDENTES
E INCIDENTES DE
AVIACIÓN CIVIL**

Report IN-005/2016

**Incident involving a Boeing 737-700,
registration D-ABLB, operated by
Germania Fluggesellschaft mbH, at runway 03R
of the Gran Canaria airport (Canary Islands, Spain)
on 7 January 2016**

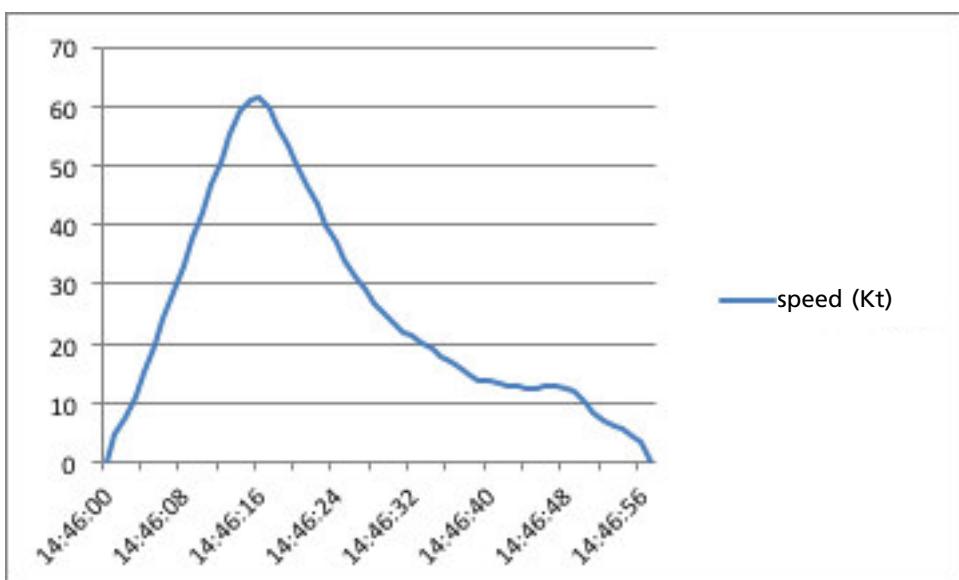
Figure 2. Graphic of the GMI6129 aircraft speeds during take-off run

At 14:45:45, the crew acknowledged the takeoff clearance and at 14:46:01 they started the takeoff run. The crew canceled the takeoff at 14:46:16, by which time the aircraft had reached a ground speed (GS) of 61.5 kt and traveled a distance of about 270 meters. The aircraft completely stopped at 14:46:57 after traveling about 740 meters.

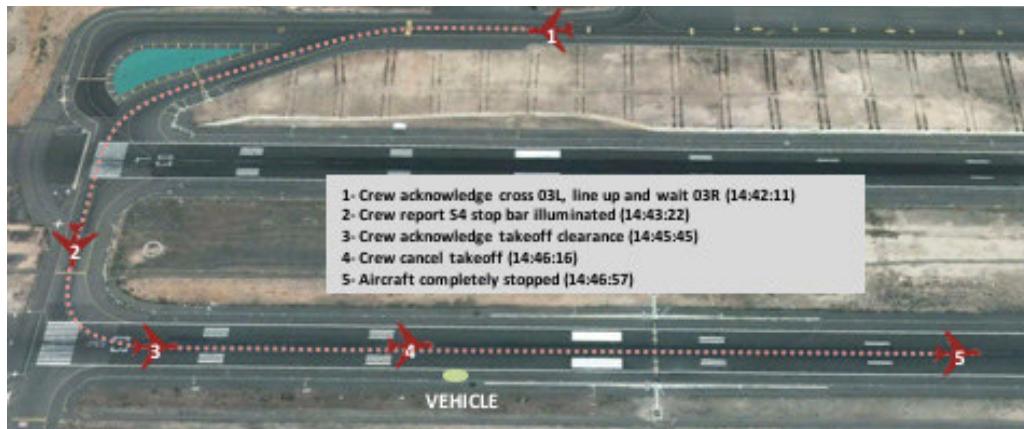
Figure 3. Approximate path of GMI6129

The QAR data were used to make an approximate reconstruction of the path followed by the aircraft. The graph includes the approximate position of the vehicle based on the version of the events provided by the personnel inside said vehicle.

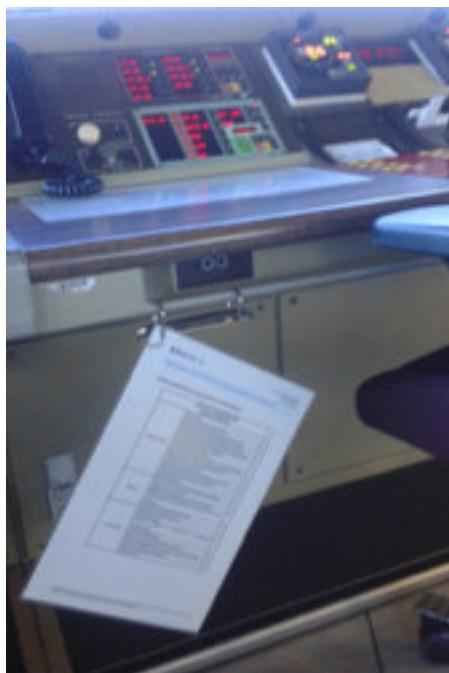
Figure 4. Relief checklist at the LCL post

ENAIKE stated that the checklist procedure had been in place since 2015, though its use was not obligatory. On the day of the incident there was no updated copy of the checklist at the LCL positions in use, as it had likely been misplaced. The use of this checklist has been mandatory since February 2016.

Section 6.3 of Annex B of the Unit Operations Manual contains a turnover checklist. According to information supplied by the services provider, the use of the checklist was in place and its use was recommended. However, on the day of the incident an updated copy was not available at the LCL post. In its report on the internal investigation into the incident, the services provider made a recommendation to implement the use of the checklist during turnovers as a safety measure. In February 2016, the navigation services provider required the use of this checklist at the GCLP TWR; as a result, the CIAIAC deems it unnecessary to issue a safety recommendation in this regard.

A recommendation regarding the use of checklists was also deemed necessary: It is recommended that ENAIRE implement checklists to be used during turnovers at the unit.

However, since ENAIRE already implemented this measure following its internal analysis of the incident, the CIAIAC has decided not to issue this recommendation.

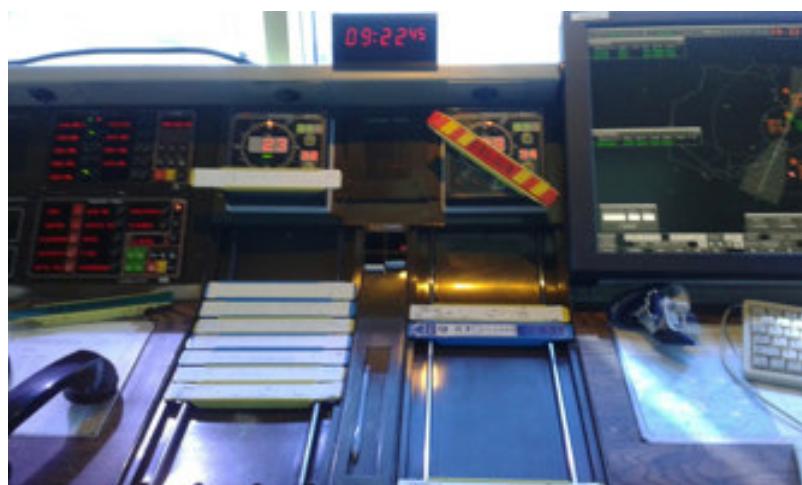
Figure 5. Visual aids at the GCLP LCL post to indicate a runway is closed

As for the review of the visual aids in the control room to indicate that the runway was closed, the unit has decided to place an additional strip on the wind speed indicator. This way, when the controller obtains the wind information required to be provided in the message authorizing the landing/takeoff of an aircraft, he can see that the runway is occupied.

Figure 5 shows the visual aids that indicate the runway is closed. Runway 03L/21R was closed for a period in excess of 15 minutes, while runway 03R/21L was temporarily occupied by a vehicle doing a runway inspection (yellow strip in the horizontal position).

- The controller did not detect his mistake despite the presence of visual aids in the tower indicating that the runway was closed. He also did not see the car in the runway 03R strip, though this may have been caused, as per the statement from the crew and the controller, by the fact that the car did not have its flashing lights on.

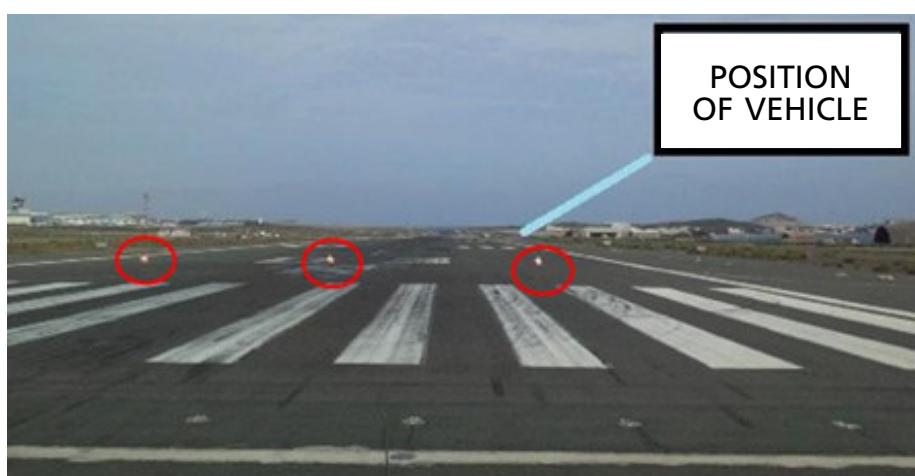
Figure 6. View from threshold of the vehicle's position with the cones in place

The report states that all of the measures agreed to at the coordination and risk analysis meeting were implemented. As for placing cones, it states that the documentation resulting from the LRSC was being reviewed and pending approval by its members, and that none of those involved proposed analyzing and using this measure during the meeting to coordinate and analyze the risk of the survey work.

- Systematic use of cones at the threshold when closing a runway. The airport manager stated that this measure was already implemented.
- As pertains to the above and for closures of runway 03R/21L involving the possibility of removing people and machinery if required for an emergency military procedure that requires installing the brake cable, the use of the runway in that situation with the cones in place should be analyzed and agreed to with the air base expressly for each case.

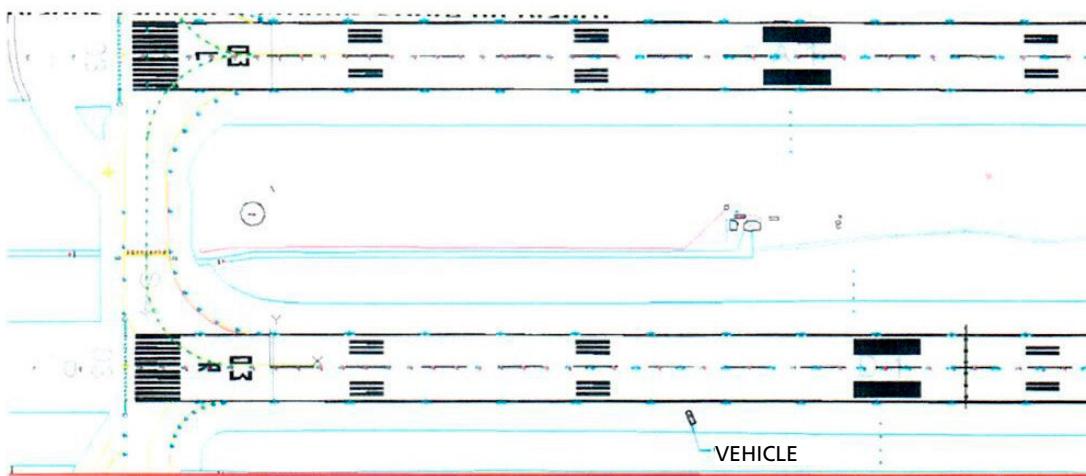
Figure 8. Vehicle's position based on the driver's account

The driver of the vehicle stated that he was inside it on the right shoulder of runway 03R. At one point he was instructed to exit the runway temporarily, which he did, leaving the runway and going to the perimeter road, where he remained until he was cleared to enter the runway again and continue with the survey work.

He also failed to notice the presence of a vehicle on the runway during those four minutes that elapsed until he gave the takeoff clearance. As the controller stated, the car was not easily visible from his position in the tower since its dark color blended in with the runway's, and its lights were either not visible from the tower or they were off at the time. The crew recalled that the vehicle did not have its flashing lights on, though they could not be certain it was equipped with flashing lights. Investigators requested security camera footage from the time of the incident that showed runway 03R to see the conditions in which the vehicle was working, its position and the aircraft's path, but the airport manager replied that said footage was not available. AENA, in its investigation report, stated that the vehicle had flashing lights and that they were on during the work. It was thus not possible to ascertain whether the vehicle had flashing lights installed, though they may have been off at the time of the event. This would have hampered the controller's ability to detect its presence on the 03R runway strip. AENA already specifies in its Platform Safety Regulation the requirement to have flashing lights installed and turned on when the vehicle is on the runway strip, even it is not moving.
