Report A-020/2016

Accident involving an EMBRAER ERJ
190-200, registration EC-LKX,
operated by Air Europa Líneas Aéreas,
at the Adolfo Suárez Madrid-Barajas
Airport (Spain) on 15 June 2016

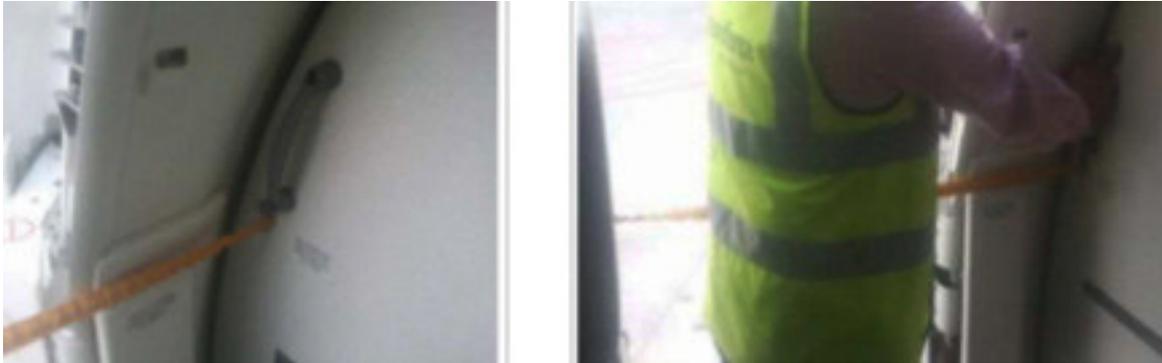
Therefore, the safety strap, as it does not prevent falls, cannot replace a work platform installed outside the door as a safety barrier.

- He was not using any tools during the visual inspection.
- AMT2 recalled that AMT1 was holding on to the door handle intended to be used with the right hand when opening the door. The safety strap was in place.

Figure 1. Close-up of the handle and safety strap (left) and reconstruction of the AMT's position (right)

His plan was to visually inspect the condition of the sensor. He did not request to have a platform installed at the door for this inspection. He set up the safety strap, as instructed by the manufacturer for a visual inspection, and held on to the handle. The strap, however, did not keep him from falling when he stepped off the edge while looking at the door sensor.

Since the safety strap has been shown to be ineffective in preventing accidental falls, a Safety Recommendation is issued to the aircraft operator so that whenever a door has to be open for maintenance, a safety system is used that can prevent accidental falls.

REC 03/17. It is recommended that Air Europa take the measures deemed appropriate to avoid a repeat occurrence of this type of accident.
