Report IN-021/2016

Incident involving an Airbus A319-111,
registration G-EZGE,
at the Ibiza Airport (LEIB, Spain)
on 19 June 2016

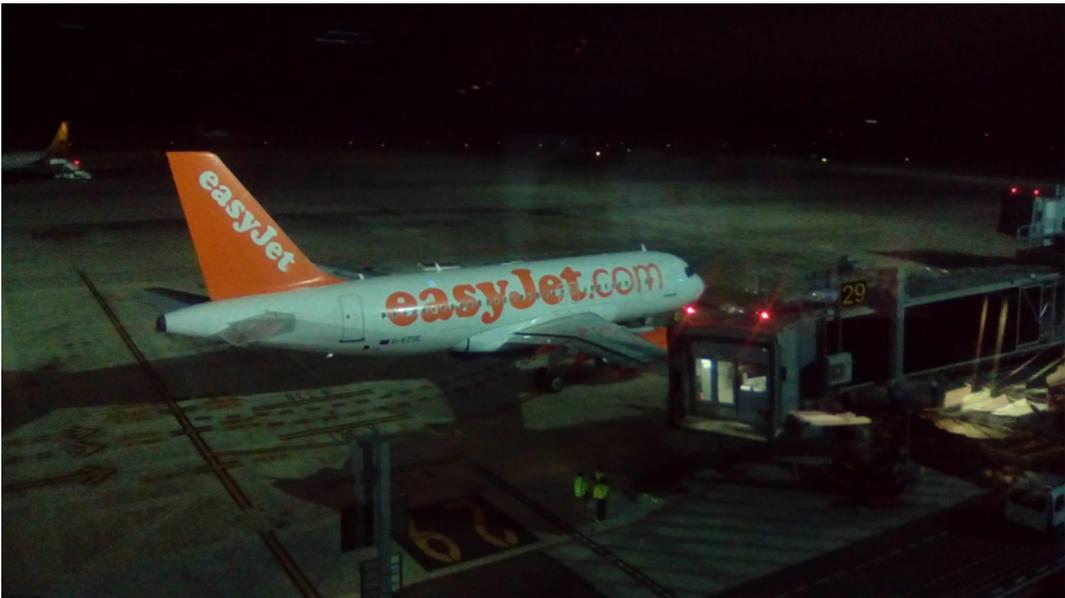
The airplane ended up facing parking stand 28 and encroaching on much of the NPA² between the two stands, affecting the departure of an aircraft being pushed back by a tractor. The incident aircraft was subsequently towed to stand 14 to await repairs.

Figure 1. Condition of aircraft after impact

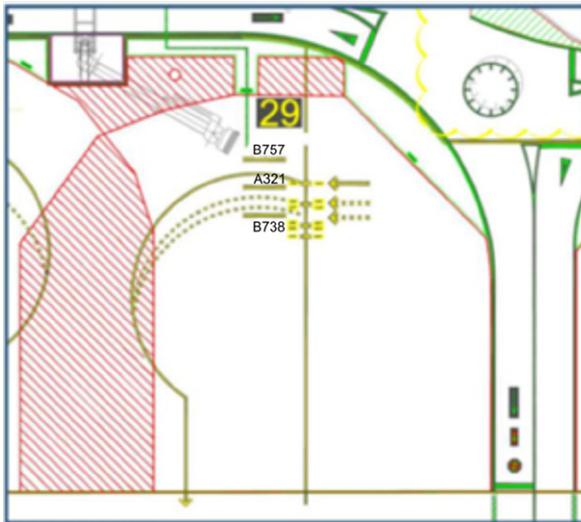
Figure 2. Sheet for parking stand 29

The exit is designed such that after advancing 3 meters (as painted), the aircraft starts to make a 180° turn such that the closest part of the aircraft to any object (jetway, docking system, terminal, vehicles, etc.) is at least 4.5 meters away (clearance for type-C aircraft).

The sheet for parking stand 29 shows the theoretical paths taken by the different aircraft that can park there to taxi out of the stand (tightest dashed line for the A319).

After this incident occurred, AENA decided to require all aircraft to be pushed back out of stand 29, a temporary preventive measure that was implemented between 23 June at 14:31 and 20 September at 22:00, and reported via NOTAM. This measure was then made permanent following its publication in the October 2016 AIP.

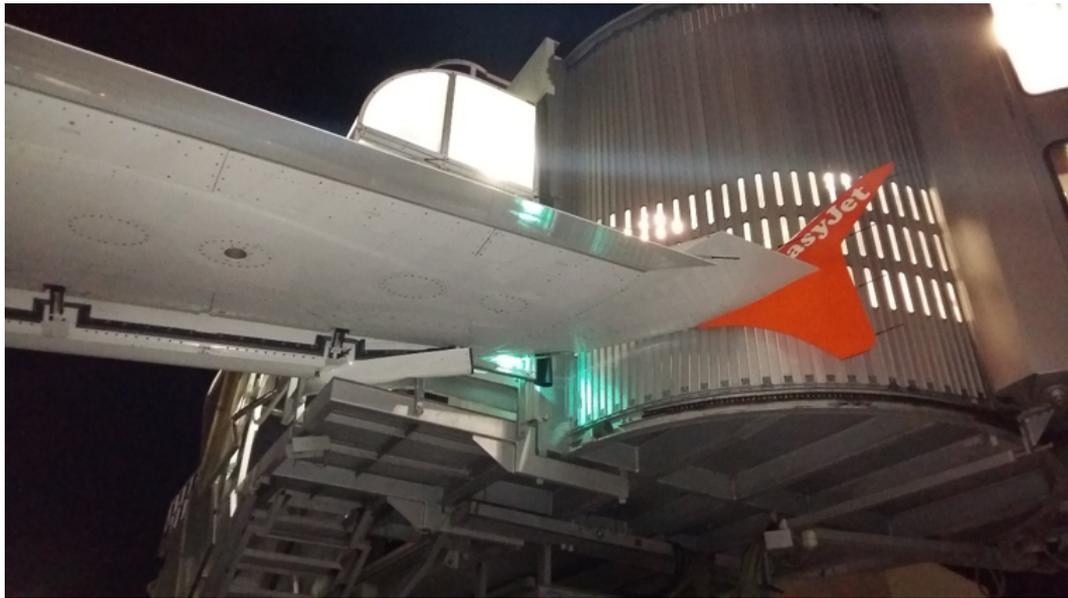
As a result of the impact, the aircraft’s right wingtip, including the outboard slat, was damaged.

Also damaged was the end of the telescoping jetway.

Figure 3. Damage to aircraft and airport facilities

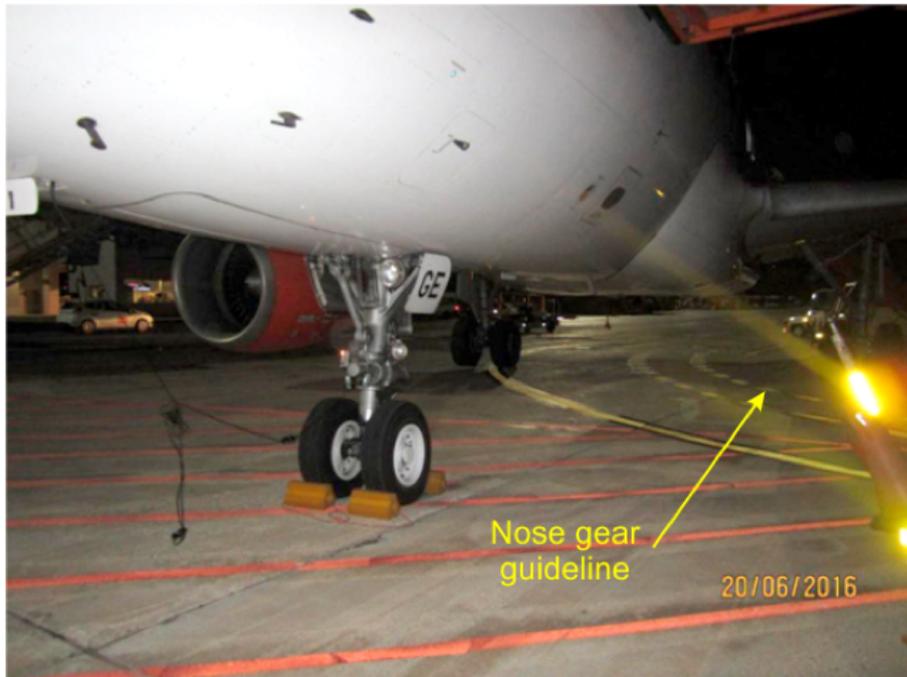
The nose gear wheels were centered.

Figure 4. Nose gear wheels centered

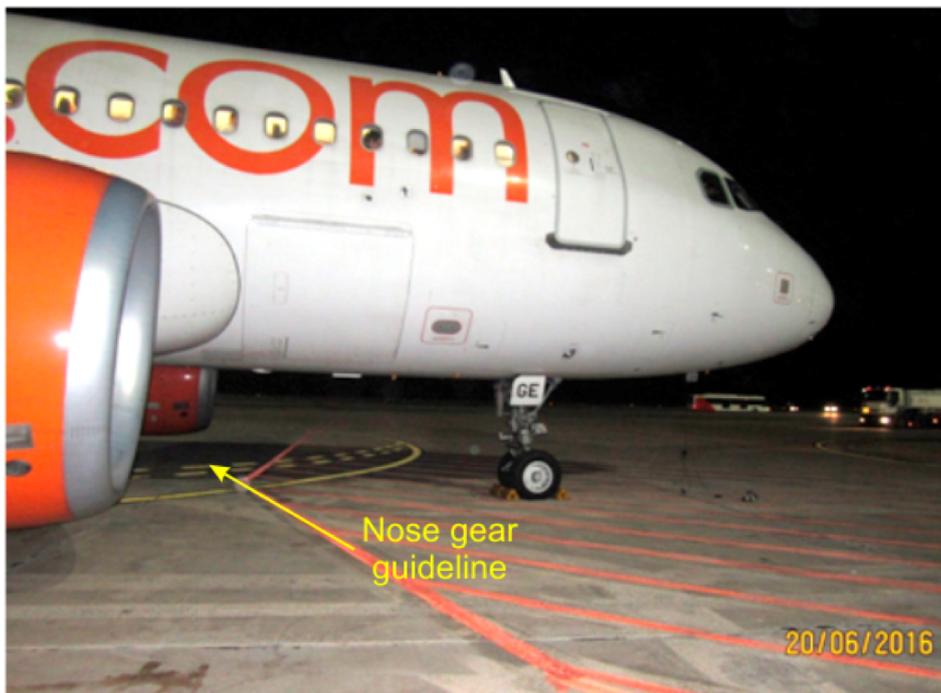
Figure 5. Deviation from the guide line

During the entire turn maneuver, the aircraft was inside the limits, but after the incident we noticed that the nose wheel was about 6 meters away from the A319 line, possibly due to the last speed increase."

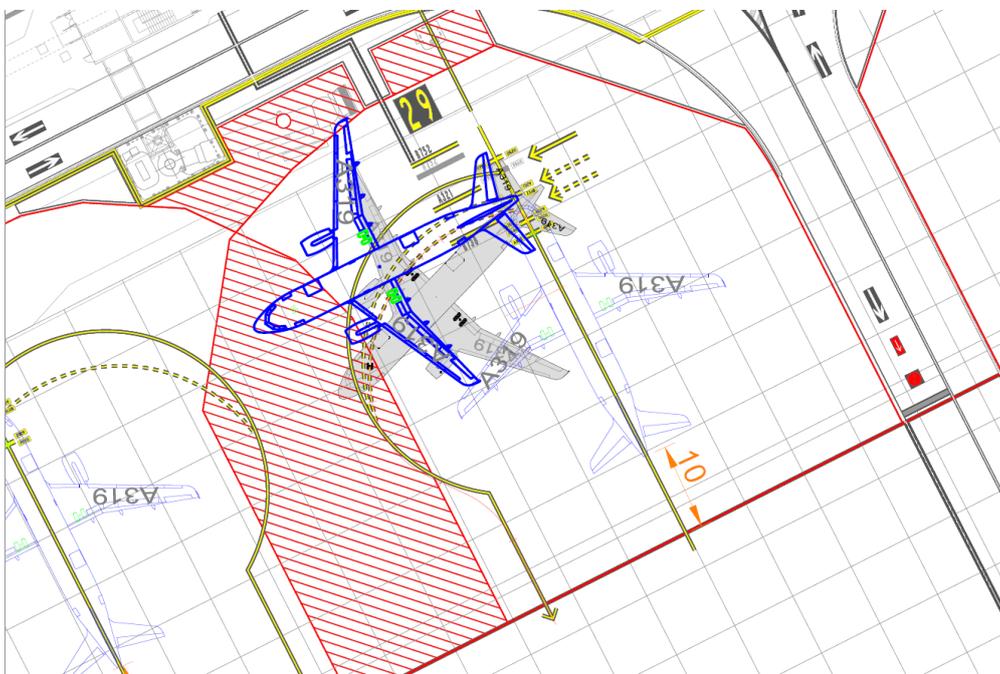
Figure 6. Comparison between theoretical and actual paths

Note that in the actual departure maneuver, when the aircraft impacted the jetway, the aircraft had turned 90°, when it should have turned about 130° by that point.

Note also that the nose wheel is about 6 meters away from the path marked on the pavement for the aircraft to follow.

The aircraft departed the stand following a different path from that indicated, more to the right, which reduced the margins separating the right wingtip from the obstacles in the area.

The incident was caused by the failure of the aircraft to follow the guide line for this aircraft to taxi out of the parking stand.

Since AENA has made the obligation for all aircraft to be pushed back out of stand 29 a permanent requirement, it is not deemed necessary to issue any recommendations.
