**COMISIÓN DE  
INVESTIGACIÓN  
DE ACCIDENTES  
E INCIDENTES DE  
AVIACIÓN CIVIL**

**Report  
IN-047/2016**

Incident involving a Boeing  
B-737-800, registration PH-HZW,  
at the Málaga/Costa del Sol Airport  
(Spain) on 2 December 2016

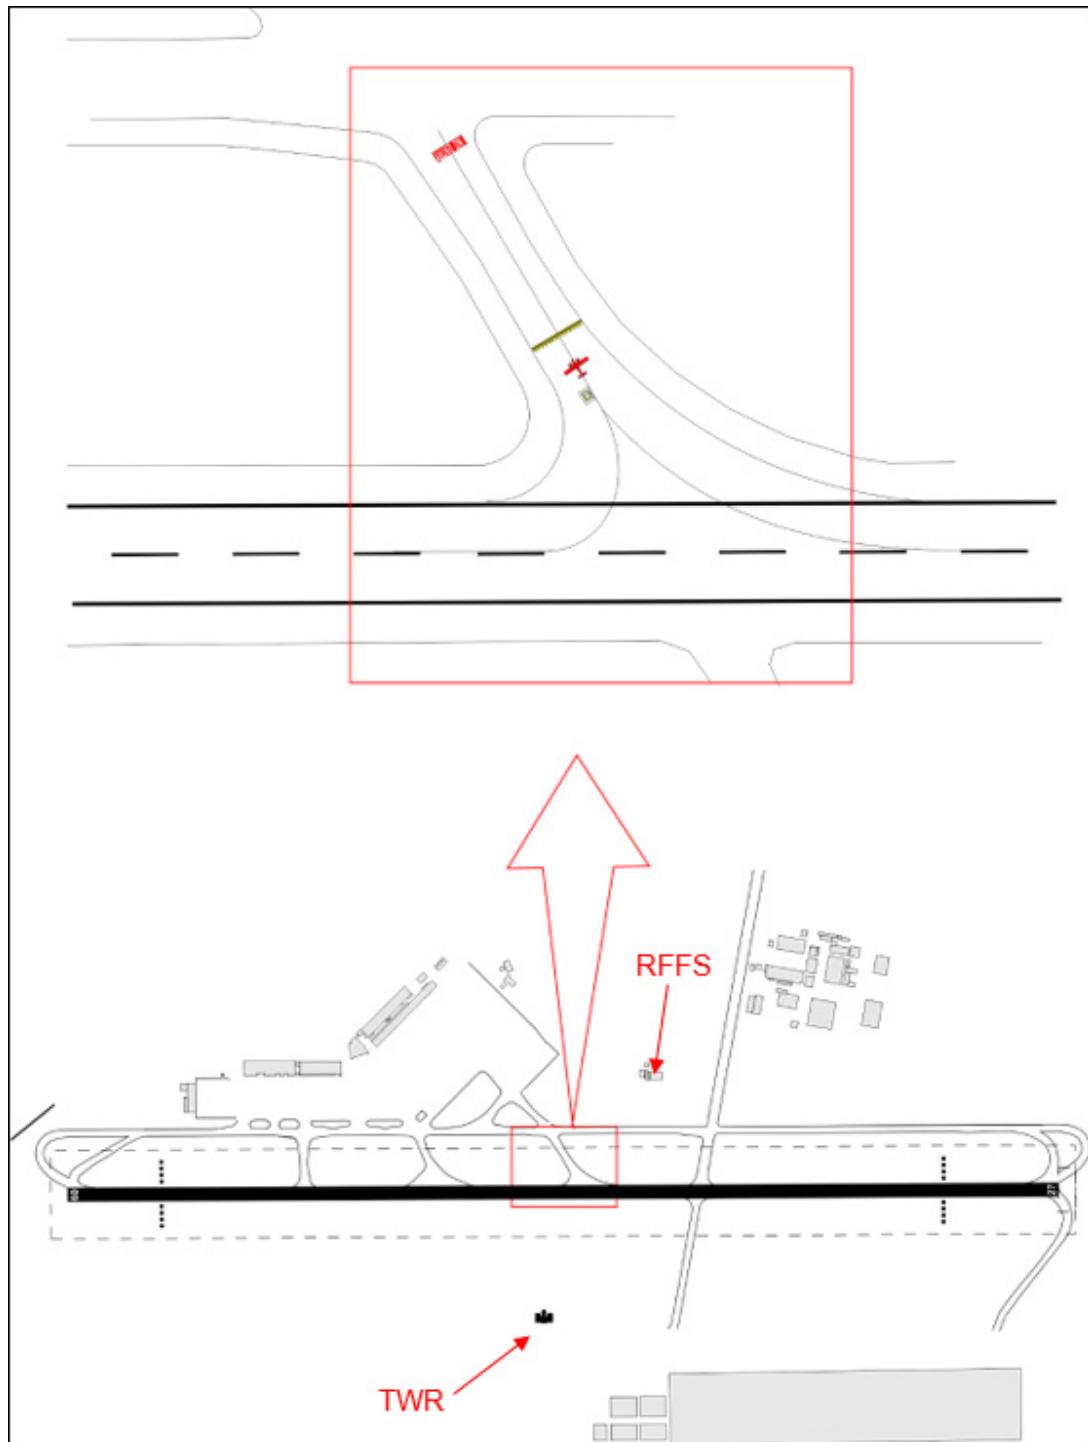
The aircraft that was blocking the runway at the Seville Airport had sustained a flat tire during the landing and was stopped on taxiway E3, between the runway and the holding point marking. The aircraft was unable to move by itself and required assistance from the Rescue and Firefighting Service (RFFS) to move.

Figure 3. General map of the Seville Airport, showing the locations of the RFFS building, the control tower and the area where the aircraft had stopped (bottom image), and a close-up of this area (top image).

**REC. 72/17.** It is recommended that AENA/Seville Airport review the procedure for moving disabled aircraft in order to guarantee the proper flow of information between all of the stations affected.

**REC. 73/17.** It is recommended that AENA/Seville Airport analyze the advisability and viability of setting up a mechanism that can be used in the initial moments following an incident of this type (aircraft stopped in the movement area) to estimate the minimum length of time that operations will be affected.

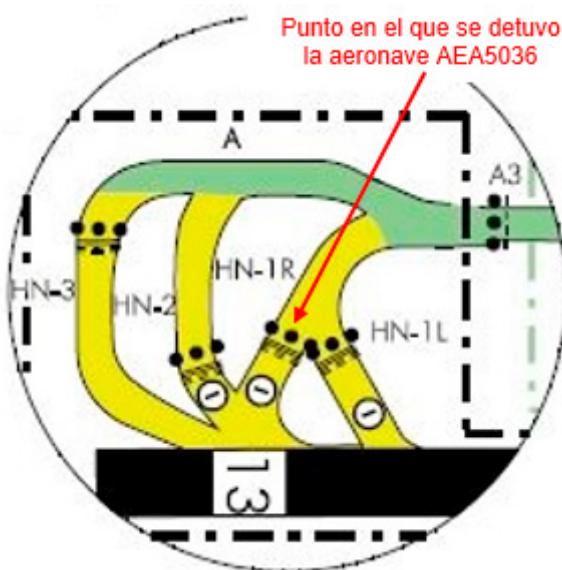
The controller asked the crew to confirm the runway was clear. The crew reported they had taxied over the holding point marking by only one meter.

Immediately afterward, specifically at 11:31:42, with aircraft TRA29B just over 1 NM out from the runway 13 threshold, the tower controller at the airport instructed

Figure 4. Close-up of the runway 13 threshold area at the Malaga Airport.

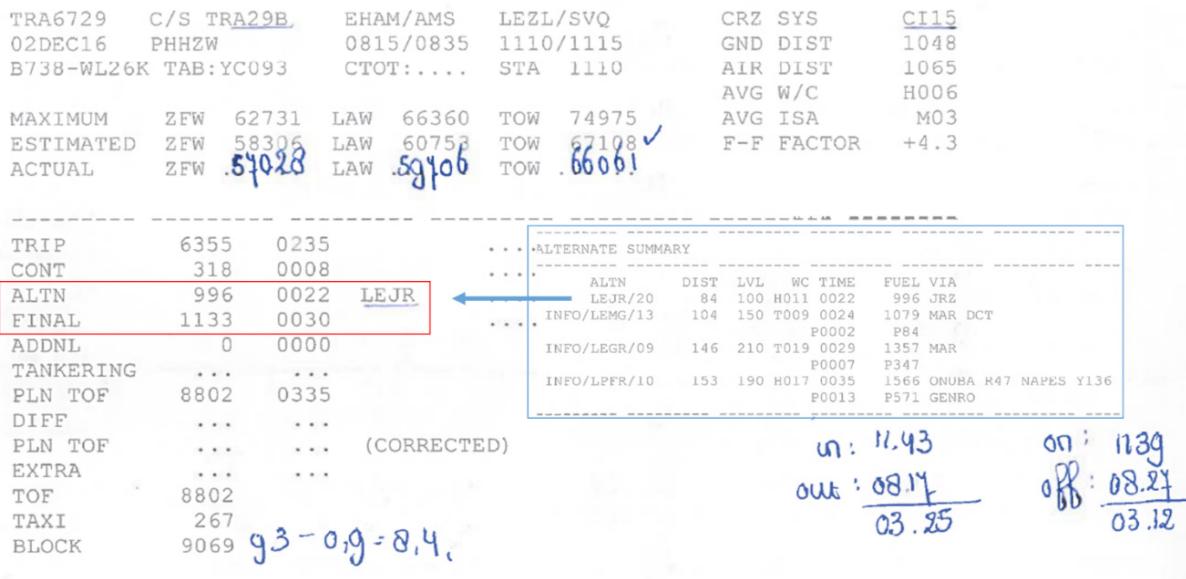
Therefore, the amount of block fuel required, with Jerez as the alternate airport, was 9069 kg (recall that the crew refueled 9300 kg according to the load sheet), and the aircraft's estimated zero-fuel weight (EZFW) was 58306 kg. This means that once the taxi fuel was consumed (267 kg for APU and taxi operations), the aircraft's estimated takeoff weight was 67108 kg. This is the weight that was used for the

Figure 5. Fuel calculations for the incident flight (OFP)

While they were circling, the aircraft burned approximately 386 kg of fuel. When they landed, they had 1035 kg remaining in the tanks, which was just under 100 kg below their final reserve quantity. Based on the consumption while circling, 100 kg of fuel is equivalent to about 2.5 minutes of flight time.
