DUTCH
SAFETY BOARD

Fatal fall overboard during loading operations

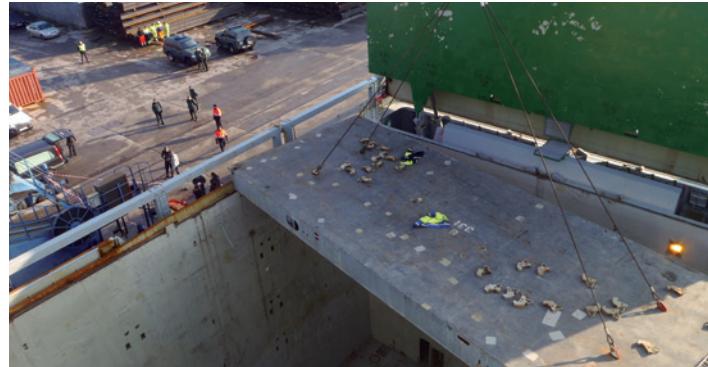
The pontoon shortly after the accident and simulated position on the stevedore platform without installed fall protection.

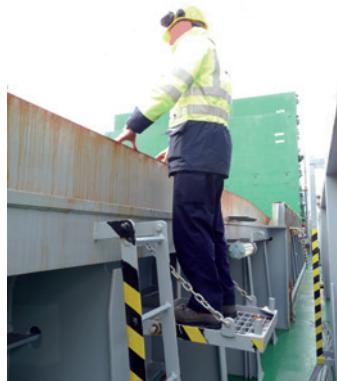
To supervise the loading and unloading operations from deck, stevedore platforms are installed on the hatch coamings. The crew can reach the fold-out platform with a fixed ladder. The platforms contain supports on which removable fall protection can be installed. With the absence of any paint damage it can be concluded that none of the platforms had (recently) been equipped with fall protection.

Most probably he did not use the stevedore's platform near the ladder, because it is unsuitable for the work carried out. The chains of the hanging mechanism and, moreover with the removable fall protection installed on the platform, a quick and easy escape would be impossible, once a load would come to close.

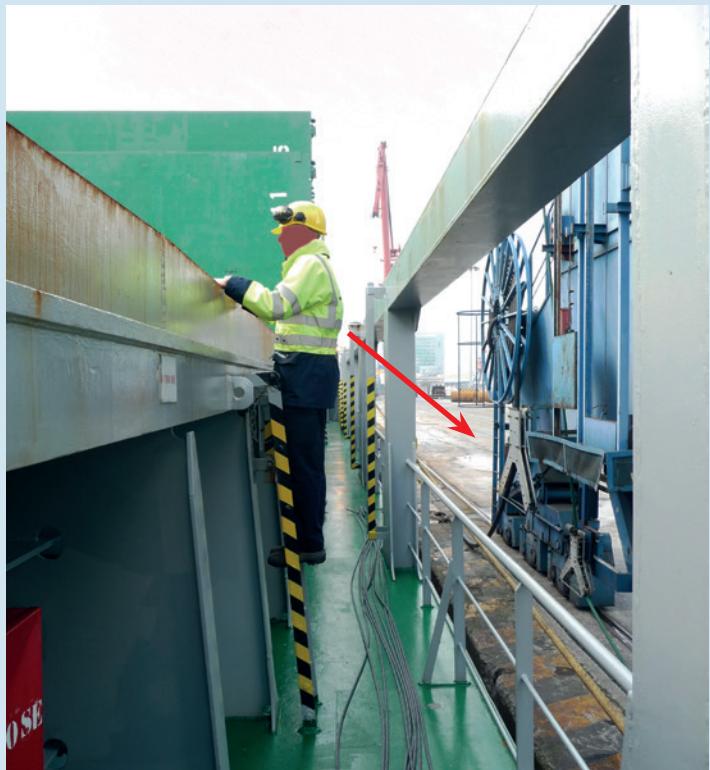
Simulated position of the chief officer.

When the chief mate was last seen, he was standing on a ladder at a height of about 80 centimetres. It follows from the witness statement and the autopsy report that the chief mate fell over the railing onto the quay and then ended up between the quay and the vessel. The proximity of the hoisted pontoon and his unstable position on the ladder meant that it was all the more relevant to have effective fall protection in place. However, there was no fall protection. Because the chief mate was standing on a ladder, the height of the railing proved to be insufficient.

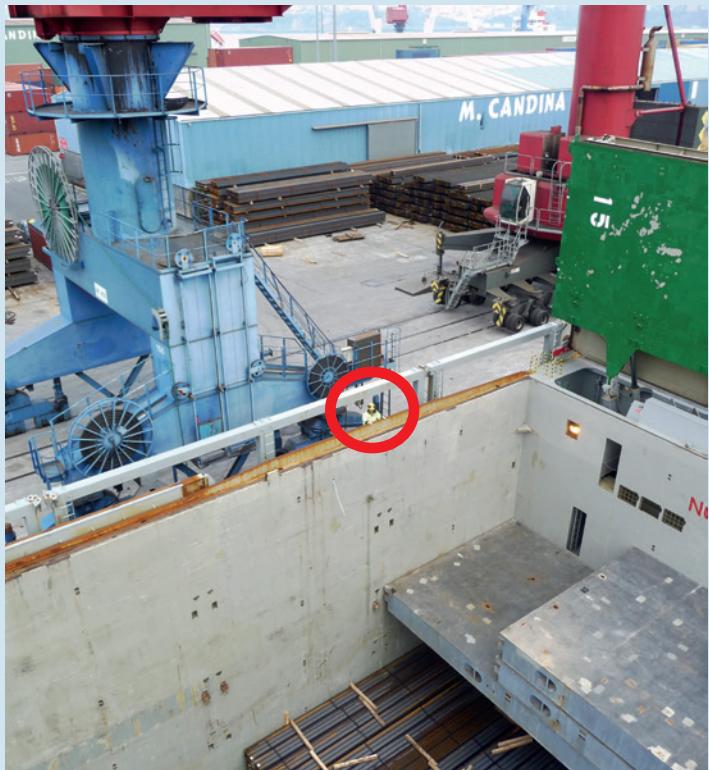
Simulated position of the chief officer from the cranedriver's position.

During the operation, the chief officer was carrying out two tasks. He acted as supervisor and gave instructions to the crane driver. He was able to perform these tasks from three positions: by positioning himself on the cross deck amidships, by using a ladder at the front of the hold or by using a ladder at the rear of the hold. He chose the latter option. This was the only position from where he could reach the pontoon directly in order to turn it by hand. If he had used one of the other positions, he would still have had to move to the location of the accident in order to turn the pontoon. From this position on the ladder the chief officer could also directly see the crane driver and the hoisting operations, as long as the pontoon had not been lifted above the hatch coaming.

After the accident, Wagenborg Shipping B.V. emphasized to the ships' crews that the person issuing instructions during tweendeck operations must stand in a safe position, where he can maintain visual contact with the crane driver at all times. Before an operation to hoist and shift tweendecks pontoons, a leading line should be attached to the pontoon in order to turn it. In June 2012 the shipping company also reiterated the importance of the safety briefing in its circular FleetNews. The accident was discussed in the safety committee on board the Azoresborg.
