DATA SUMMARY

Date and time	Friday, 21 January 2012; 07:30 h¹
Site	San Sebastian Airport (Spain)

Registration	EC-HCG
Type and model	ATR-72-212A
Operator	Air Nostrum

REPORT

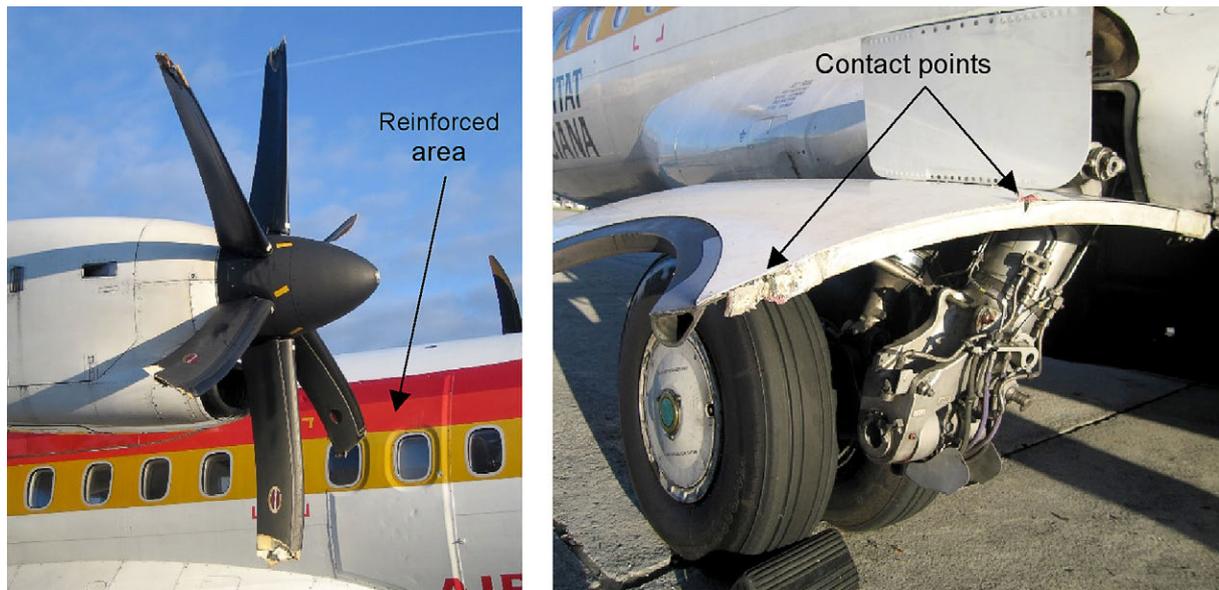
All six blades on the right propeller broke as a result of its impact with the GPU (see Figure 1). Each blade lost about 56 cm of material.

The door for the right main landing gear wheel well also impacted the GPU and was damaged.

The aircraft's fuselage is reinforced near the area of the propellers (see Figure 1) so that it can withstand an impact from material ejected by the propellers, such as chunks of ice that may be thrown outward by the blades by the action of the anti-ice system, pebbles, etc. Some of the blade fragments that detached impacted the fuselage of the aircraft, most of them striking this reinforced area and causing only small dents.

Figure 1. Photographs of the damage to the propeller and to the right main landing gear door

A stronger impact took place at the top of the fuselage, opening a crack that penetrated all the way into the passenger cabin.

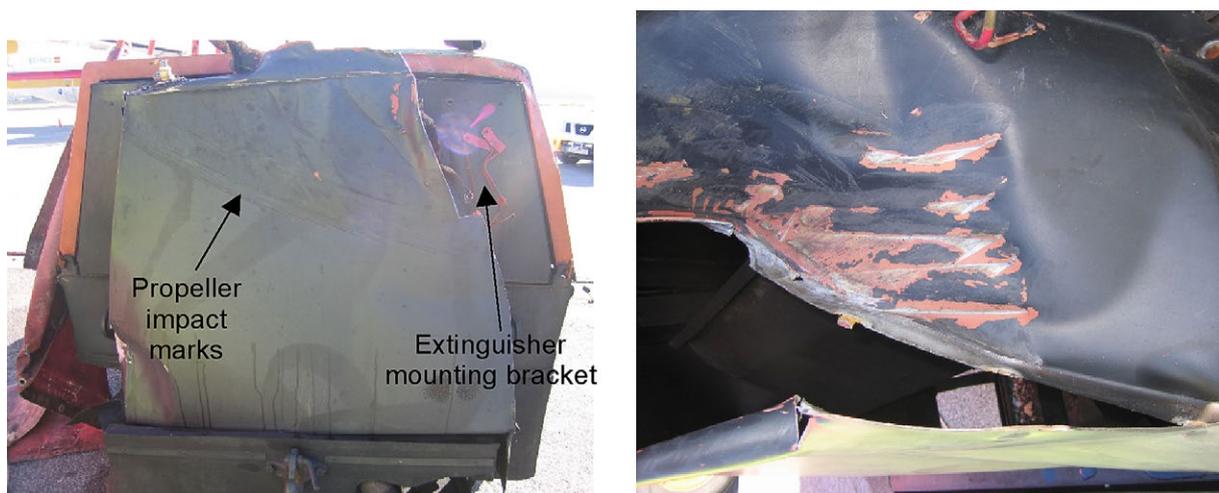
The right propeller hit the rear of the ground power unit (GPU), causing significant damage to the cover in this area. The fire extinguisher outfitted on the GPU was located at the back right of the unit, and thus it was also struck by the propeller, as a result of which it was thrown outward to the other side of the aircraft, where it was found.

Figure 2. Photographs of the GPU. Left: impact marks on the rear of the unit. Right: Close-up of the impact marks

The left rear part of the GPU was struck and damaged by the right main landing gear door.

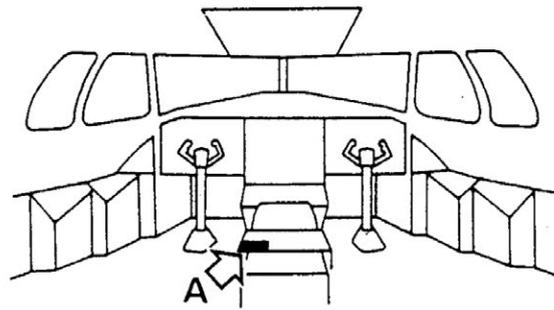
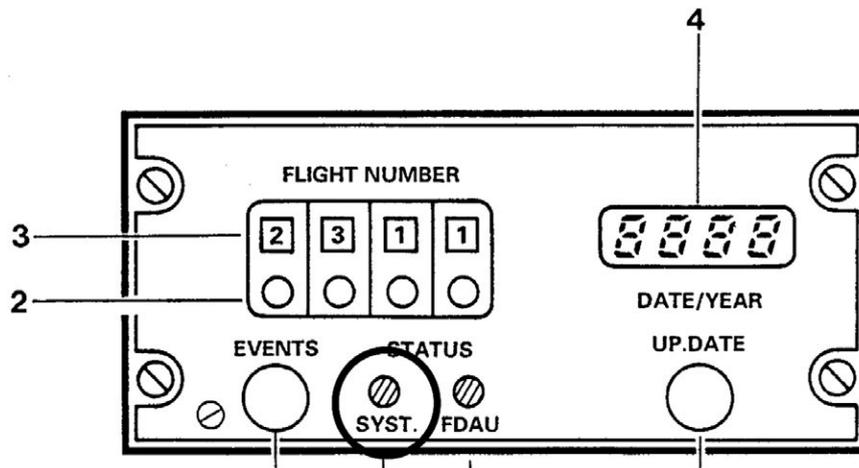
Figure 7. Data Entry Panel

Whenever recording faults like those present in the FDR's solid-state memory are present, the FDR itself sends a signal to warn of the malfunction that turns on a caution light in the cockpit. This light also turns on if the electricity to the FDR is interrupted or cut off. This STATUS SYST caution light is shown in Figure 7.

The flight crew did not report seeing this light energized in the cockpit. The checks made in the airplane revealed that the STATUS SYST light was not burned out, since when another recorder was installed, the light turned on when the FDR was deenergized, as expected.

Under these conditions, the FDR should have generated a fault signal, which in turn should have been relayed by the monitoring system to the cockpit, triggering a STATUS SYST light. This did not happen on this airplane.
