**DATA SUMMARY**

Date and time	<b>Monday, 16 July 2012; 14:28 LT<sup>1</sup></b>
Site	<b>San Rafael (Ibiza, Illes Balears) (Spain)</b>

Registration	<b>EC-HMD</b>
Type and model	<b>AIR TRACTOR 802</b>
Operator	<b>Martínez Ridao Aviación, S.L.</b>

Type and model	<b>PT6A-67AG</b>
Number	<b>1</b>

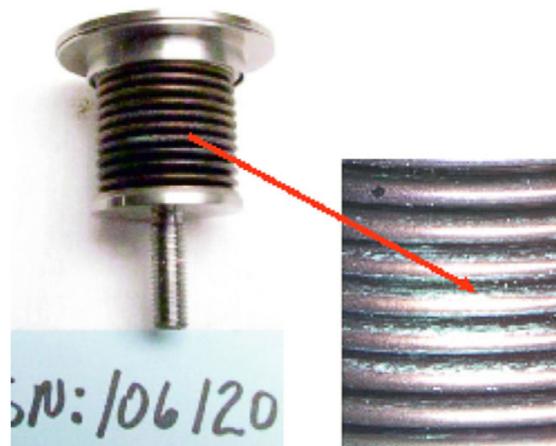
This test showed that the engine reverted to minimum fuel flow power as the result of a loss of pressure in the bellows used to transmit the compressor outlet pressure (P3) to the FCU. The engine performed normally when the FCU was replaced.

The bellows was removed from the FCU. An initial visual inspection revealed the presence of corrosion on its outer surface (Fig. 2). It was sent to the manufacturer (Woodward) for a detailed laboratory analysis. The laboratory report concluded that the leak occurred when the corrosion that had started on the outer surface advanced enough to reach a pre-existing defect on the inner surface of the bellows.

Figure 2. Close-up of the corroded portion of the bellows

The corrosion of the bellows used to transmit the compressor outlet pressure to the fuel control unit resulted in an interruption in fuel flow to the engine, which translated in an irreversible loss of power. Several prior occurrences of this failure have been documented, a failure that in single-engine airplanes makes it impossible to continue flying and requires a forced landing if the airplane is not equipped with an optional emergency power control system.

**REC 58/13.** It is recommended that Transport Canada evaluate the suitability of issuing an Airworthiness Directive (AD) that makes the implementation of the last version of Service Bulletins SB14389, SB13402 and SB13408 mandatory on single-engine airplanes that do not have an emergency fuel control system (MOR).
