## Report A-026/2016

Accident involving a PZL W-3AS  
aircraft, registration EC-LQA, operated  
by Hispánica de Aviación (HASA), in  
Villanueva de la Cañada  
(Madrid-Spain) on 17 July 2016

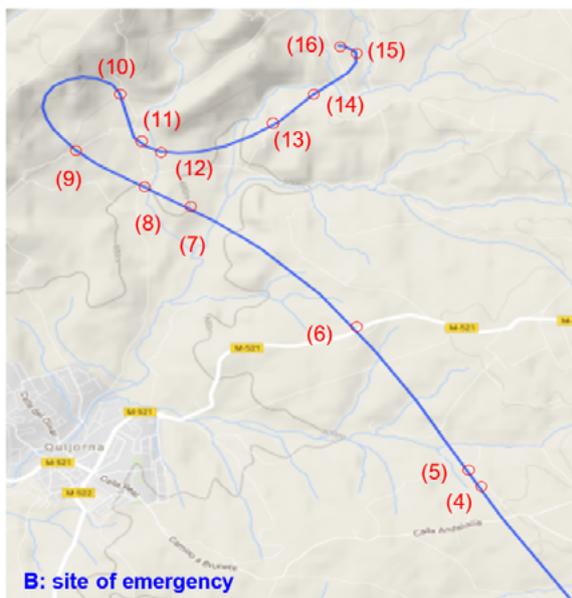
Figure 3. Flight in the emergency site

- (1) 18:55:19 Takeoff from base
- (2) 19:26:20 First comment about fuel imbalance
- (3) 19:29:16 Code 5
- (4) 19:38:21 Engine 1 pump reported OFF
- (5) 19:38:25 Close shut-off valve engine 1
- (6) 19:38:56 Cranking started
- (7) 19:39:38 Cranking completed
- (8) 19:38:50 Captain PF
- (9) 19:40:07 Decision to land and start engine on ground
- (10) 19:40:41 First field selected
- (11) 19:41:04 Second field selected
- (12) 19:41:13 Confirmation of field
- (13) 19:41:32 Wind information request
- (14) 19:41:43 Decision to land and turn
- (15) 19:42:05 "Too much slope"
- (16) 19:42:26 Accident

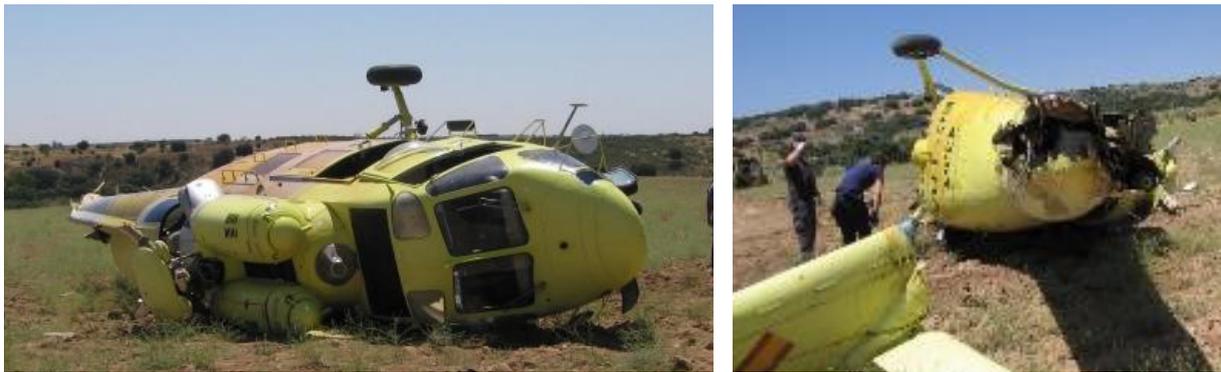
Figure 4. Condition of aircraft EC-LQA after the accident

The damage mostly affected the right side of the helicopter, on which it was resting. The cockpit retained its structure and showed no apparent deformation.

- Vertical stabilizer: completely separated from the tailcone. Half the surface of the left horizontal stabilizer was missing.
- Right engine: damaged, primarily in the fairing and exhaust nozzle.
- Rotors: all three main rotor blades detached at the root. The tail rotor blades were also damaged but to a lesser extent than the main rotor blades.

- Right-side windows: two of the three side windows were broken.
- Landing gear: there was damage to the main landing gear structure.

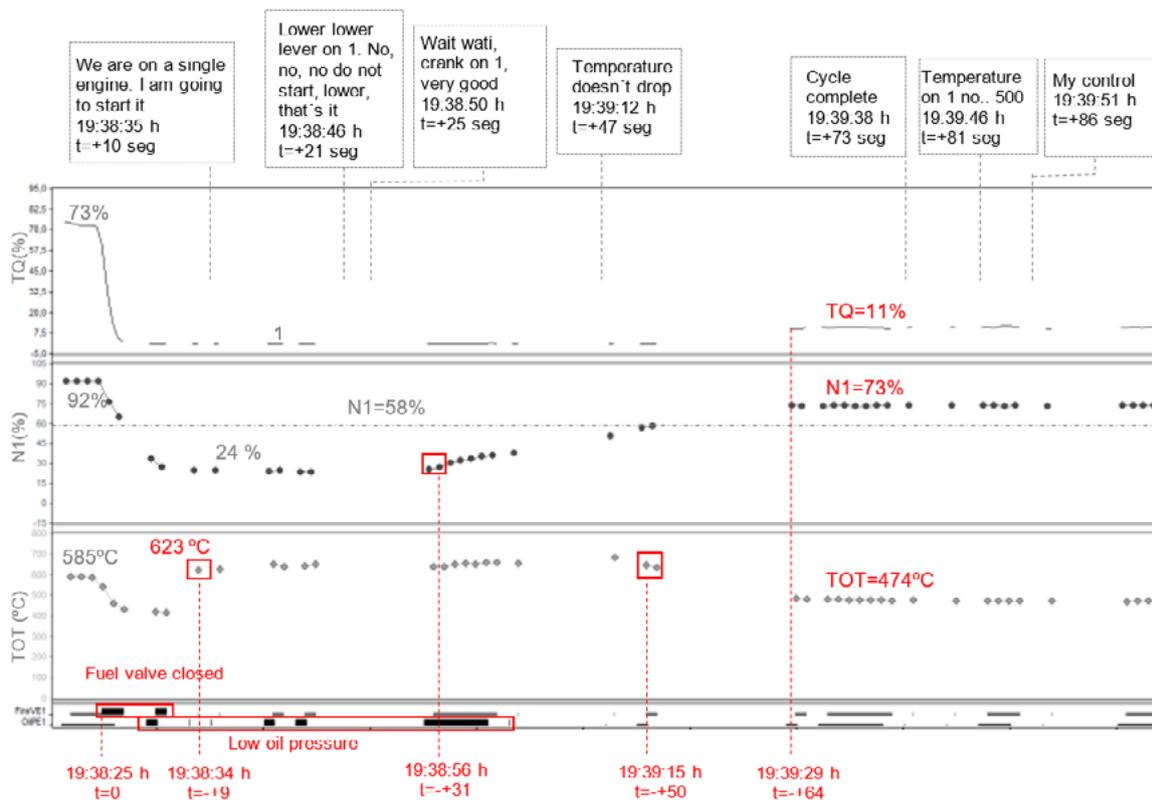
Figure 5. Behavior of engine 1 (left) during the event

- When the shut-off valve to engine 1 was closed, that engine was at N1=92%, TOT =585° C and TQ=73%. The helicopter was flying at 73 KIAS and 180 m AGL.
- t=+1 sec. The TQ, N1 and TOT immediately began to fall and the second pilot confirmed the closing of the valve.
- t=+5 sec. The values had fallen to TQ=1%, N1=24% (below the 58% corresponding to one engine inoperative) and TOT=420° C. The speed dropped to 66 KIAS (4 kt below the Vy speed given in the Flight Manual for the conditions on the day of the accident).
- Since N1 had fallen below 58%, the engine stopped acoustic warning (4-second tone) sounded and the low pressure warning for engine 1 appeared.
- The N1 and TQ parameters for engine 2 immediately increased and then fluctuated before stabilizing, supplying the missing power from engine 1 and keeping the main rotor RPM (Nr) at normal operating levels.

- The engine parameters stabilized after 19:39:29 at N1=73% TQ=11% and TOT=474°C, values that would not change until the end of the flight.
- Seconds later, the second pilot announced "cycle complete", referring to the crank, and both pilots verified that the temperature was 500° C.
- t=+86 sec (19:39:59). Given this situation, the captain decided to take control of the helicopter. Its speed was 39 KIAS and its altitude 187 m AGL.

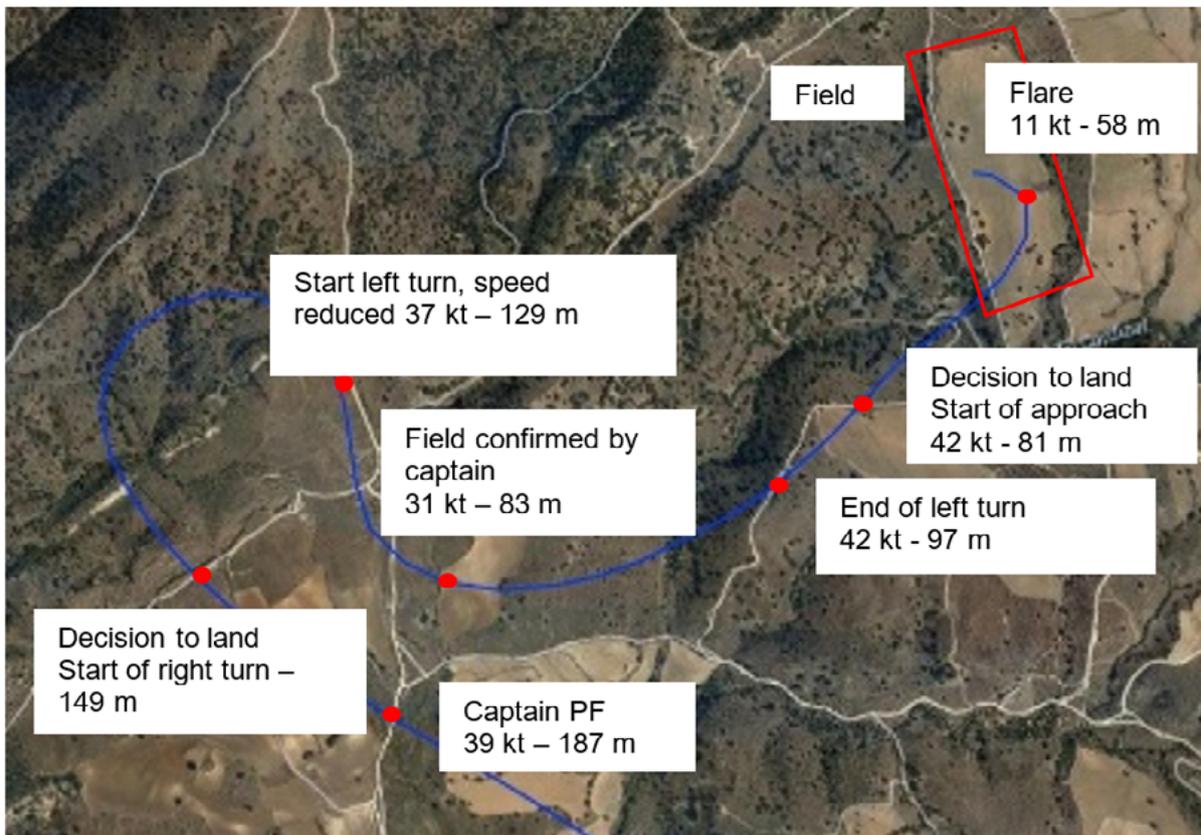
Figure 6. Final minutes of the flight (speeds and altitudes with respect to ground)

- Flare and turn (19:42:04): after this descent, the helicopter altered course with a left turn to a northerly heading, aligned lengthwise with the field. This course, however, was not maintained until landing; rather, a second left turn was made to course 306° while performing the flare. The data recorder logged inputs to the cyclic (moved toward the pilot) and collective (upward shift) controls, causing an increase in the helicopter's pitch angle from 5° to 11°, and a drop in speed to 11 KIAS. The helicopter was at 58 m AGL 130 m away from the landing point at 11 KIAS. This turn coincided with the second pilot's comment about the gradient of the terrain, *"Too much slope, too much slope, come over to my side"*. This last turn oriented the helicopter to be perpendicular to the field that is, aligned with its width, in the direction of the upward slope.

- Landing (19:42:23 – 19:42:26): The landing was initiated at 4 KIAS and 5 m AGL, with a +13° pitch angle, the collective lever fully displaced on a course of 286°. RPM decreased to 88%, TQ on engine 2 rose to 108%. Engine 1, which had been at the same levels since the event started, saw a rise in TQ from 11 to 21% and a slight increase in TOT. After the helicopter fell on its side, engine 1 continued running for 20 sec more, with the values of TQ, N1 and TOT rising and then falling.

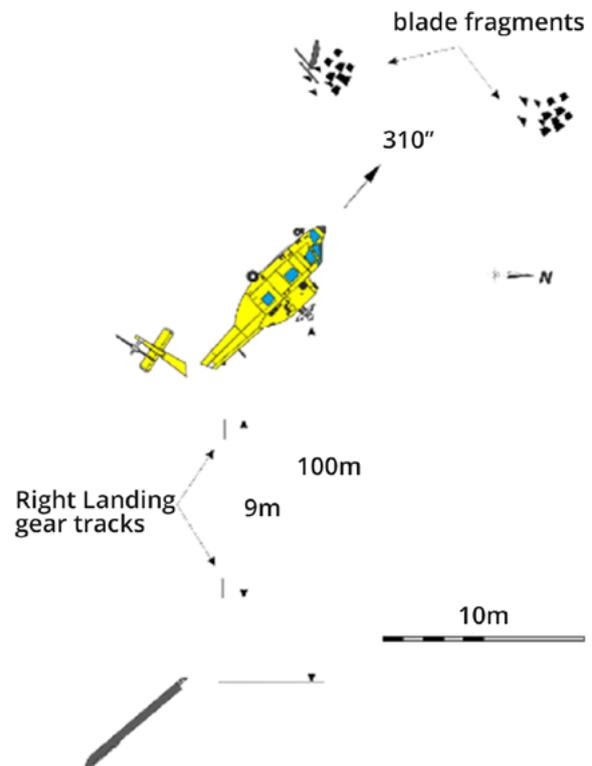
Figure 7. Debris field

At the site where the helicopter was found on its side, the tracks on the ground formed by the main landing gear legs were clearly identifiable. The left track was shallower than the right, and in fact, the right leg was half buried in the ground. Moving backwards from the direction of flight another two marks were identified 9 m apart and left by the right wheel. On the left side of the helicopter, near the tail cone, was the tail assembly, which had completely detached.

Most of the blade fragments were found forward of the helicopter, although one blade fragment was found 100 m behind it.

There were oil stains on the fuselage. These stains were vertical, not horizontal, indicating they were made on impact, not during the flight.
