## A-004/2017

Accident involving a Socata TB-20 Trinidad aircraft, registration D-ECJP, in Sierra de Tejada, Canillas de Aceituno (Málaga) on 29 April 2017

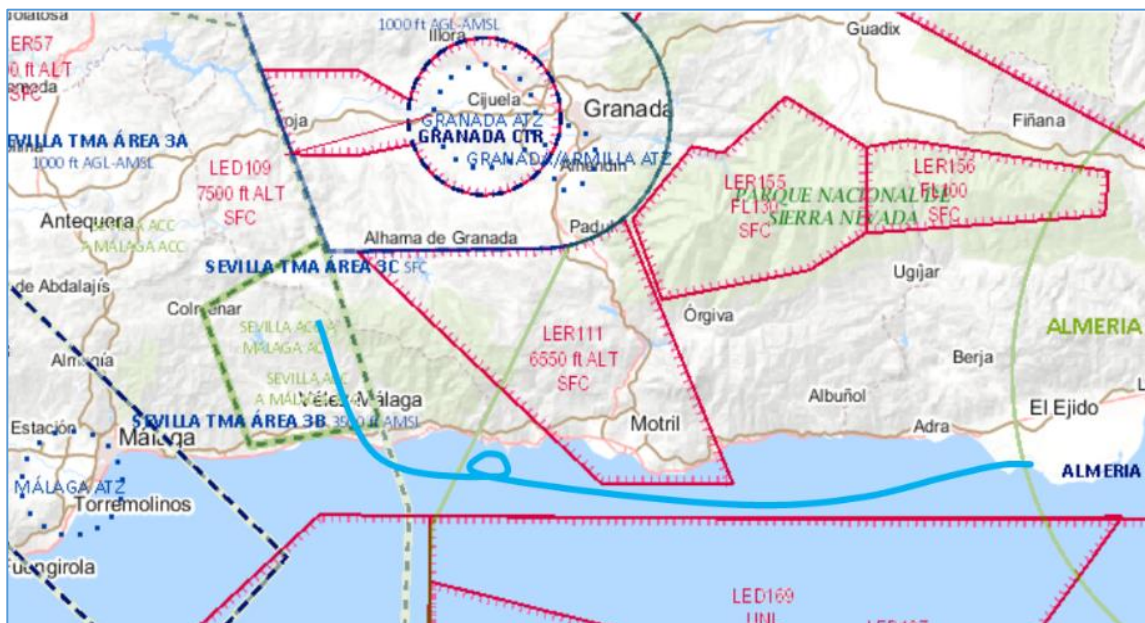
Figure 1: Flight path

The blue line in Figure 1 shows the final part of the flight path. In the first part, until LEAM, the aircraft maintained an altitude of about 1000 ft.

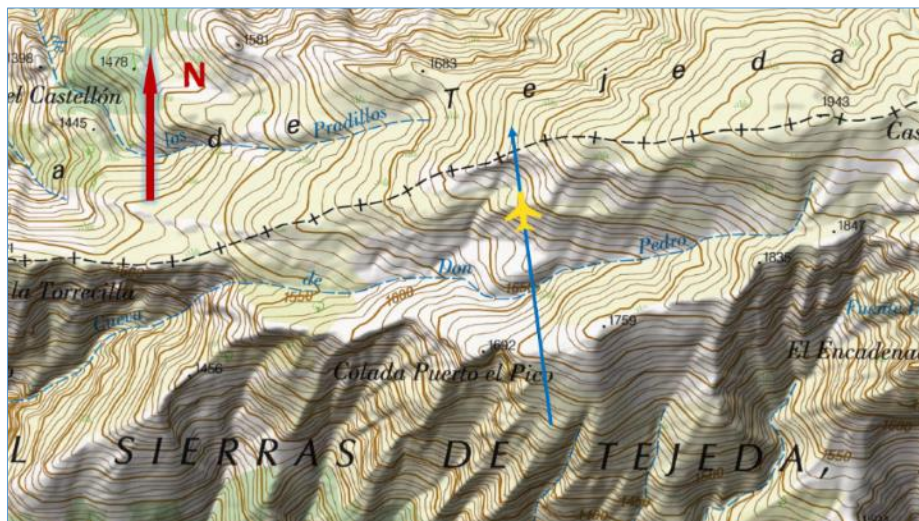
Figure 6: Map of wreckage location

The data recorded by the air traffic control radar show that the aircraft was on a steady altitude of 5500 ft when it reached an 1800-m (5905-ft) foothill that rose to 1943 m (6374 ft) on its right and decreased on its left. See Figure 6.

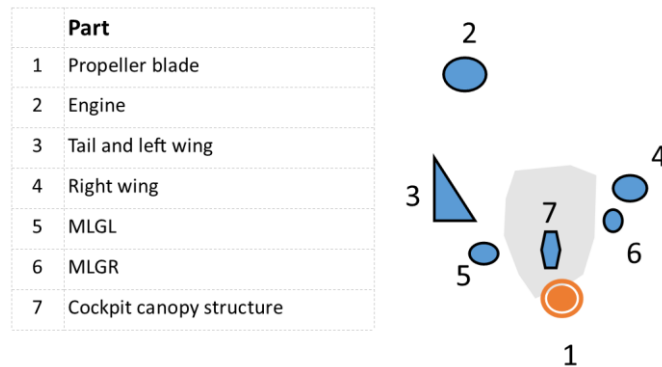
**Figure 7: Positions of the main wreckage<sup>6</sup>**

The aircraft wreckage was found scattered on a slope with a 28° gradient at an elevation of 1718 m (5636 ft), rising in the direction of flight. The first impact point contained debris from the propeller and, fanning out, other aircraft parts, with the engine, at 23 m, being the furthest away. Spreading out from this first point was an area affected by the fire caused by the fuel contained in the tanks. Figure 7.

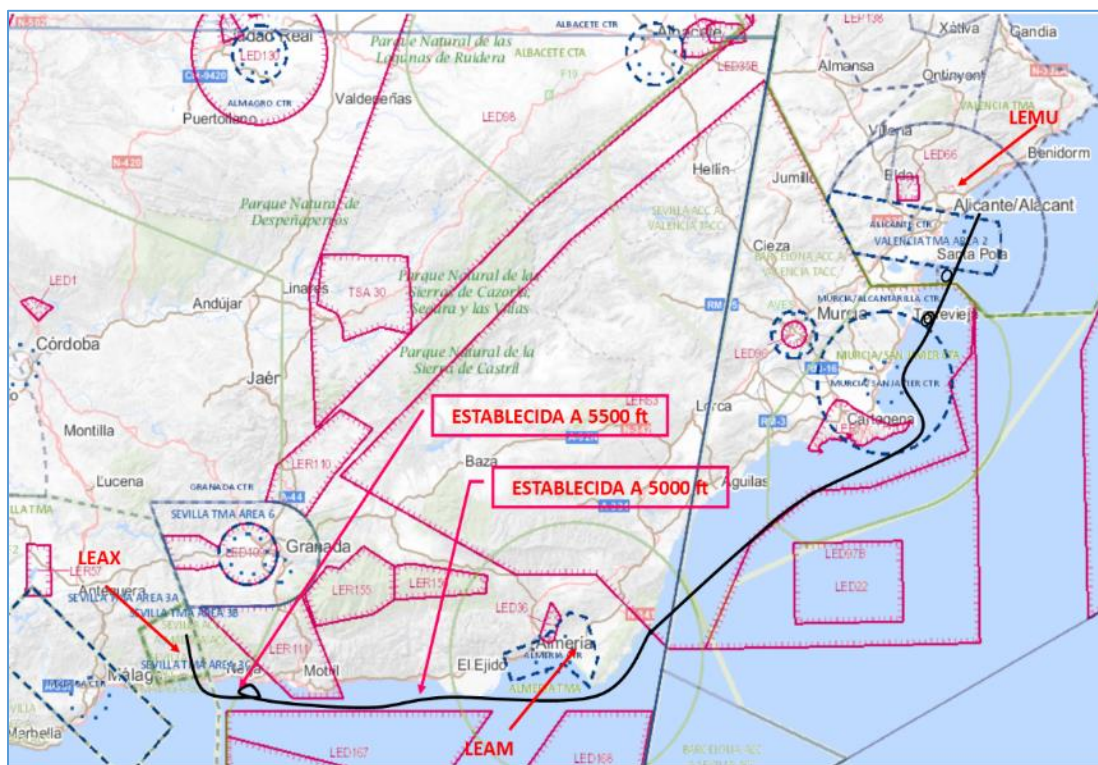
**Figure 8: Reconstruction of the aircraft's flight path**

Figure 8 shows the flight of aircraft D-ECJP from LEMU to the accident site based on radar information. The figure shows that the aircraft flew along the coastline, avoiding restricted areas LER111, LER155 and LER156.

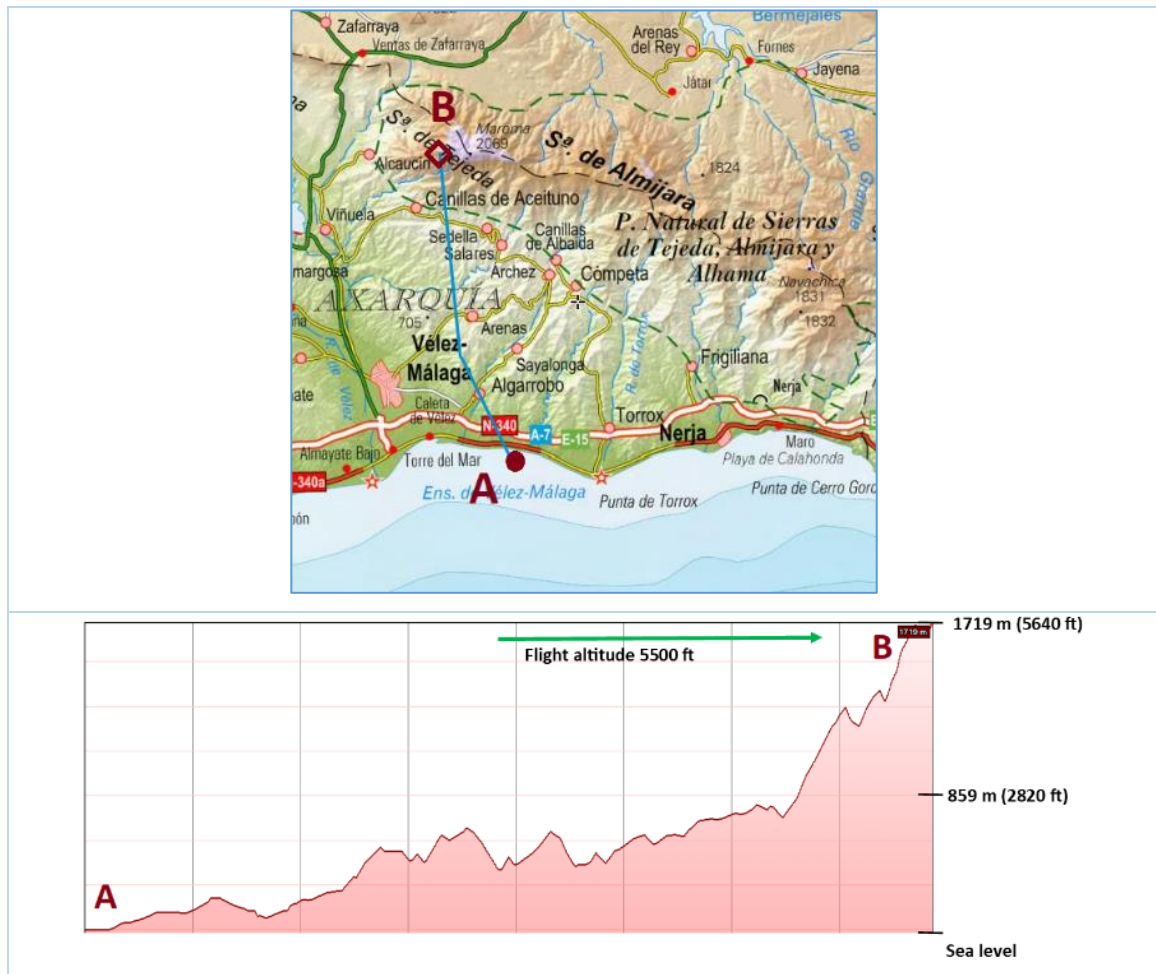
Figure 9: Location of crash site and terrain profile

Figure 9 shows the geographic location of the aircraft's final flight path, level at an altitude of 5500 ft. The terrain slopes up constantly up to the elevation where the wreckage was found. The highest foothills in the Sierra de Tejada closest to the site are to the right of the flight path, with a maximum elevation of 2069 m (6775 ft), and continuing to the southeast with elevations of 1824 m (5984 ft) and 1832 m (6010 ft) practically to the sea.

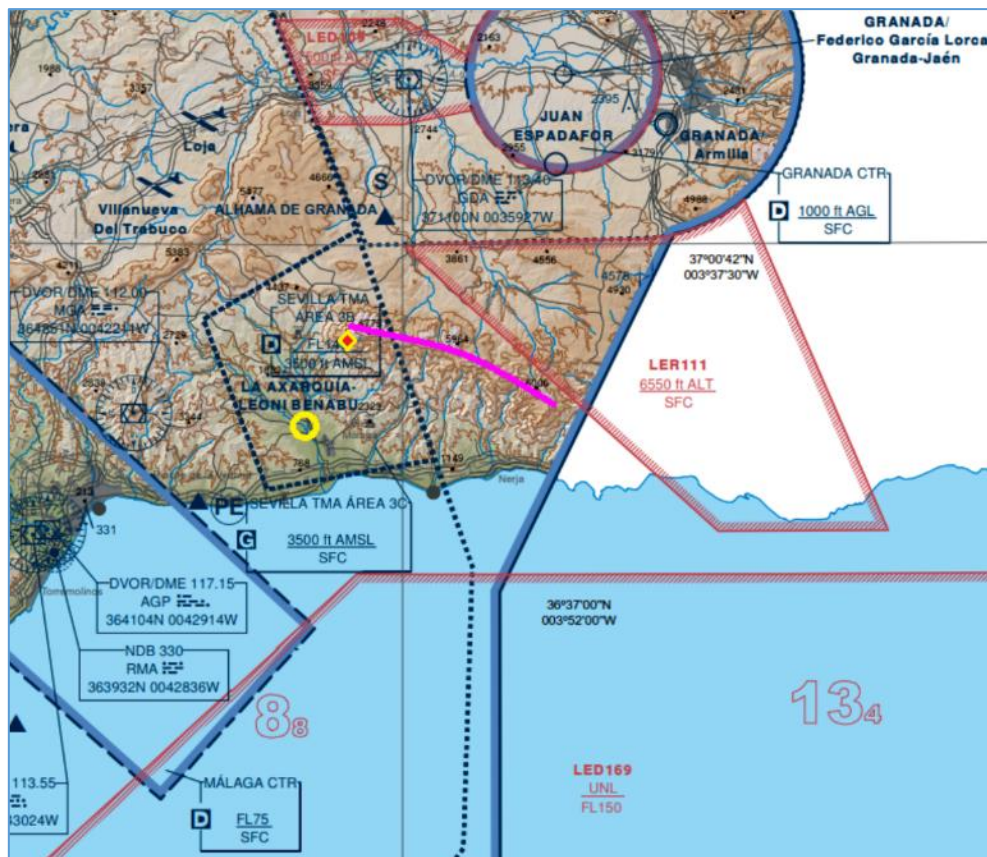
Figure 11: Visual chart of the area

Figure 11 shows, using the visual chart published in the AIP Spain for the area, the position of LEAX (yellow circle), where one of the aircraft landed; the accident site (yellow diamond); the foothills at an elevation of 6775 ft (purple line); and point S (Alhama de Granada) on the LEGR visual approach chart.
