Report

A-037/2018

Accident involving a Piper PA-28R-200, registration EC-HSZ, at the Cuatro Vientos Airport (Madrid) on 4 September 2018.

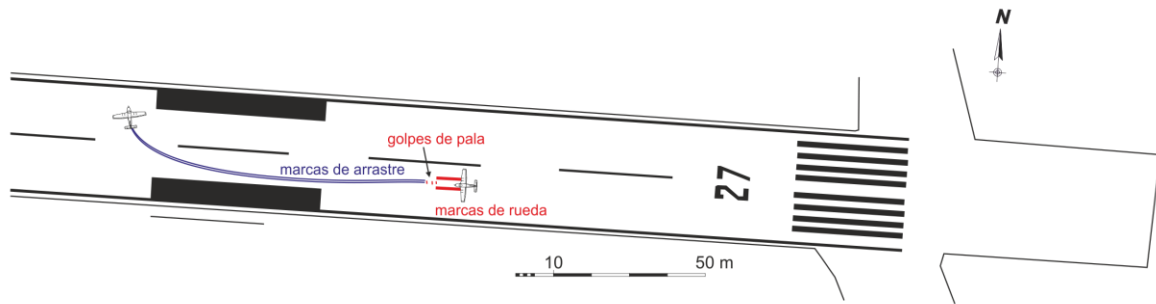
Fig. 4.- Diagram of the marks and location of aircraft

The aircraft touched down at the start of the runway, approximately 87 m past the threshold markings and slightly left of the centerline. After this point, for a length of about 10 m, there were tire marks on the runway, along with contact marks left by the tips of the propeller blades. Next, over an 80-m length, there was a mark, initially in a straight line that later veered to the right, compatible with the skidding of the underside of the fuselage that led to where the aircraft came to a stop on the right side of the runway with the nose pointing north.

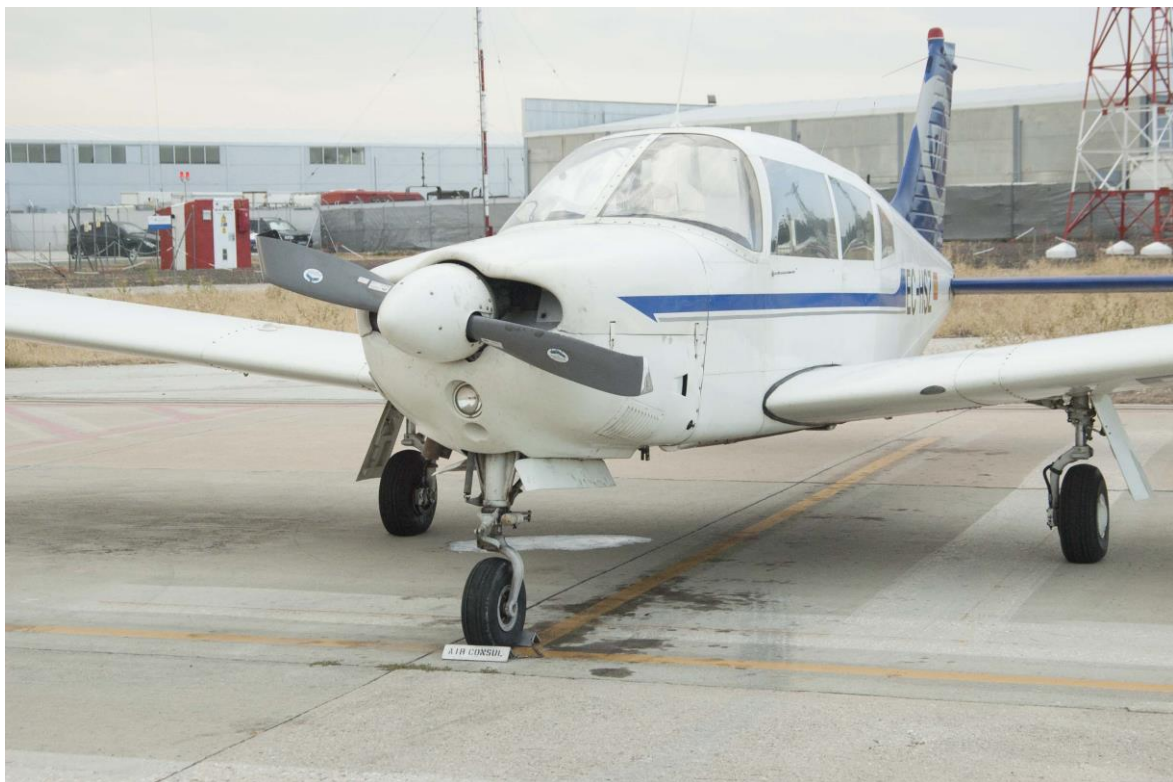
Fig. 5.- Condition of the aircraft

As a result of the landing, the aircraft sustained significant damage to the propeller as well as fractures and scraping in the landing gear and underside of the fuselage.

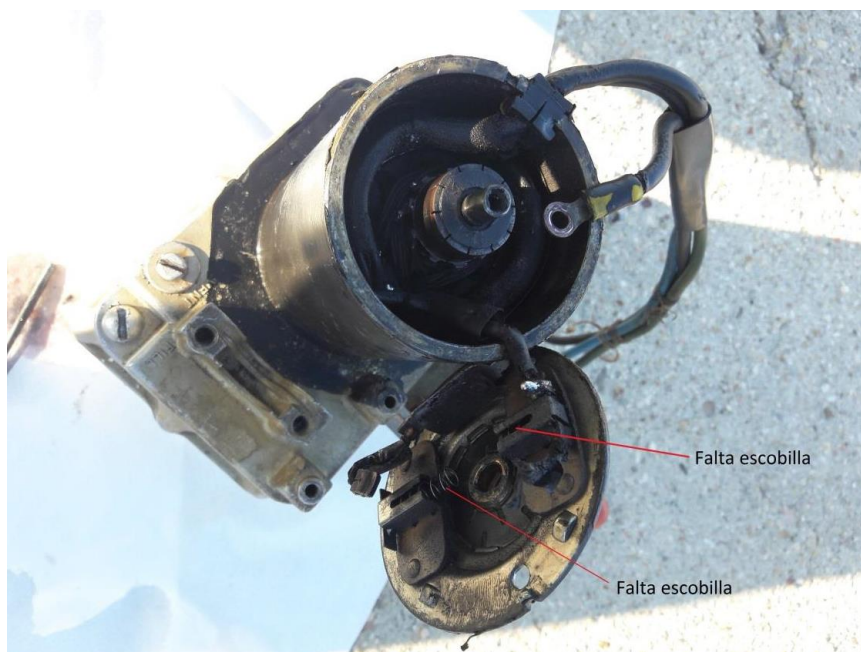
Fig. 6.- Condition of the electric pump

The electric motor was noticed to be missing one of the two screws that attaches the brush holder cover to the body of the motor. Once the brush holder cover was removed, both holders were verified to be excessively worn and outside their housings. One brush was detached from its connecting cable and was resting on the top part of the motor winding. The rotor on the electric motor turned freely, and there were traces of worn brushes and hydraulic fluid. It was determined that the electric motor had not been maintained properly.

The inspection of the electric pump revealed that it had been improperly maintained; specifically, the brushes showed excessive wear and had been dislodged. According to the pilot, he did not pull the fuse during the flight, so it is possible that the motor was running the entire time, which contributed to the poor condition of the brushes.

Even so, the overall condition of the pump is indicative of a lack of proper maintenance and is sufficient reason for the inability to change the position of the landing gear.

The electric pump stopped working because of its defective maintenance condition.

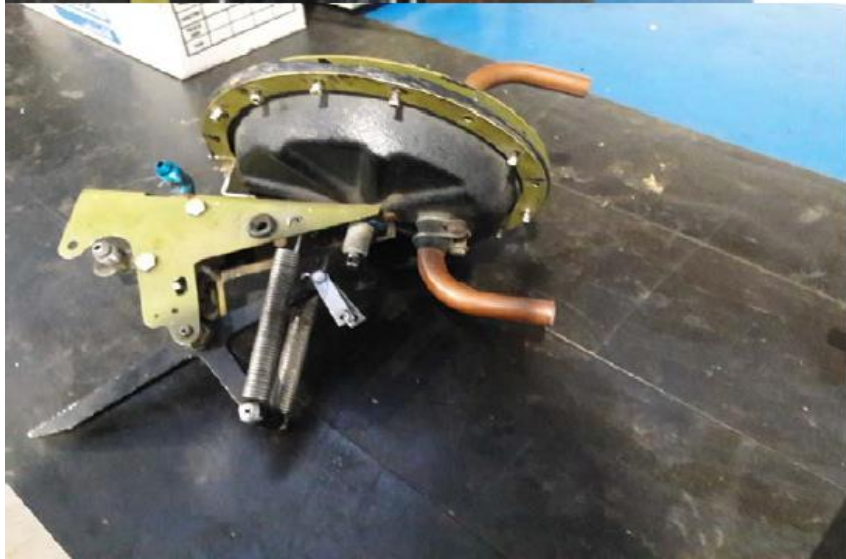
Fig. 7.- External appearance of the pressure sensing mechanism

As for the pressure sensor mechanism, once opened it was found to be blocked because the diaphragm assembly, consisting of a membrane and circular metal supports, was stuck to one of the sides of the casing that housed it, which prevented it from moving.

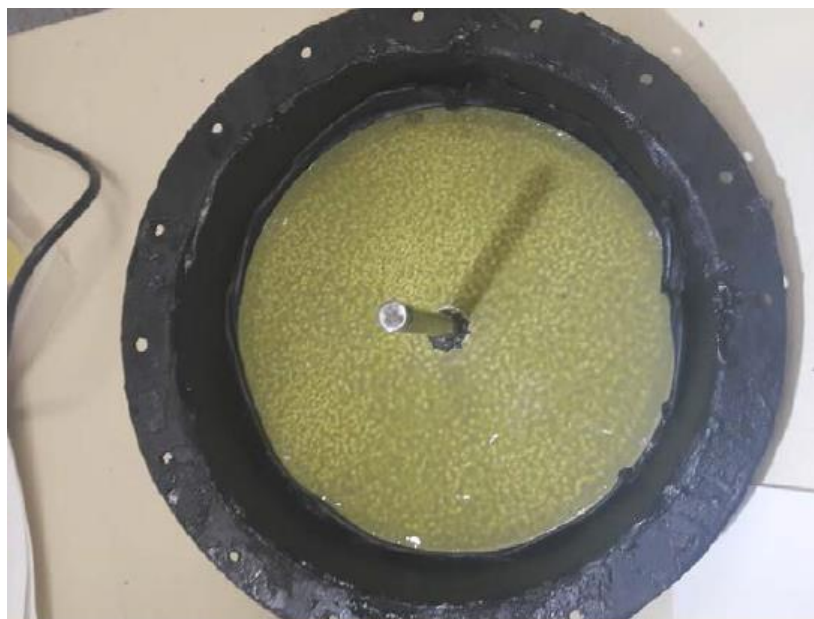
Fig. 8.- Diaphragm assembly stuck to the casing

Opening the casing that contained the diaphragm revealed that the membrane had deteriorated and stuck to one side of the casing (see Fig. 8), precisely in the position where it would be when the lever is in the topmost, or override, position, which disarms the automatic gear extension system. As a result, the rod was only able to move as far as the distance between its two tabs – which push the diaphragm – a distance that, as the diagram/photo show, is insufficient to change the condition of the landing gear mechanism (see Fig. 3).

The casing and diaphragm system is arranged vertically. It is located underneath the rear left seat and is not directly exposed to sunlight or to hot engine components. It therefore seems unlikely that the material could have degraded – practically melted – to the point where it could accidentally adhere to the casing. Even if it could, this condition would only have affected the lower half of the diaphragm; instead, the diaphragm was affected around its entire perimeter (see Figs. 10 and 11). It is more likely, therefore, the result of a conscious action to seal the piston to the casing in the position associated with the removal of the automatic system without realizing that this would disable the manual emergency gear extension system.

The diaphragm was worn and stuck to one of the halves of the housing, which prevented the rod from moving.

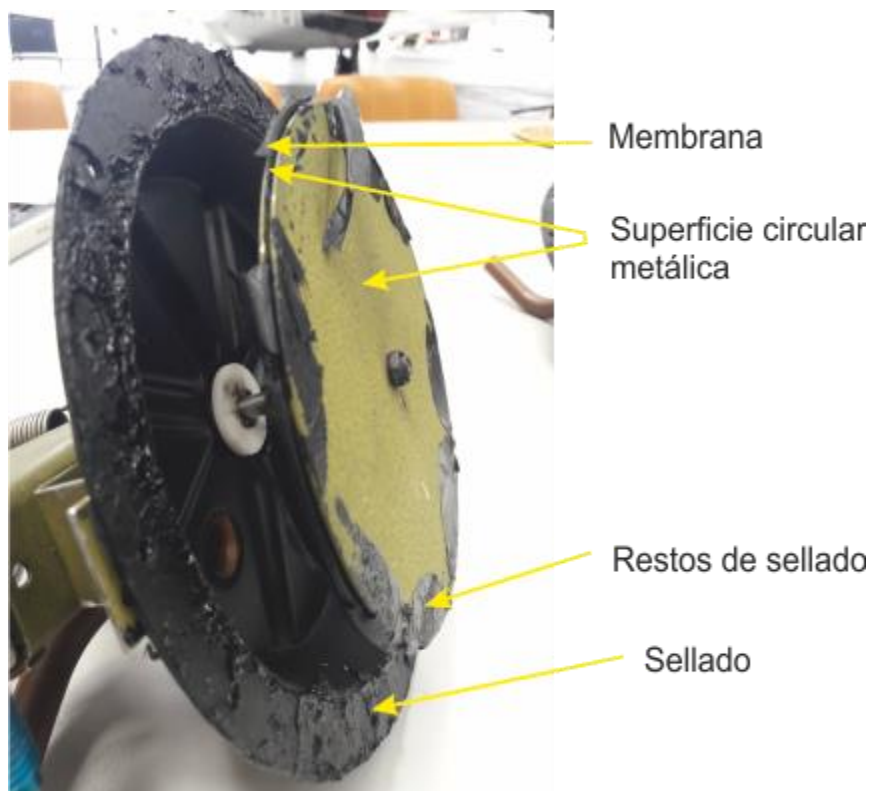
Fig. 10.- Diaphragm assembly detached from the casing

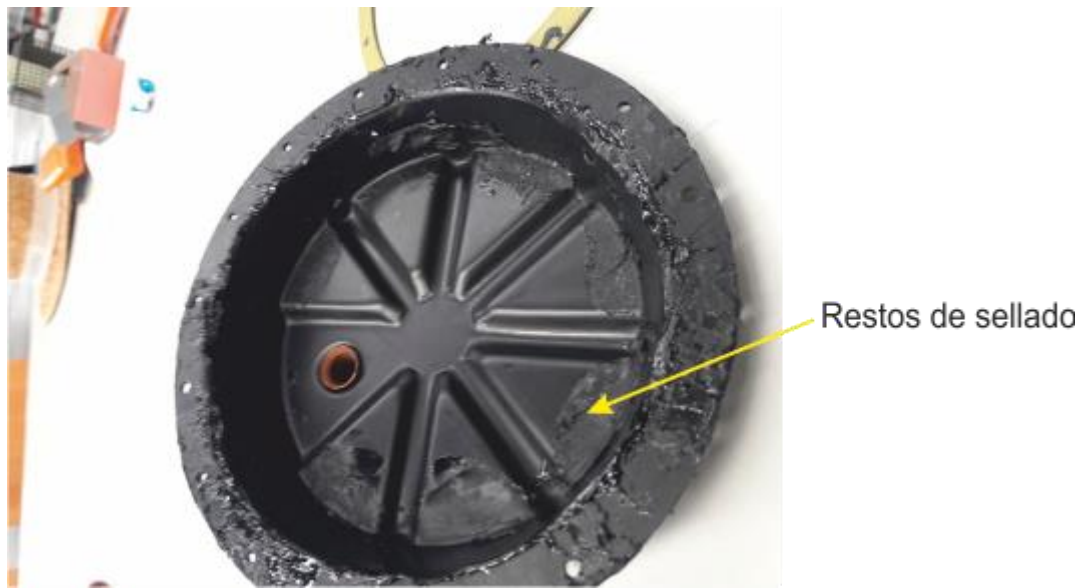
Fig. 11.- Half of casing to which diaphragm assembly had adhered
