Arab Republic of Egypt
Ministry of Civil Aviation
Aircraft Accident Investigation

Final Report

Air Balloon Burning and falling Accident

Registration SU-283

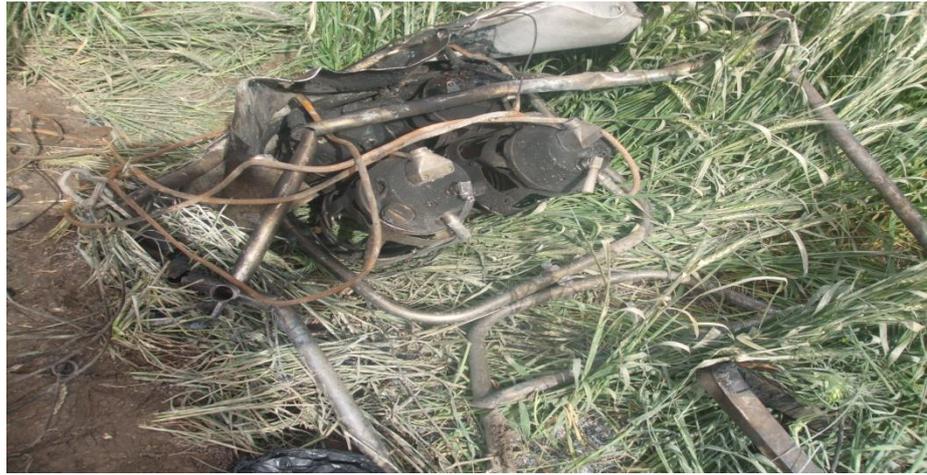
2.1 Burners Status

- The four burners were fixed through fastening screws to the balloon metallic frame
- The frame connected to the burners was affected by the rescue procedure. Some cuts in the frame were made to facilitate rescue procedures

- The four burners showed traces of fire; in addition of traces from the falling site muddy soil.
- Three fuel hoses were attached to the burners, whilst one of the burners was missing all the hoses. One burner hose connection was attached to it.
- The size of the attached burner hose connection (missing the hose), was different than the other three connecting nuts
- The Cow Valve Handle that belongs to the burner with the missing hose was completely melted.

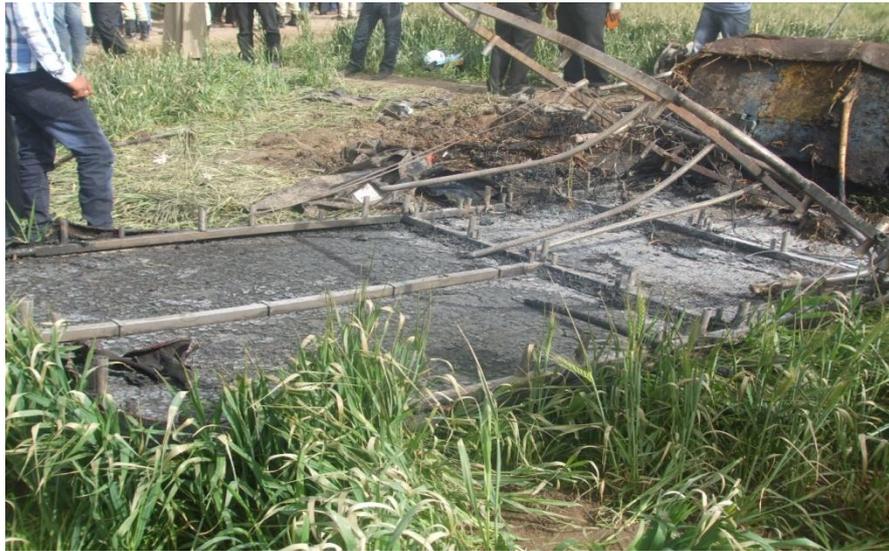
2.2 Basket:

- The basket was completely burned except the metallic frame, the base and one of its sides.
- The basket was moved slightly beside the pit that was caused as a result of the final fall down (crash) of the balloon. The basket frame beams showed some cuts as a result of fire extinguishing and human remains recovery.

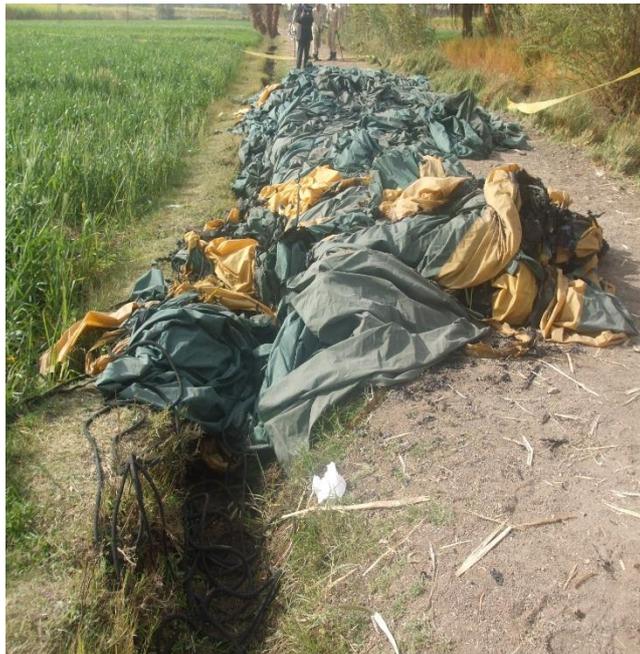
2.3 Envelop:

- The envelop was located on the unpaved road adjacent to the wreckage site. The rescue personnel positioned this envelop far from the wreckage to facilitate moving the dead bodies.
- The features of the balloon yellow and green clothes (tissues) were definite. They did not burn totally, except at some parts which allowed deflation of the hot air until the complete fall down of the balloon in a free fall
- The cables attaching the envelop to the basket were scrambled as a result of the fall in addition of the operations of lifting and turning the basket.

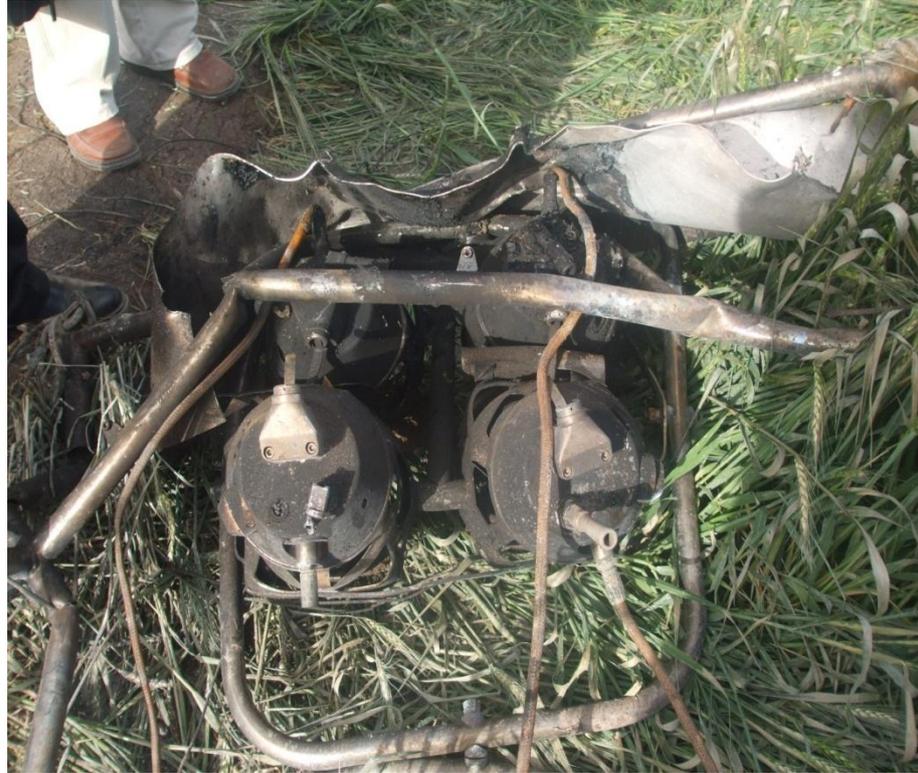
2.4 Hoses:

- Three hoses were found connected to the burners and were scrambled with the wreckage. The fourth hose was not connected to its burner. It could not be found in the wreckage fall site.
- The outer rubber of the hoses was burned except for some few parts. The inner metallic wire of the hoses was the only remaining parts.
- The hose union nut was found connected to the burner. The hose was separated from the hose swaged on sleeve. The sleeve was found loose about the axial axis. It was apparent that the fastening nut thickness was different than the other three nuts.
- The TEMA attachment quick connections were not found with the fuel cylinders for any of the three hoses at the wreckage site.

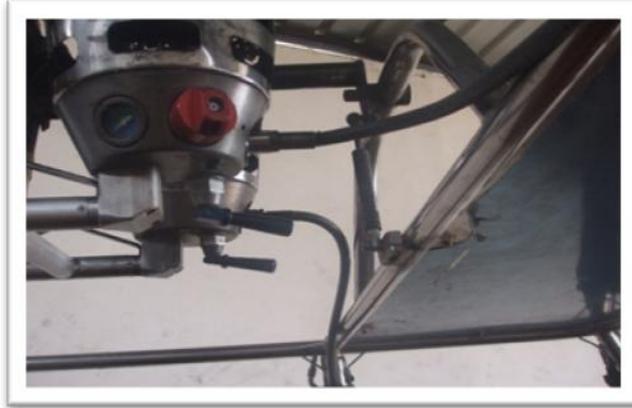
- Bents were visible in the hoses, in the upper part before connecting the hoses with the burners

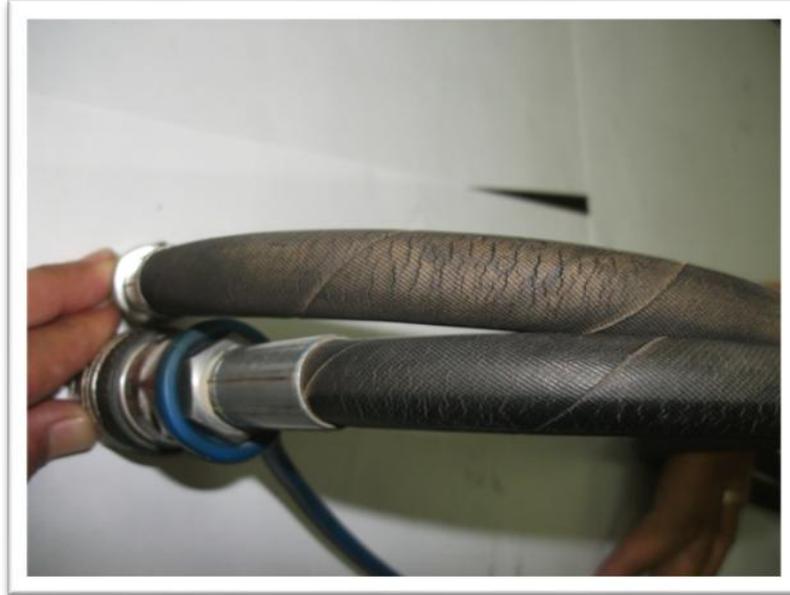
- The start of the influence of the heat and the environmental conditions at the adjacent part of the igniters at the part near to the quick connection connectors (TEMA) were easily observed, this can be identified through the dissimilar colors.
- Cracks were visible at the part adjacent to the burners, its intensity increasing as it becomes more near to the igniter, it decreases as it becomes more far from it, until it almost disappears

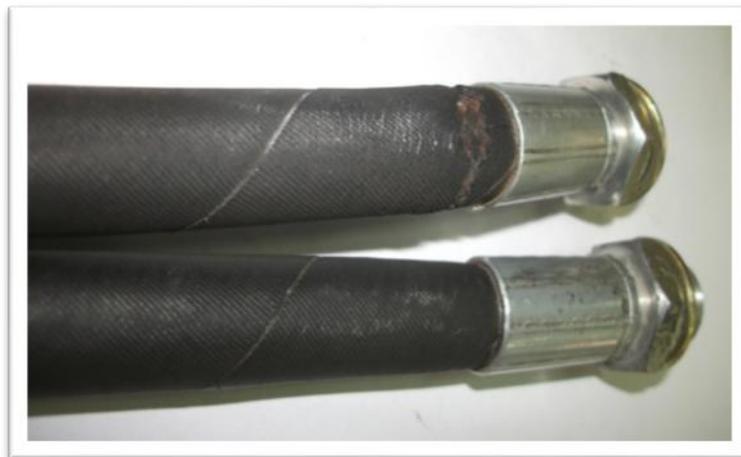
A thorough examination for one of the hoses having the same part number (PV8015730/01, manufactured by BINS A Company) by the investigation committee, torn parts of the rubber were observed at the part adjacent to the connection of the hose to the burner, showing the parts of the hose reinforcing metallic wire as shown in the adjacent photo.

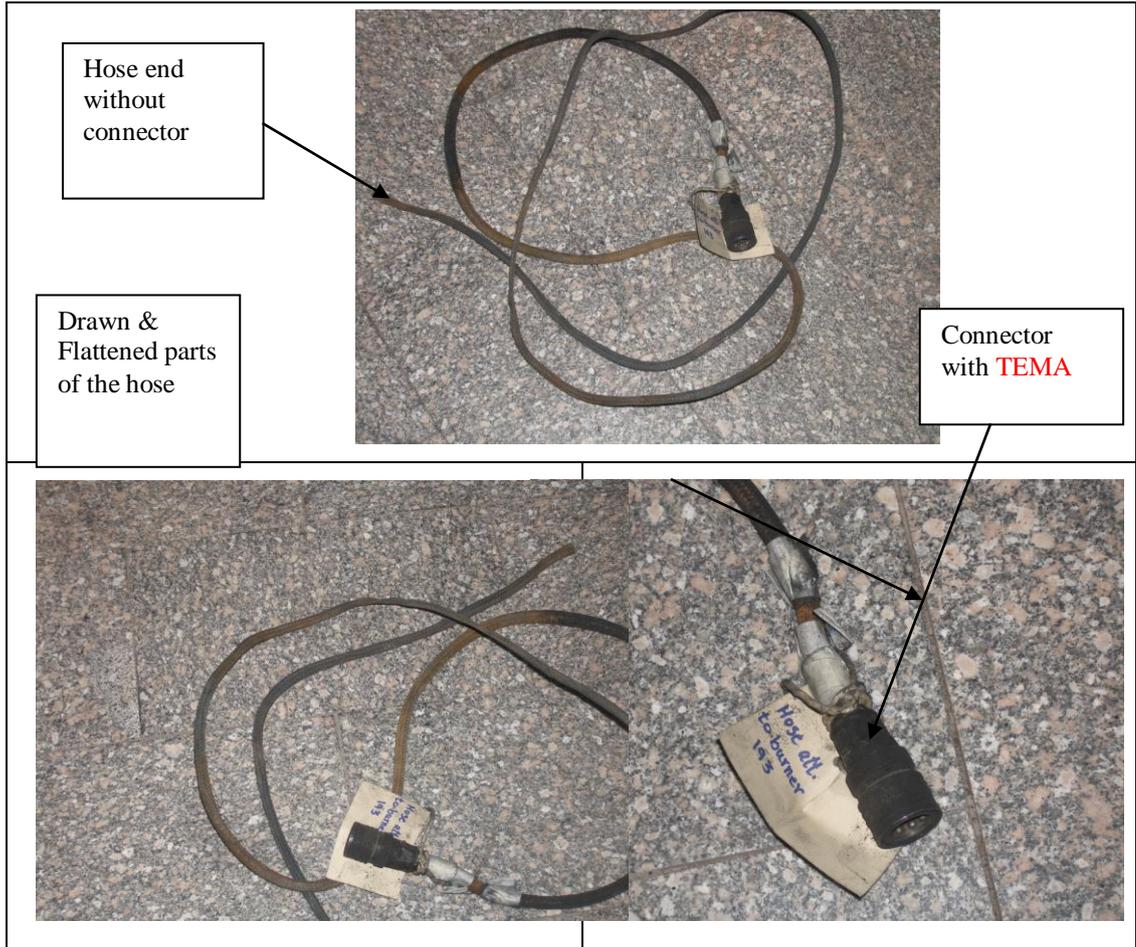
- It was found that the hose lost totally the outer rubber layer as a result of a fire exposure.
- The hose contains different diameter areas as a result of a puling force of fragments. The hose diameter was found deformed and varies between 13 mm to 6.8 mm.
- The hose was expanded due to puling with its length measuring 323cm.

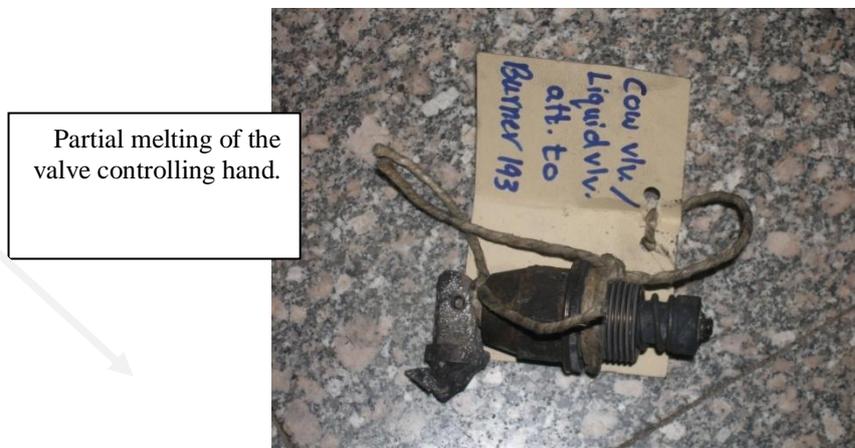
Item #3: Cow burner vlv. attached to burner (193)

- The cow valve connected to burner 193 was found with partial melting of the valve controlling handle.
- The cow valve was subjected to a direct fire, which caused partial melting of the valve controlling handle manufactured of Aluminum alloy - 6000 series (Magnesium Mg and Silicon Si are major alloying elements) AlSi1Mg0.5Mn with UNS. No. (A96351) alloy with an approximate 650 °C melting temperature.

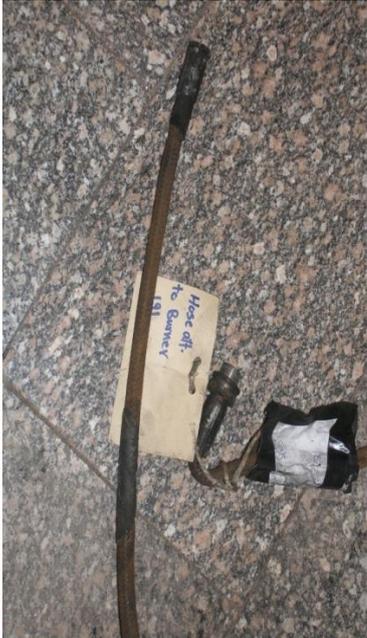
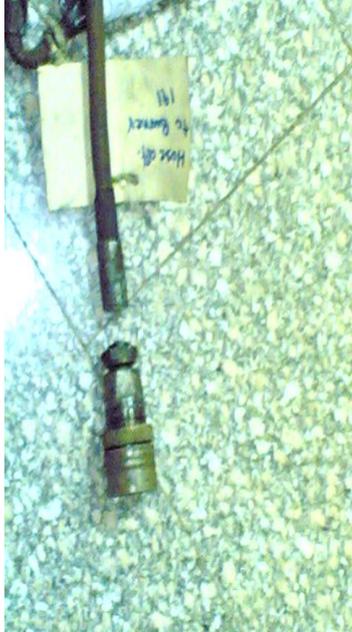
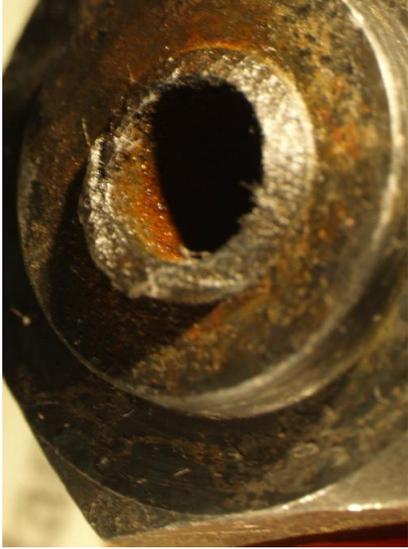
It was noticed that one its end was attached to the burner, while the other side was connected to TEMA, it was affected by the shear force resulting in its fracture (as shown in the following photos)

| <p>Hose attached to burner 191</p> | <p>A part of the connector was separated and connected to the TEMA</p> | <p>Features of a part of the connector which was separated and connected to the TEMA</p> |

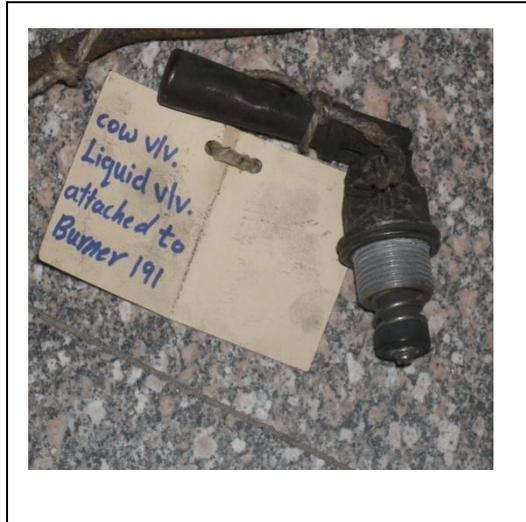
The cow valve attached to burner 191 was found in a right situation (undamaged) .

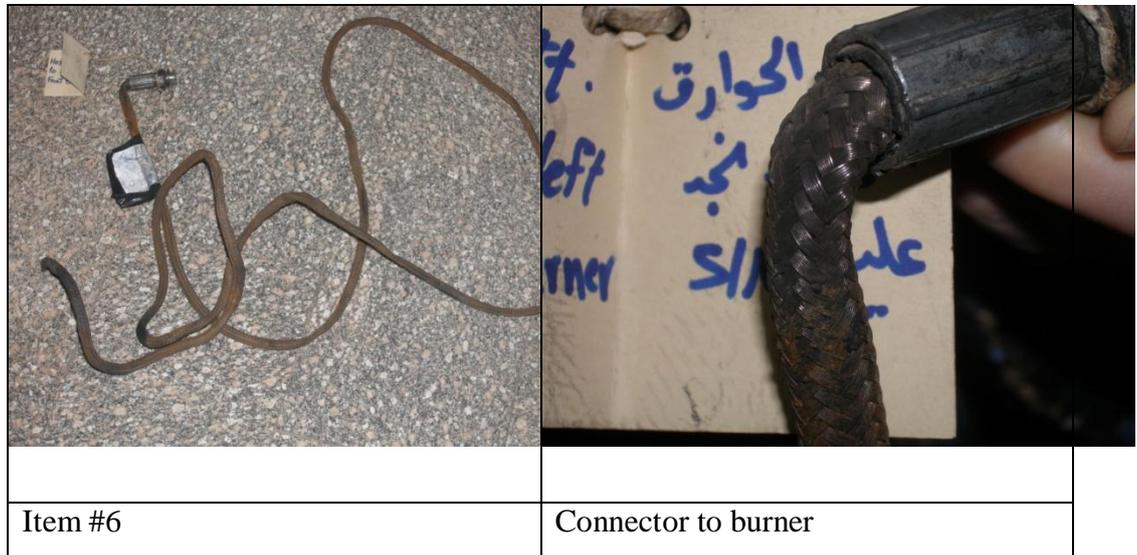
It is also noticed that there is great variety between the hose diameter (8.9 -12.7 mm) as a result of a pulling force.

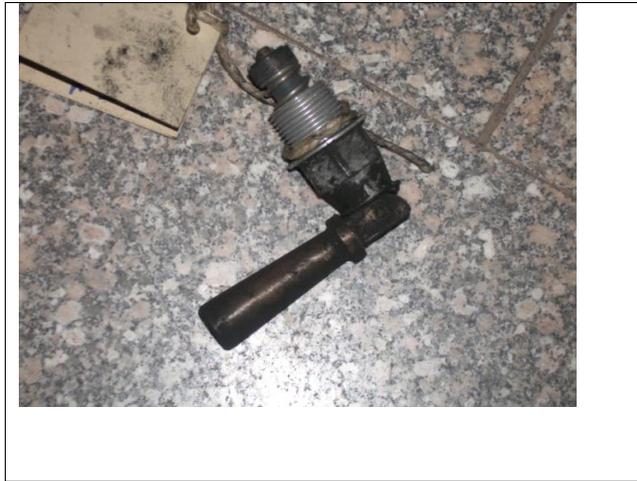
Item #7: Cow vlv. of one of the two unidentified burner serial No. (left front side)

By visual inspection, it contains no damage at any part of the valve.

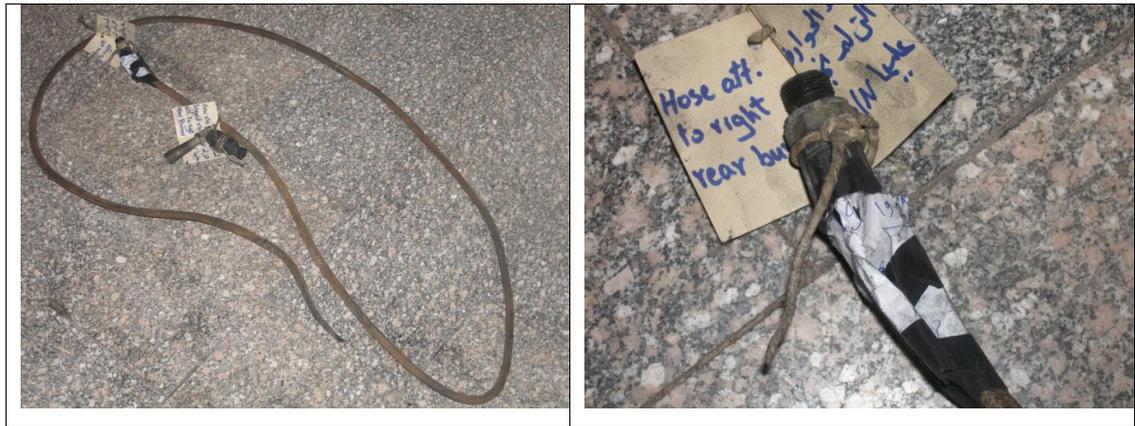
The hose contains one of the connectors, while the other end was found free (released from connector). The hose is highly damaged by a fire, where its length 293 cm. It is also noticed that there is great variety between the hose diameter (8.4-12.9 mm).

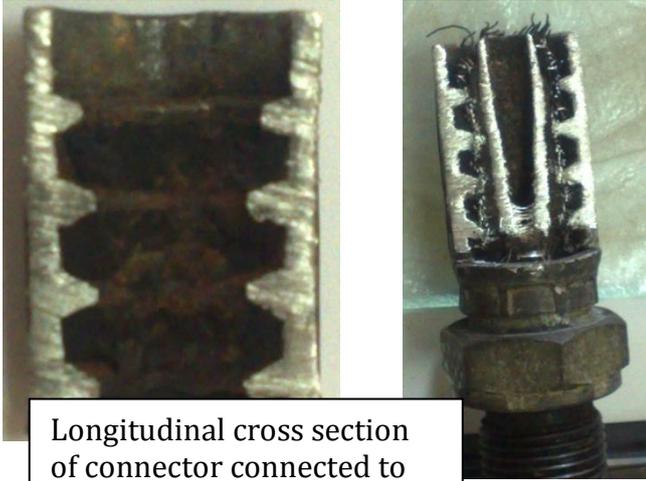
Longitudinal cross section of connector connected to hose item#8

The connector was mechanically cut to longitudinal section to look at investigate the effect of fire. After longitudinal sectioning, it was found that rubber of the hose was totally fired and traces of rubber aches was noticed at a different areas between the inner and outer tubes of the connector.

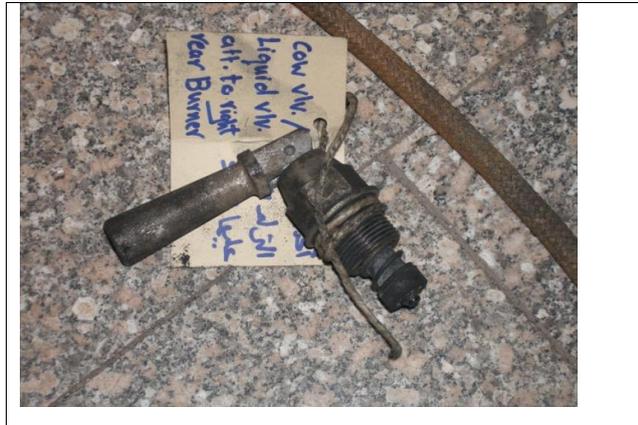
Item #9: Cow vlv. of one of the two unidentified burner serial No. (right rear side)

The cow valve item #9 of one of the two unidentified burner (right rear side) is undamaged.

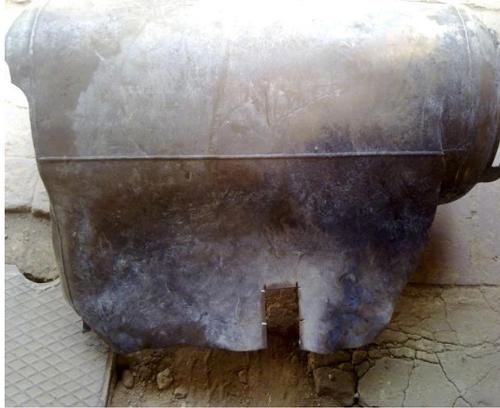
Edges of the failed wall of the cylinder move Outward

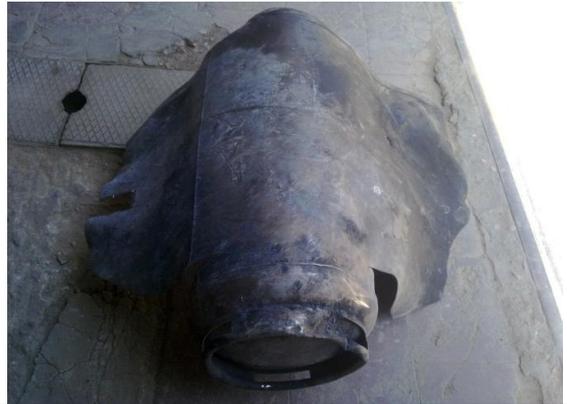
Lower seam welding lines
Edges of the failed wall of the cylinder move outward

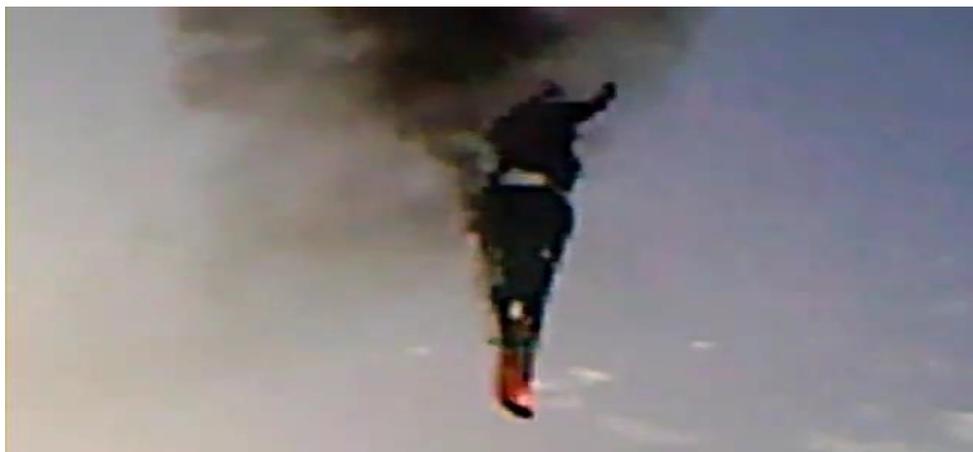
- The appearance of black smoke started at the left side of the balloon and the continued growing.
- The balloon height was increasing with smoke growing.
- The smoke was severely growing until both the envelop and the balloon totally changed to a heavy smoke flame.
- The balloon and its parts fell down on the ground

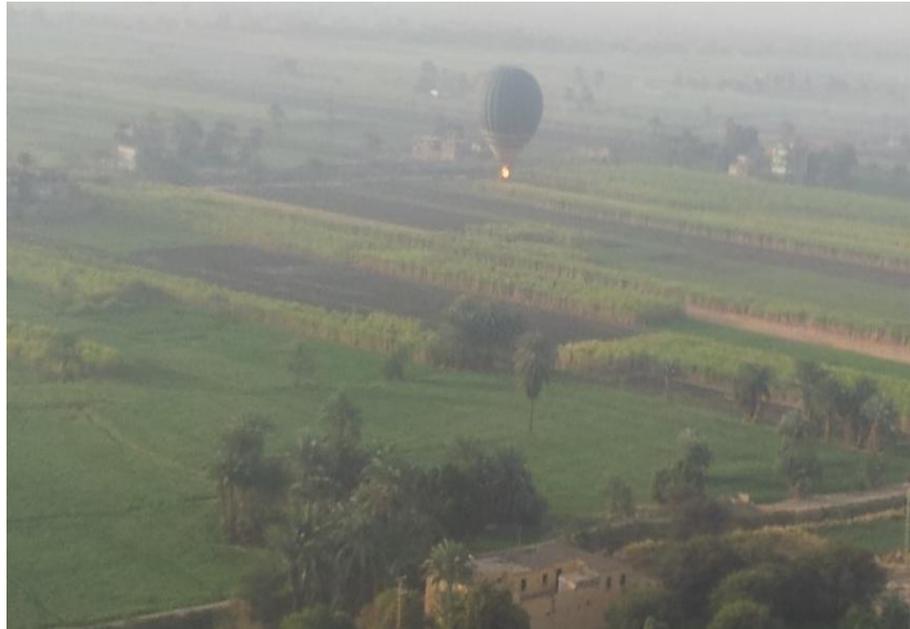
- Visible flame in the balloon basket

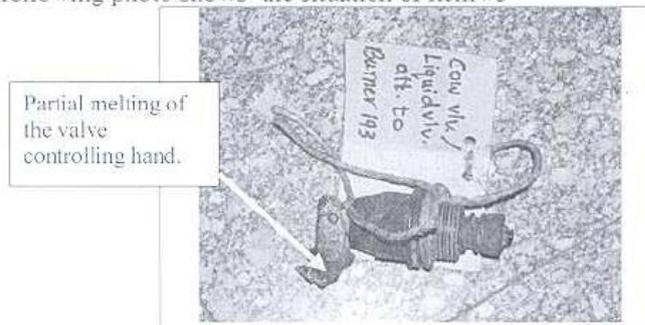
The cow valve connected to burner 193 was found with partial melting of the valve controlling handle.

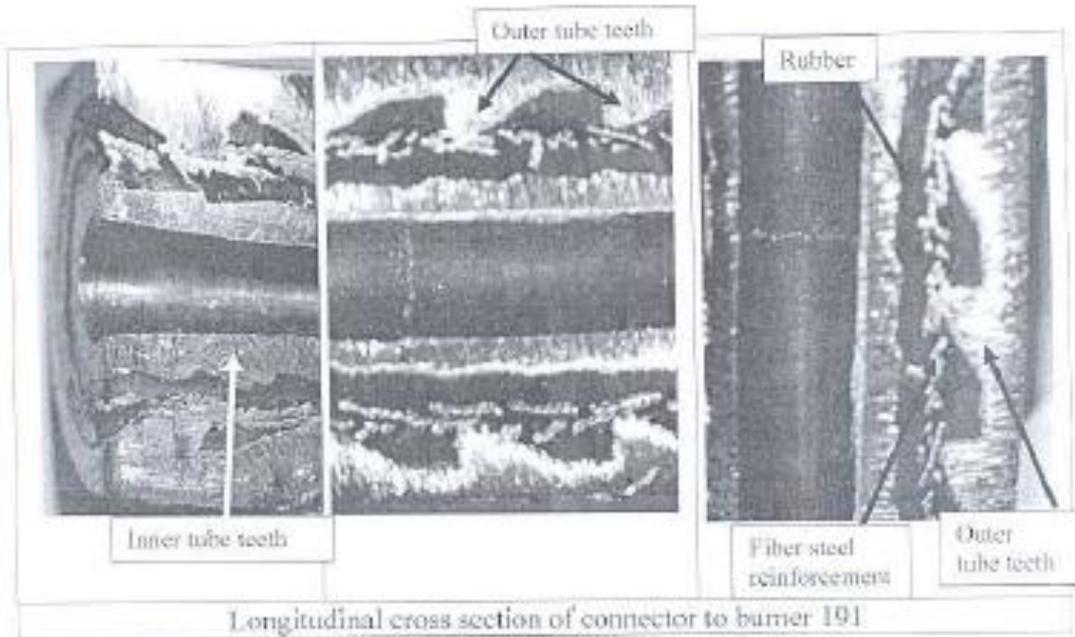
After longitudinal cutting of connector to burner 191, it was noticed that the inner as well as the outer tubes contains teeth that bite the rubber layer of the hose. Biting continues to the fiber steel reinforcement. The biting mechanism clearly shown in the following photos suggest it is a remote possibility that the hose could release from its connector under normal circumstances unless it is subjected to an external pulling force.

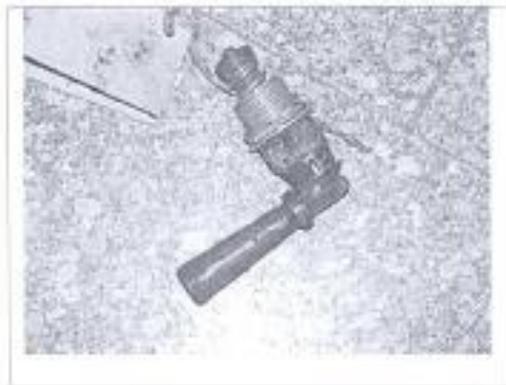
By visual inspection, it contains no damage at any part of the valve.

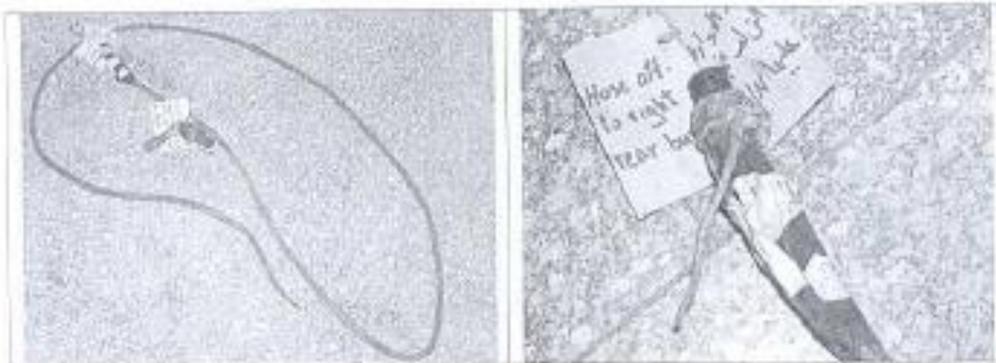
The following photos describes the situation of item #8. The hose contains one of the connectors, while the other end was found free (released from connector). The hose is highly damaged by a fire, where its length 293 cm. It is also noticed that there is great variety between the hose diameter (8.4-12.9 mm).

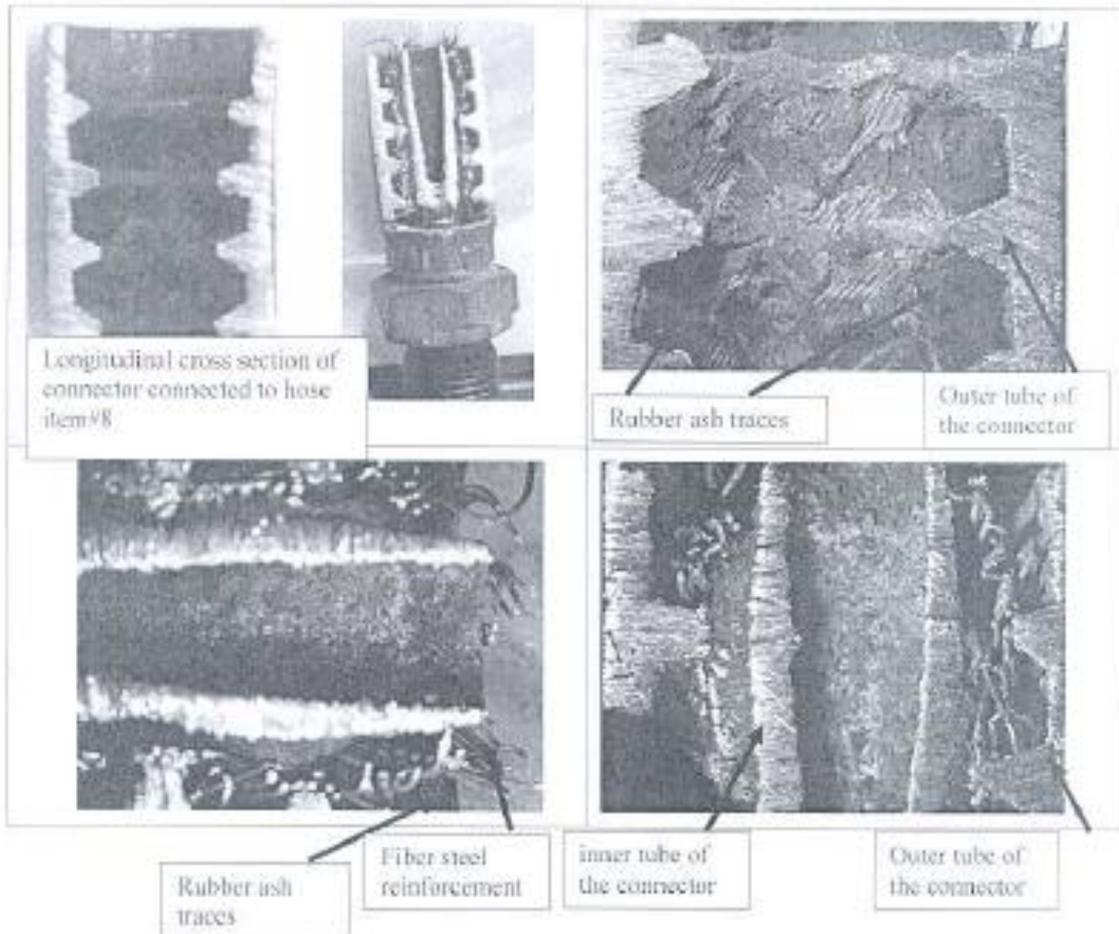
The connector was mechanically cut to longitudinal section to investigate the effect of fire. After longitudinal sectioning, it was found that rubber of the hose was totally fired and traces of rubber ashes was noticed at a different areas between the inner and outer tubes of the connector.

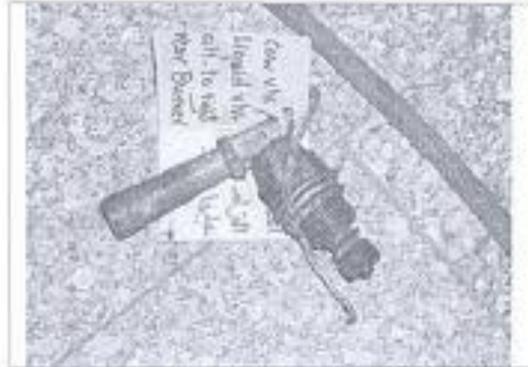
The cow valve item #9 of one of the two unidentified burner (right rear side) is undamaged.
