COMISIÓN PERMANENTE DE  
INVESTIGACIÓN DE ACCIDENTES  
E INCIDENTES MARÍTIMOS

## REPORT CIAIM-17/2020

### Fire aboard the ALGECIRAS JET vessel on the route Ceuta-Algeciras, the 6th of February 2020

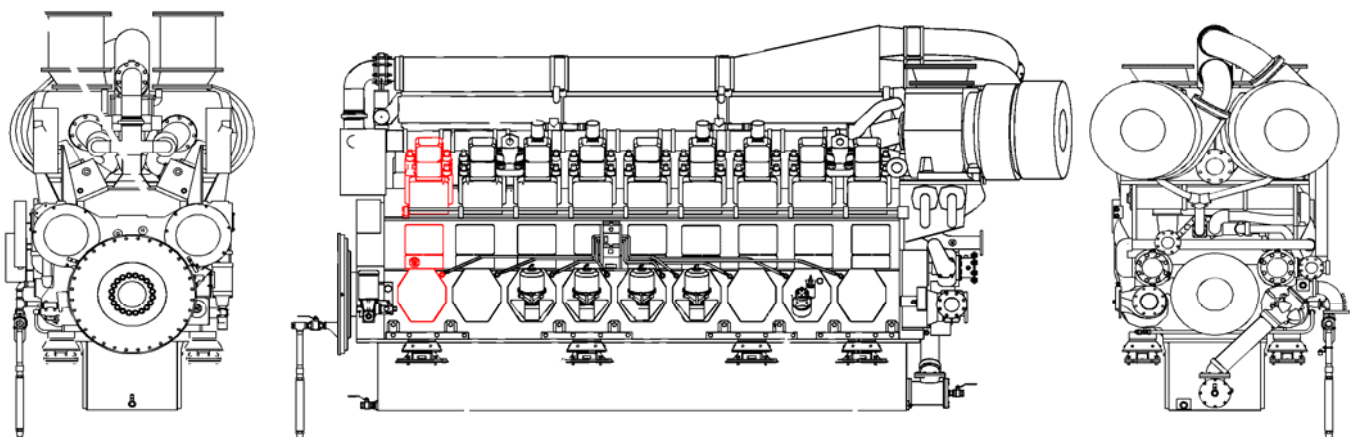
Figure 7. Caterpillar 3618TA engine schematic.

The Caterpillar 3618TA engine has an 18-cylinder V-arrangement. Figure 7 shows a diagram of the engine. Cylinder no.17, which is where the fire occurred, has been highlighted.

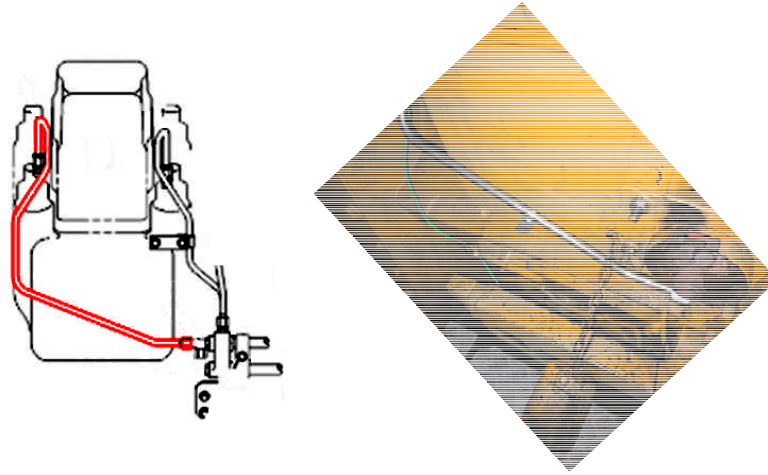
Figure 8. Cylinder no.17 fuel return circuit.

Specifically, the fire occurred in the fuel return line of cylinder no.17, as shown in Figure 8.

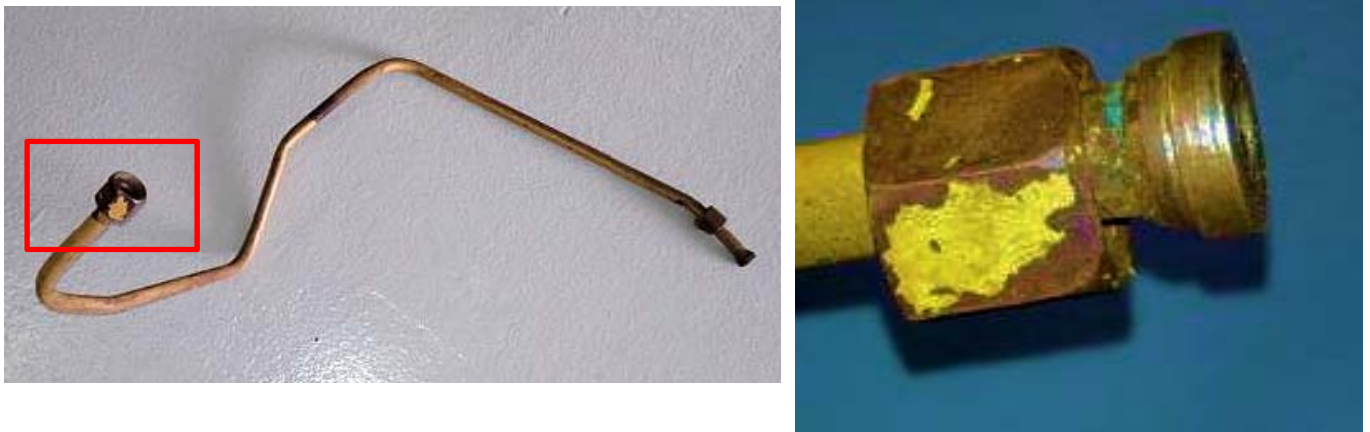
Figure 9. Cylinder no. 17 fuel return circuit pipe and connection detail.

The return line was connected to the engine by a threaded connection to ensure an efficient seal.

The fuel return line of cylinder no. 17 was checked when the ship arrived at the port of Algeciras. No pores or cracks were found in the pipe (Figure), but the connection between the pipe and the block was loose.

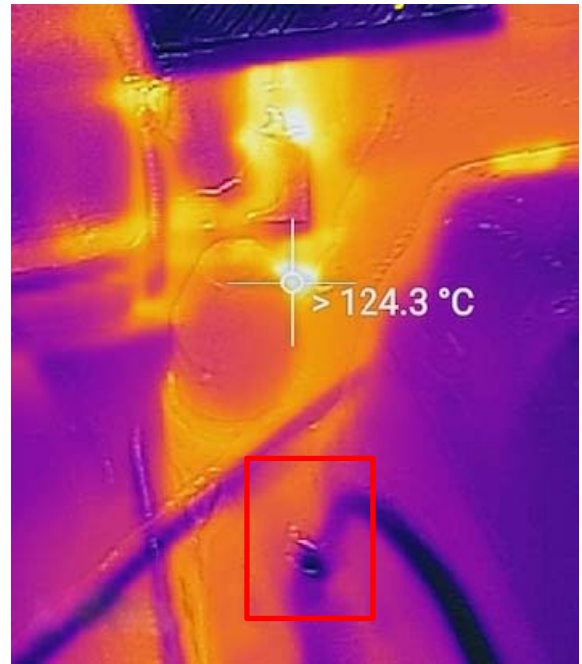
Our analysis identified hotspots (over 120°C) in the vicinity of the connection between the return line and the engine. The hotspots were caused by the exhaust system and are shown in Figure 10.

Figure 10. Hotspot close to cylinder no.17's fuel return circuit connection.

Following an analysis of the accident, CIAIM has concluded that it was caused by fuel leaking from the return line of cylinder no. 17, which then came into contact with a hot engine surface. The leak occurred because the threaded connection on the nut that connected the pipe to the engine had become loose. Without ruling out other potential causes, this may have been due to engine vibrations or a failure to properly tighten it during the last maintenance check in which the pipe was dismantled.

1. Inspections have been scheduled to identify any hot spots that could lead to similar accidents.
2. Analyse possible improvements in thermal insulation.
3. Training on fuel system hazards will be provided for crew members working with the engines.
4. Torque periods and practices for connections will be reviewed, including the replacement of the adhesive aluminium tapes.
5. Installation of splash caps for all connections.

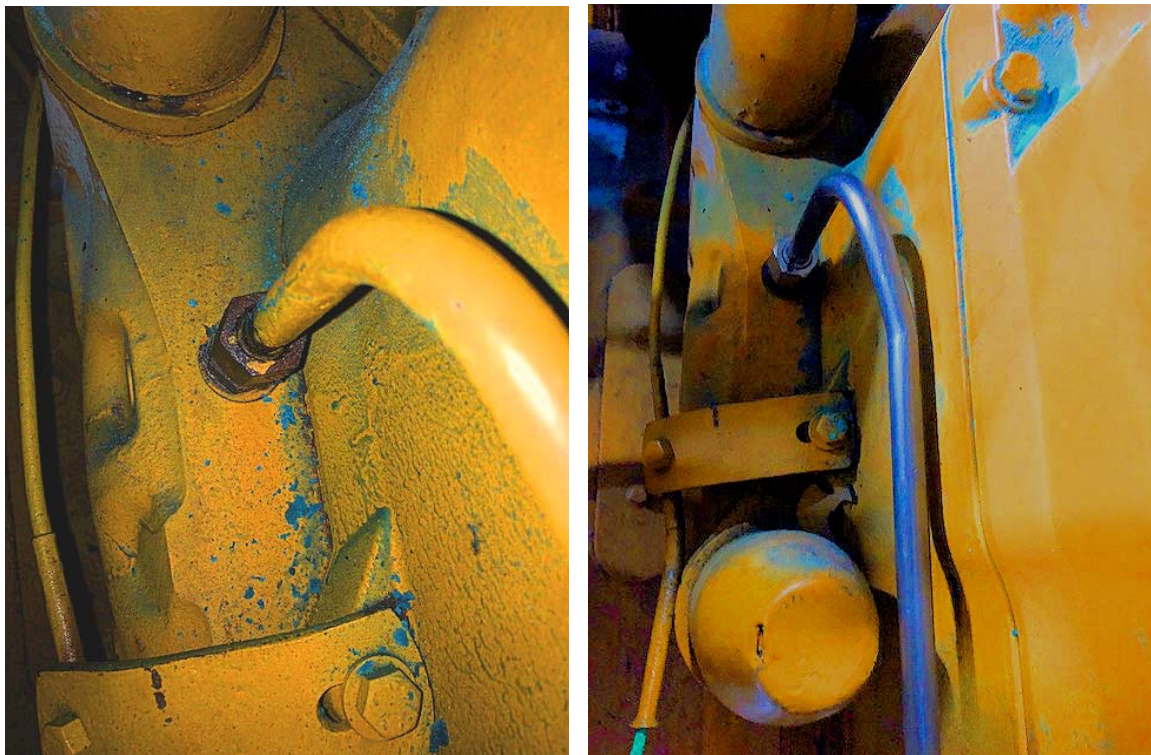
Figure 11. Detail of cylinder no. 17 fuel return circuit connection (before and after repair).

As a precaution, cylinder no. 17's fuel return line was removed and replaced.

1. Cleaning of the affected areas.
2. Replacement of affected pipes and connections.
3. Inspection of the other fuel lines in the ship's engines.
4. Checking the torque of all connections.
5. Installation of anti-splash adhesive aluminium tapes on all connections.
6. Replacement of used portable fire extinguishers.
