Report on the investigation of
of the fatal crush accident
on the general cargo vessel

Karina C

at Seville, Spain

on 24 May 2019

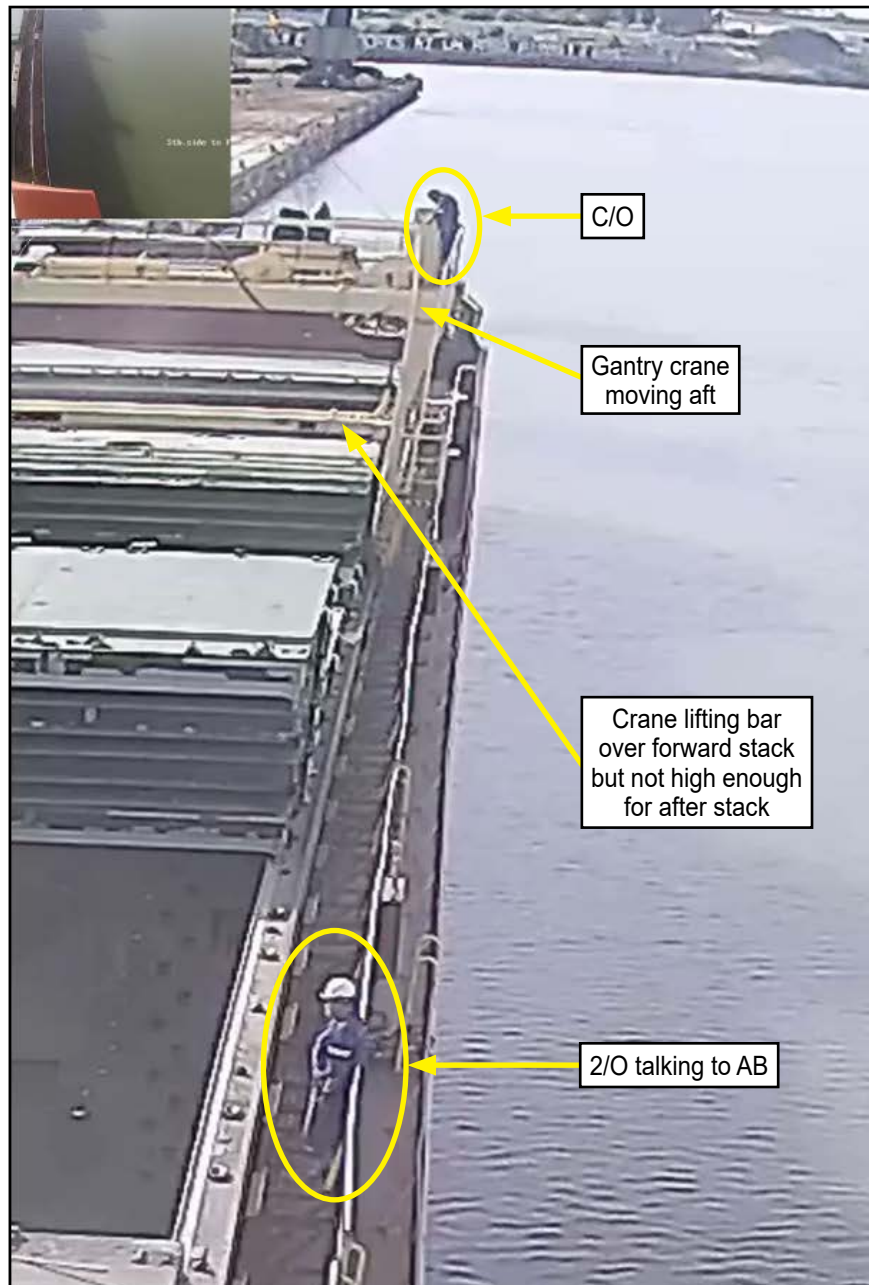
Figure 3: Second officer leaning on the starboard walkway guardrails while the gantry crane was being driven aft

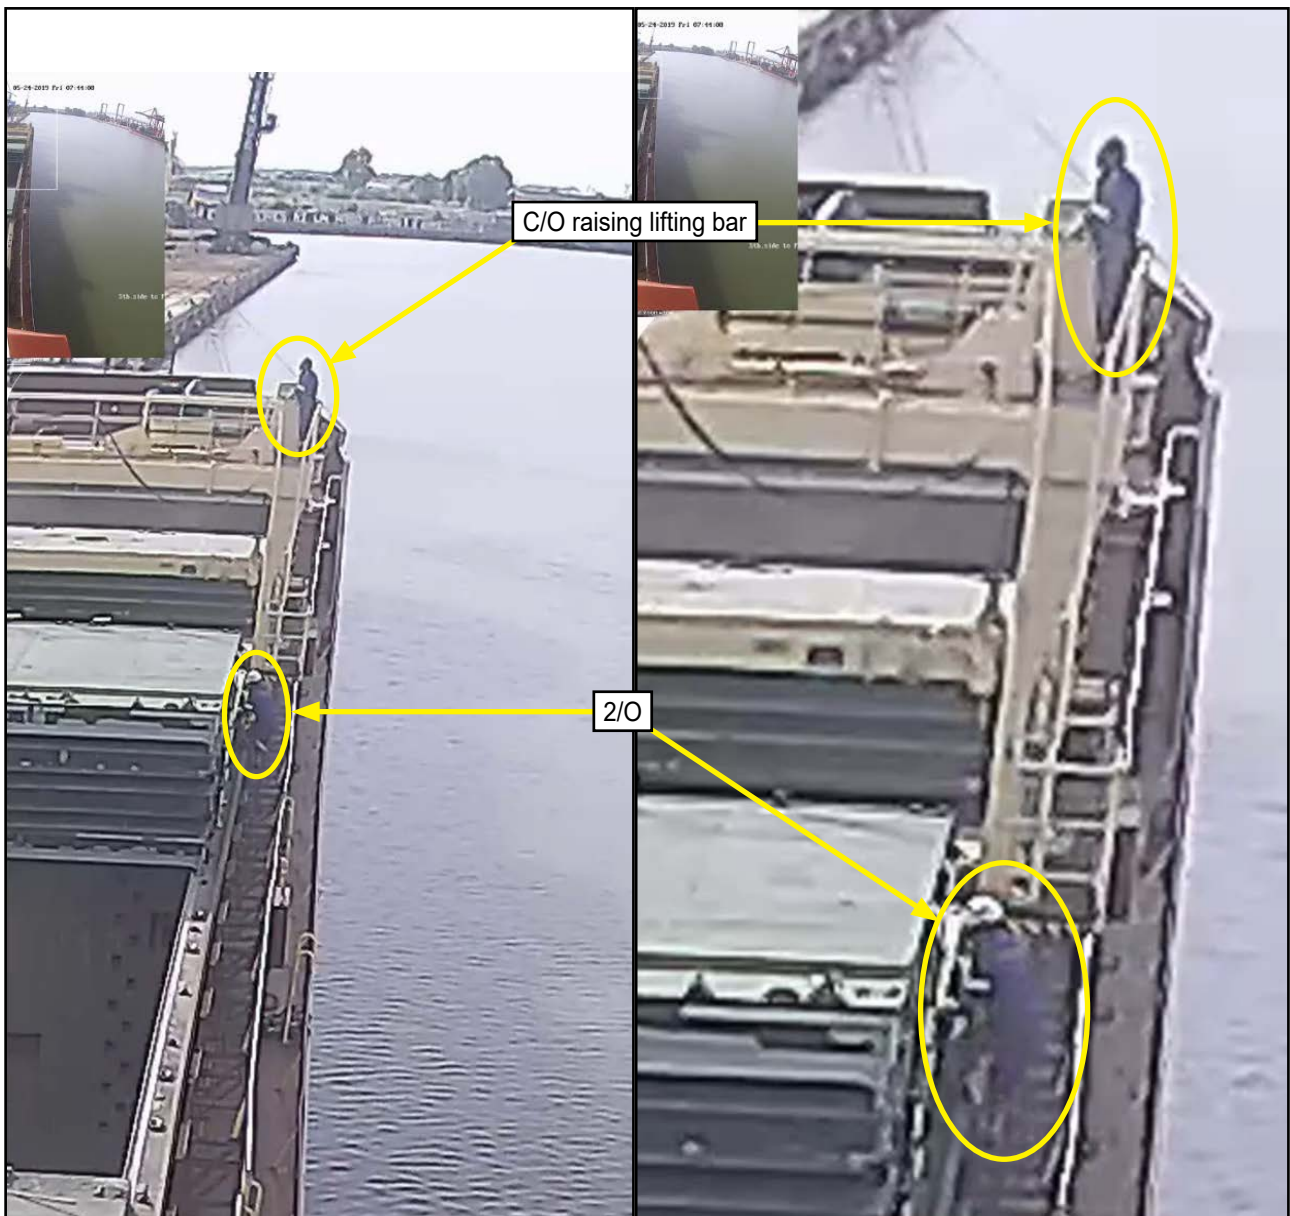
Figure 4: Zoomed CCTV screenshot showing the second officer climbing onto cargo hold hatch coaming at 0944:10

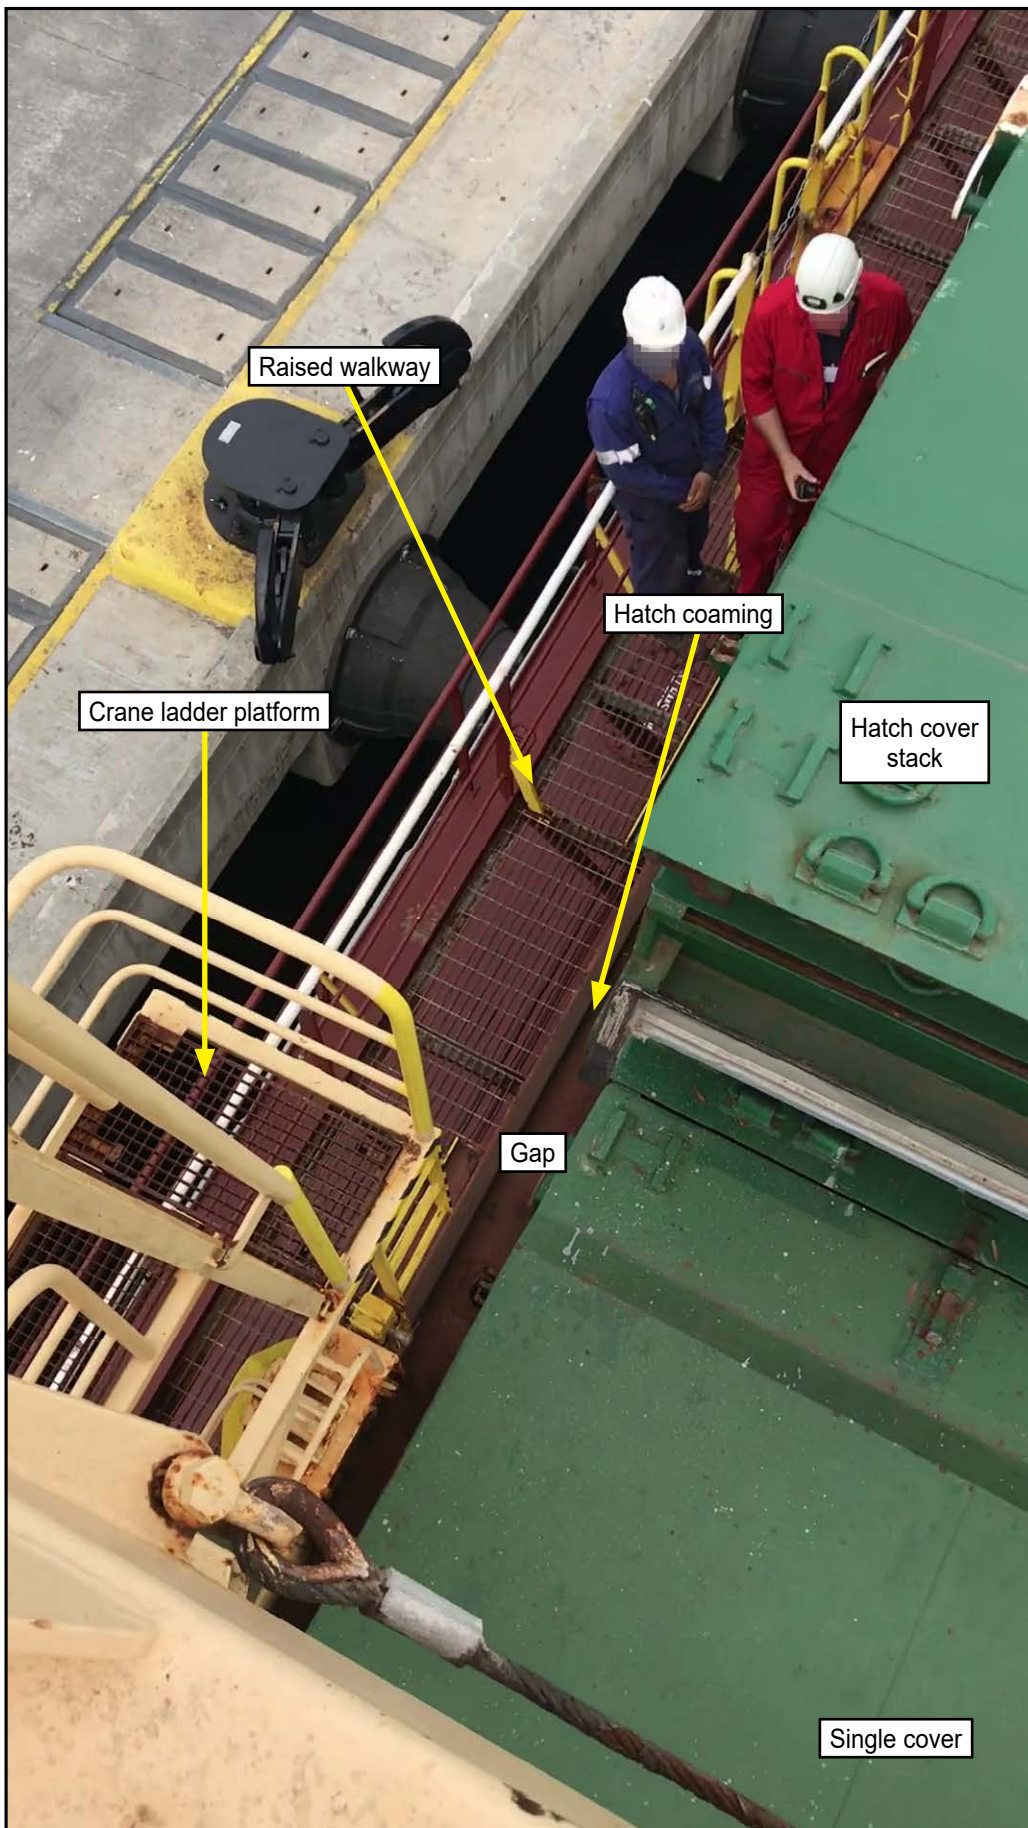
Figure 5: Reconstruction showing the distance between the crane ladder platform and the stack of hatch covers when the second officer climbed onto the coaming

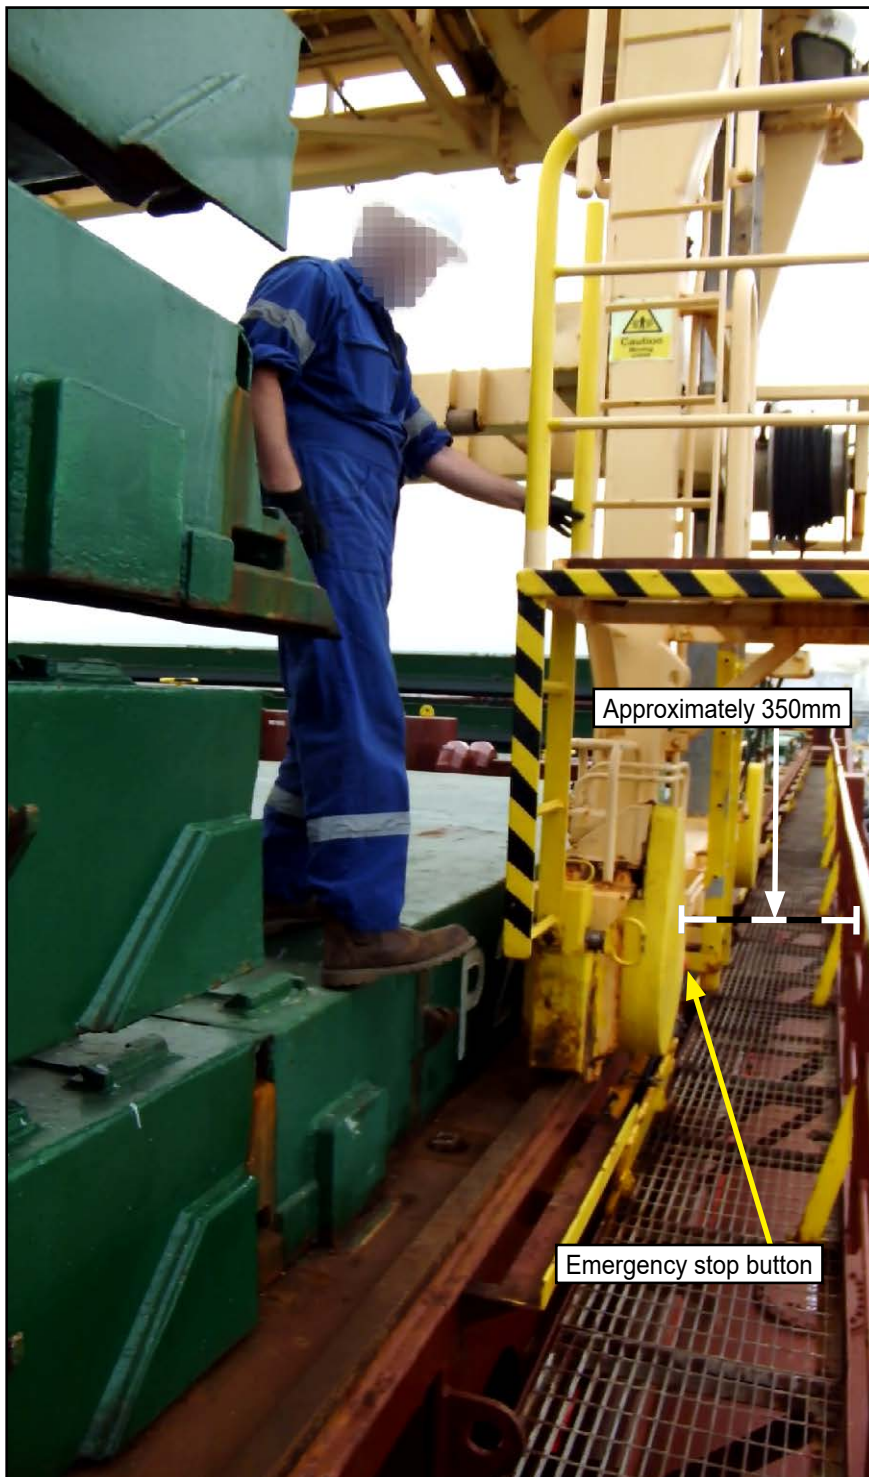
Figure 12: Access to starboard emergency stop

- It was impossible for the 2/O to reach the gantry crane emergency stop button (**Figure 12**) from the position in which he became trapped.
- The gantry crane's audible warning bell could be clearly heard at walkway level.

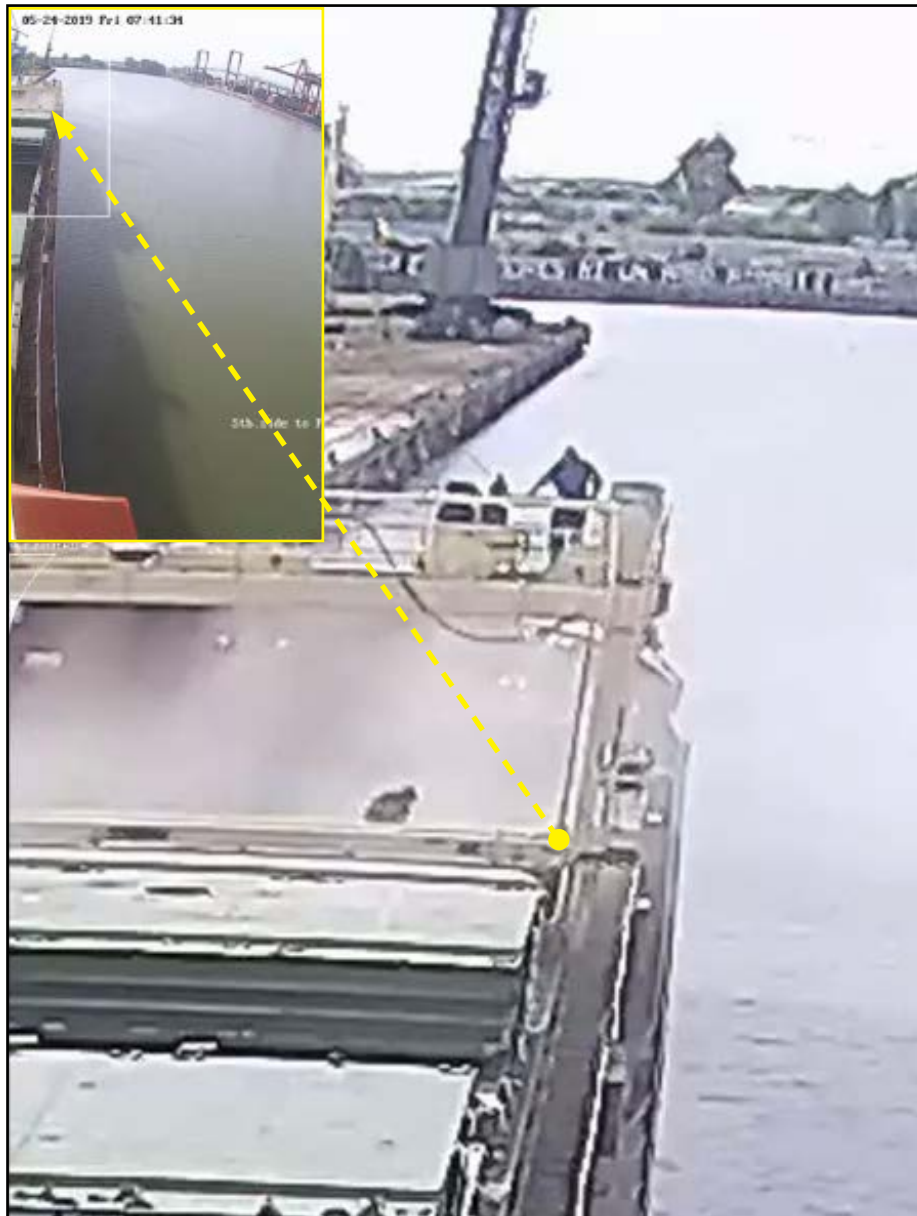
The company's *RA D15 – Loading and Discharging Dusty Cargo (Annex C)* required the use of suitable personal protective equipment (PPE), which included face masks and goggles. During the pre-departure cleaning operation occasional clouds of cement dust were created (**Figure 13**). The deck cadet and two ABs were wearing face masks and eye protection; the 2/O and C/O were not.

Figure 13: CCTV screenshot showing cement dust cloud

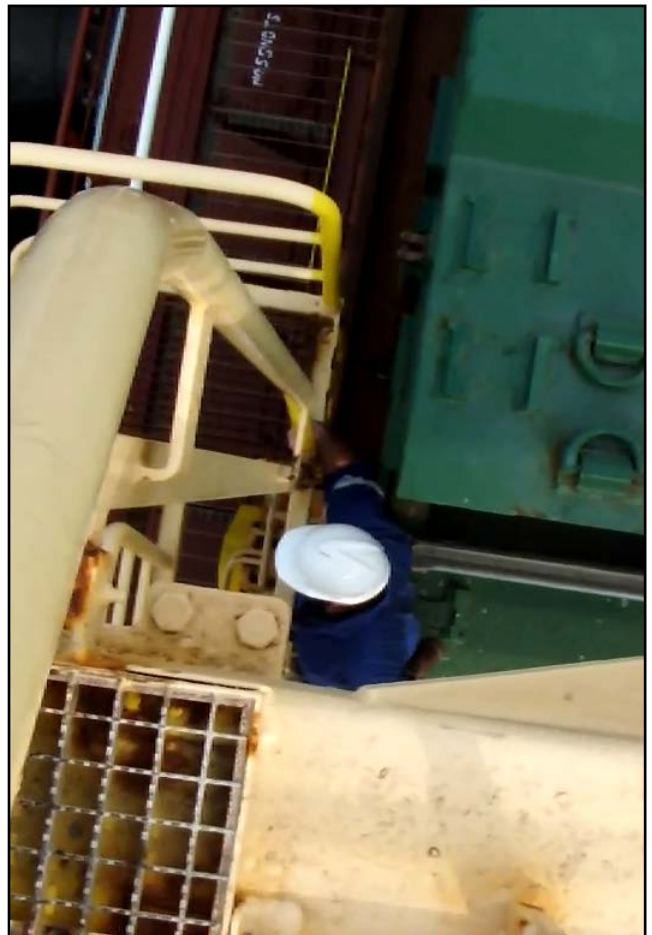
Figure 15: Reconstruction showing size of the gap between the ladder platform and the stacked hatch covers

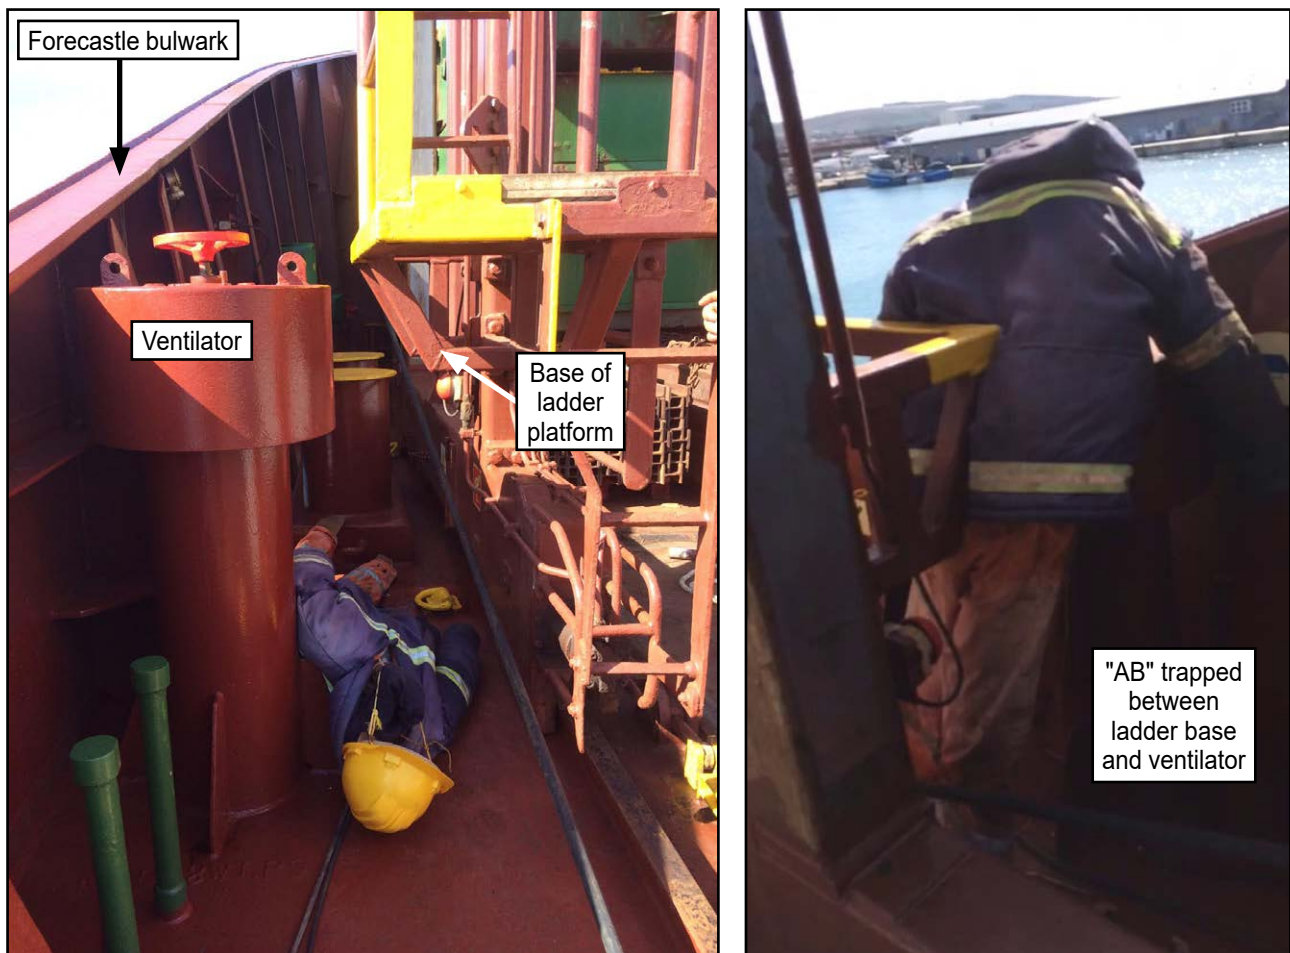
For the majority of the crane's path, the outboard space was unobstructed, allowing safe access past the crane. However, the forecastle area narrowed and the walkway was obstructed by the vent and other deck fittings. The AB, who had not had his minimum hours of rest in the last 24 hours, was not concentrating and misjudged the available space.

Figure 17: Reconstruction of gantry crane accident on board *Vectis Progress*

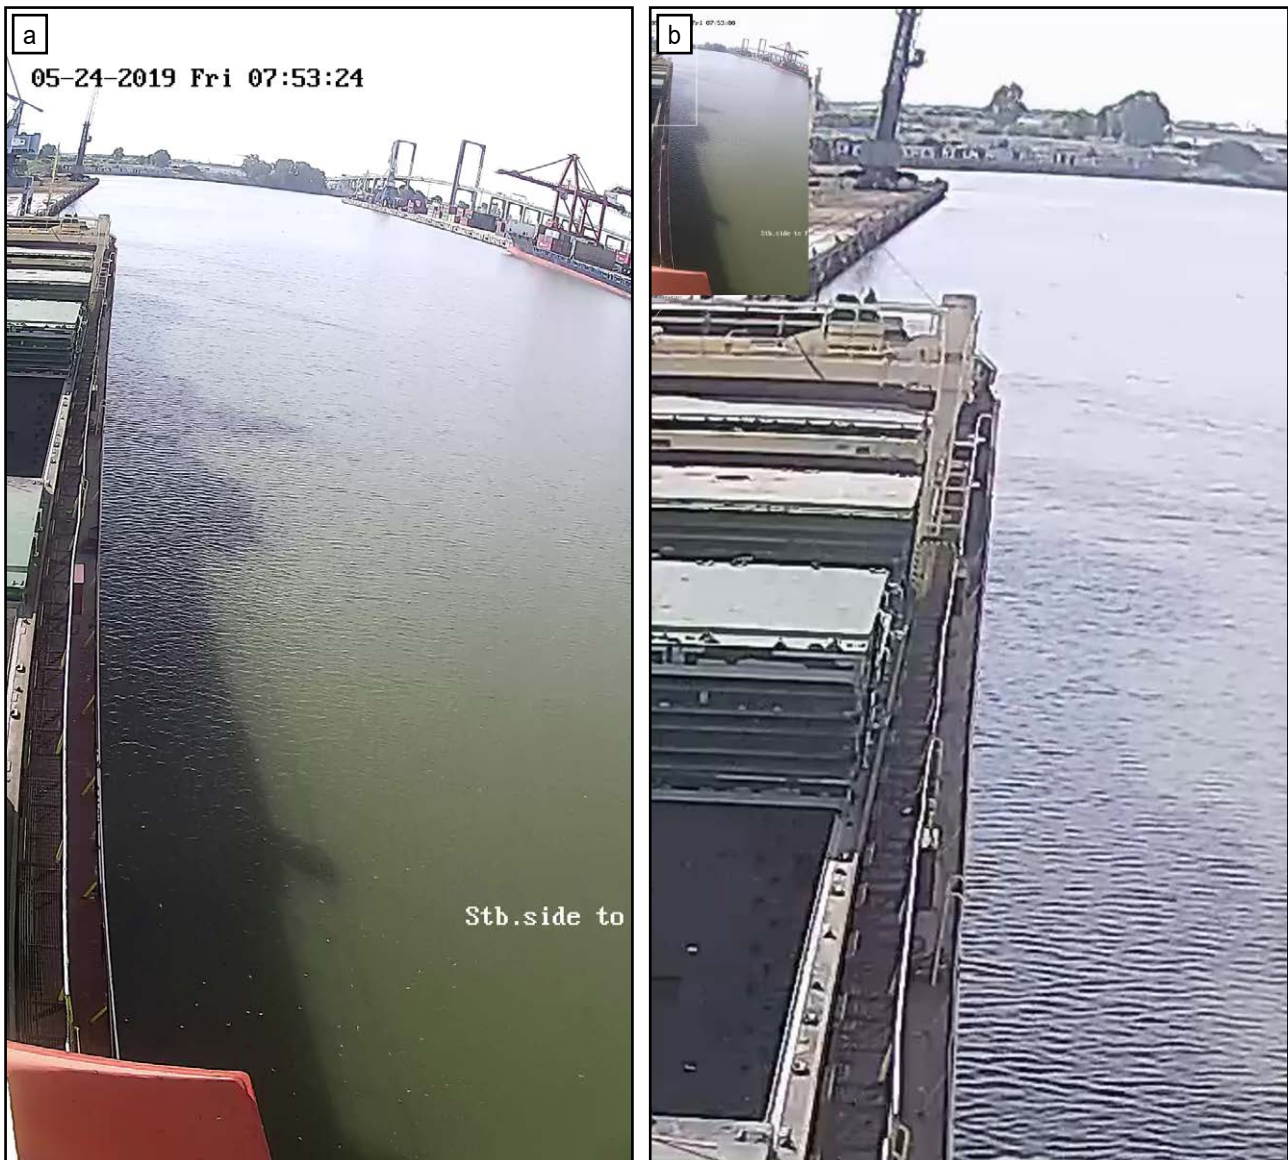
The CCTV recording was obtained by the MAIB in October 2019. From close examination of the recording it was apparent that the crane was involved with the accident. Using commercially available software, the footage was enlarged (**Figure 20**) to make the sequence of events significantly clearer. From the zoomed images it was evident that the 2/O had been trapped by the crane and crushed between the moving crane's ladder platform and the stack of hatch covers.

Figure 20: CCTV snapshot of the starboard side of cargo deck (unenhanced (a) and enhanced (b), showing significantly more detail)
