Report on the investigation into the capsizing of the  
fishing vessel

**Z 582 ASSANAT**

off the British coast near Margate with the loss of two lives  
on 27 December 2016

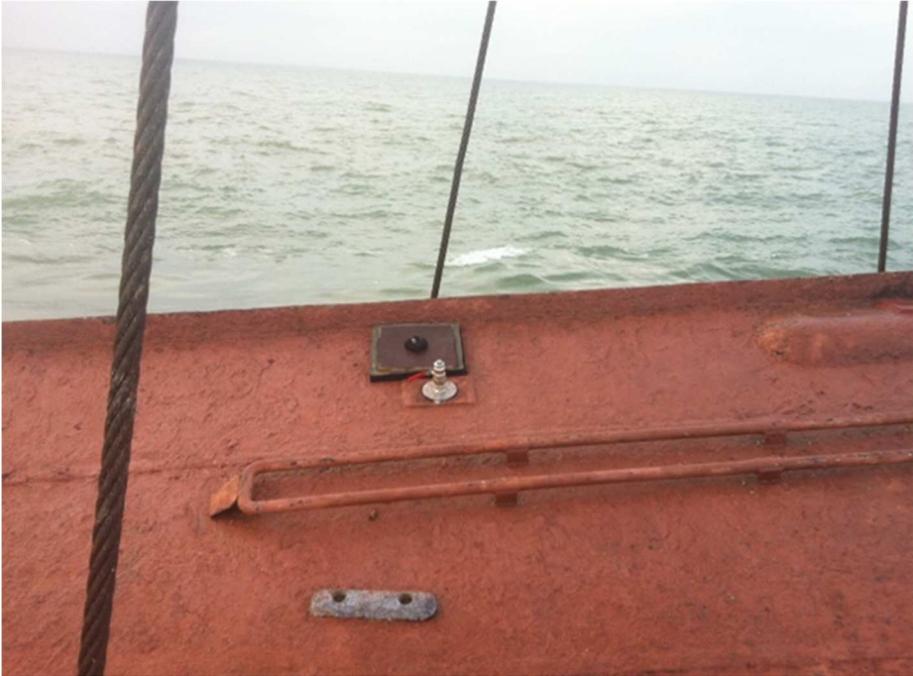
*Figure 5 - Hot taps placed onto hull of Z582 ASSANAT*

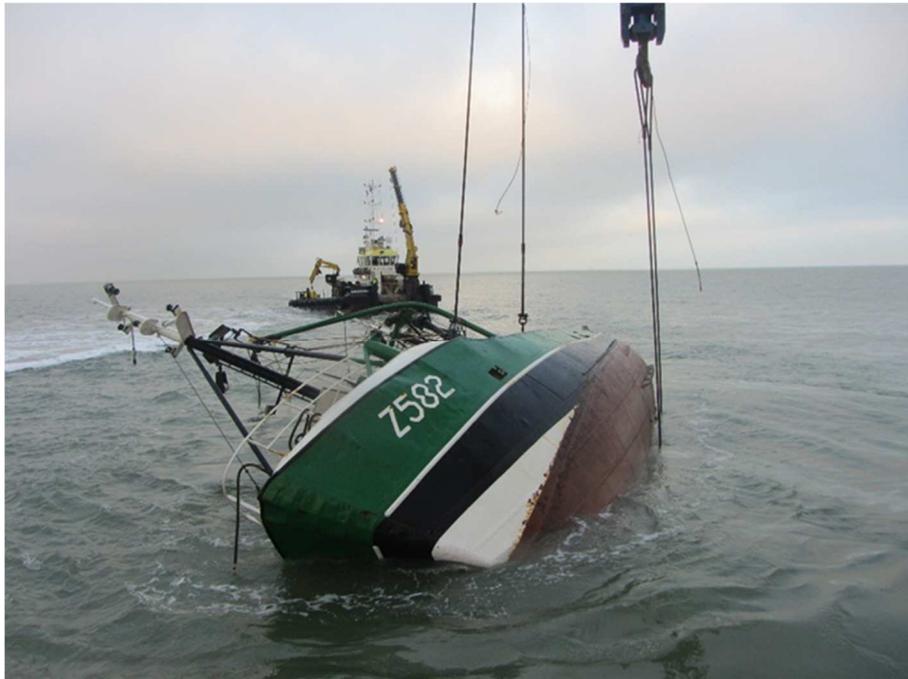
During the turning right side up of the fv Z582 ASSANAT, the bulwark of the vessel got damaged by the hoisting cables of the crane barge.

*Figure 7 – Z582 ASSANAT Being turned right side up*

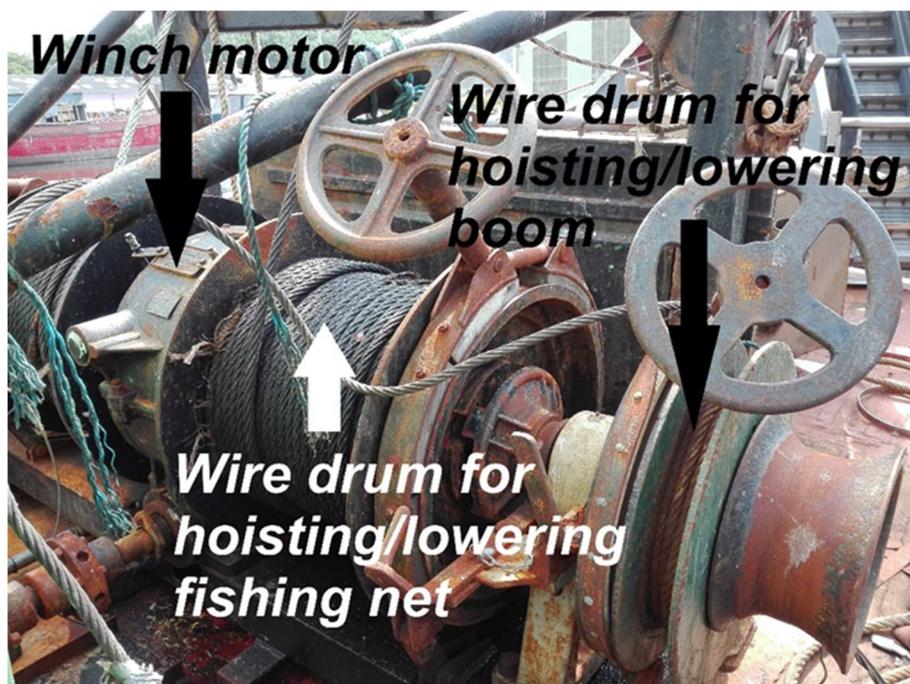
Figure 16 - Wire drum arrangement on board the fv Z582 ASSANAT  
(damaged during salvage)

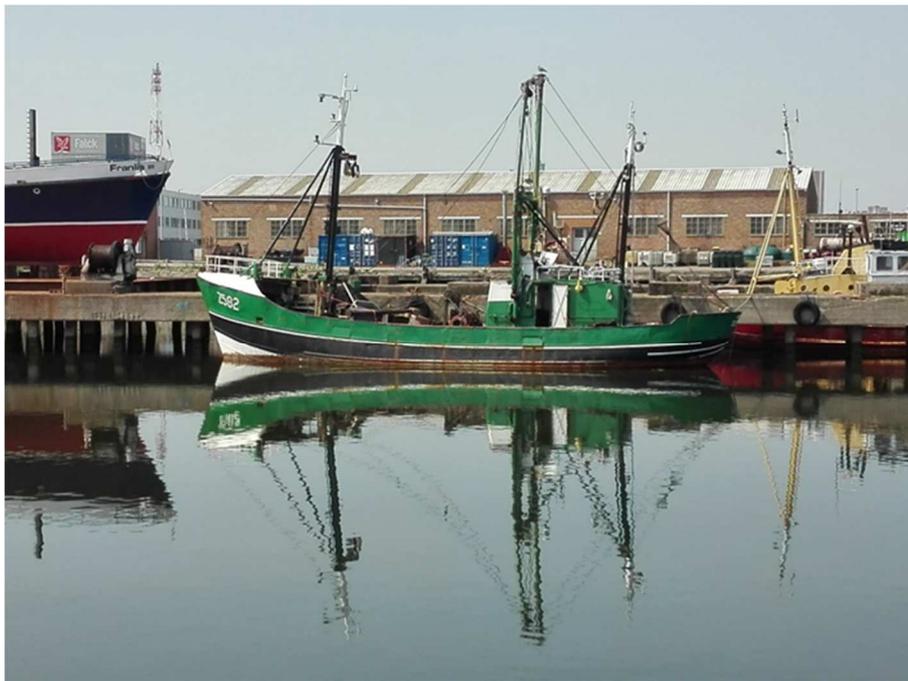
*Figure 27 - fv Z582 ASSANAT afloat in the port of Ostend  
after having being salvaged and turned right side up*

No apparent damage to the hull was noted, however, when the vessel was found floating upside down in the North Sea, the appointed salvage company reportedly had found some weak spots in the hull. Before placing a hot tap, a salvage worker tapped the hull with a hammer in order to find the most suitable place for placing the hot tap, and reportedly the salvage worker punched holes into the hull. The holes were reportedly provisionally plugged in order to prevent the sinking of the fv Z582 ASSANAT after it would have been turned right side up.

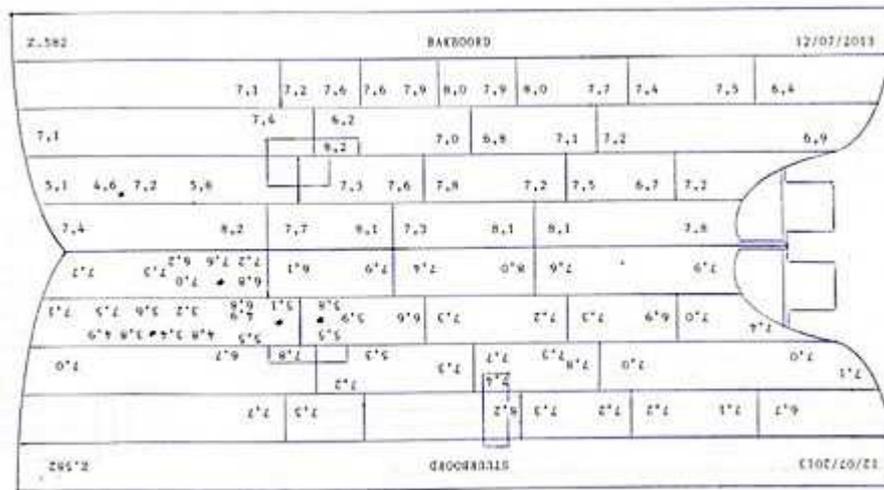
Figure 28 - Thickness measurement of 2013

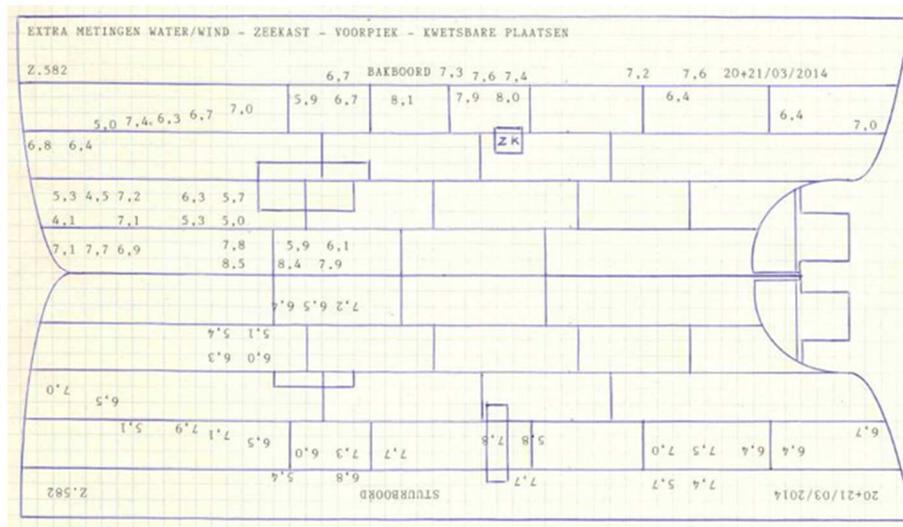
Figure 29 - Additional hull plate thickness measurement of 2014

The Federal Public Service Mobility and Transport, DG Shipping, Belgian Maritime Inspectorate performed an out of the water survey in march of 2014, same time the hull plate thickness was measured and it was noted that the frames, hull plating and stern and stem were not in sound condition as seen in Appendix 5.

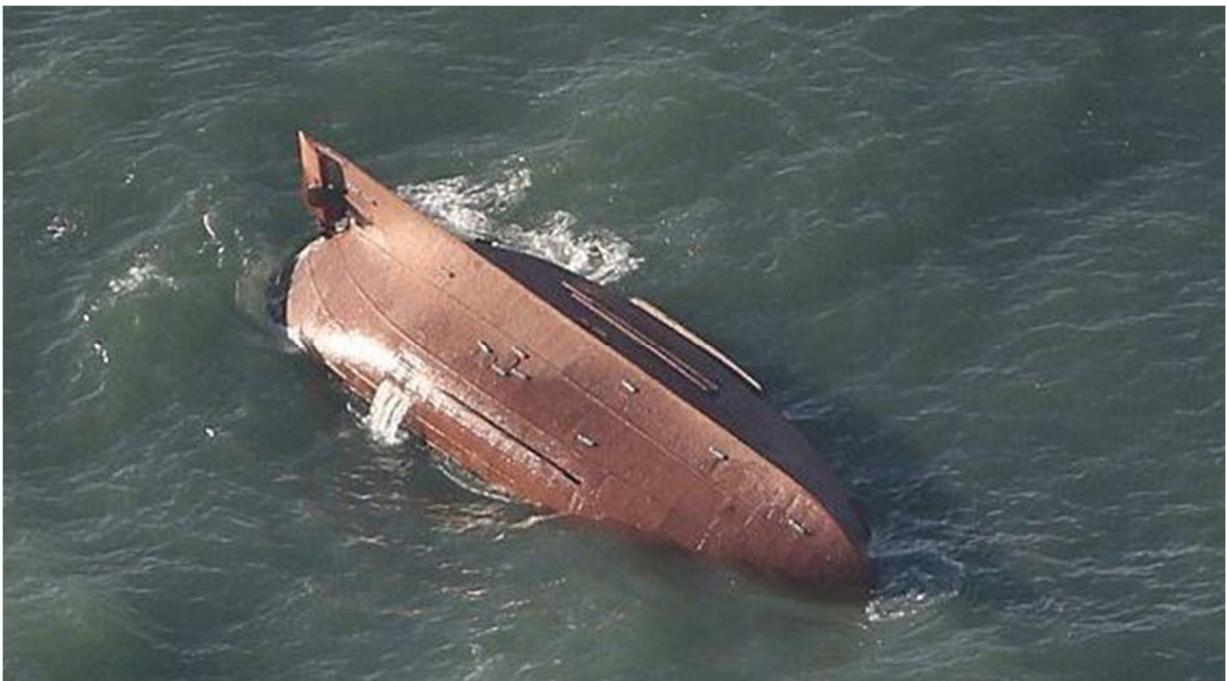
Although there were some areas of the hull that were reason for concern with respect to hull integrity, since the salvage worker tapping the hull, punctured it, damage to the hull and consequential flooding leading to loss of stability of the Z582 ASSANAT could be excluded as cause of the capsizing since *no structural damage to the hull was apparent after the capsizing*.

*Figure 30 - No apparent damage to hull*

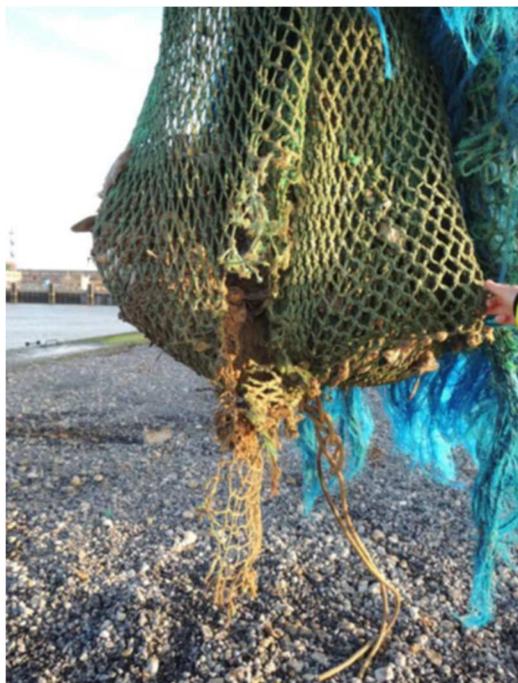
During a survey by a court appointed investigator, it was noted that the starboard fishing net had been damaged.

Reported close observation of the damage learned that the tear did not occur as a result of wear but the tear reportedly appeared to be a cut in the net.

*Figure 31 – Damaged Starboard Fishing Net*

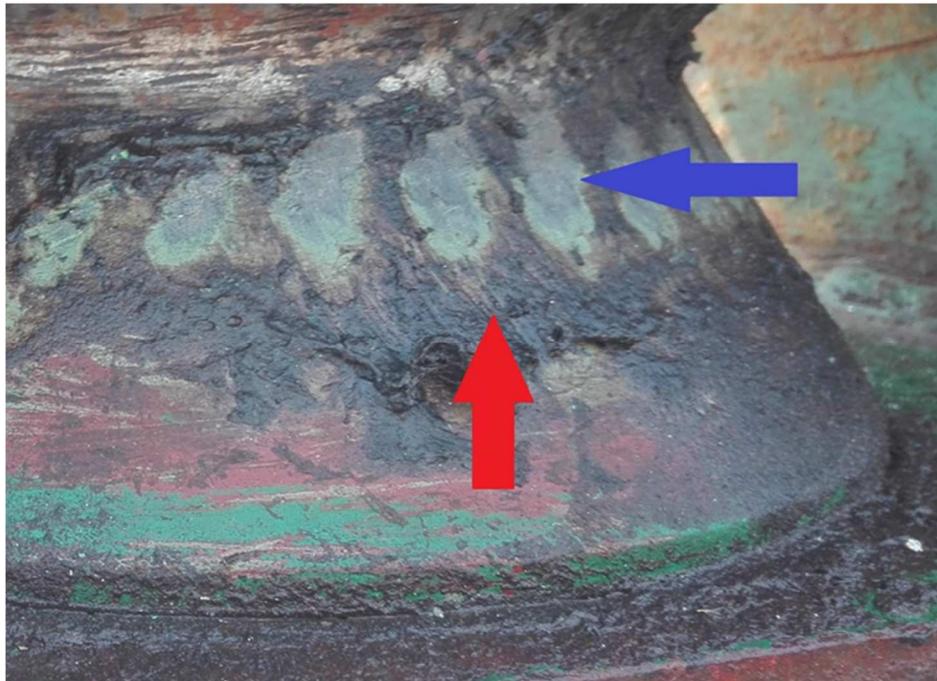
Further, on the portside fairlead on deck of the fv Z582 ASSANAT, several marks left by the warp of the portside fishing net, were found.

*Figure 34 - Scratch marks on fairlead*

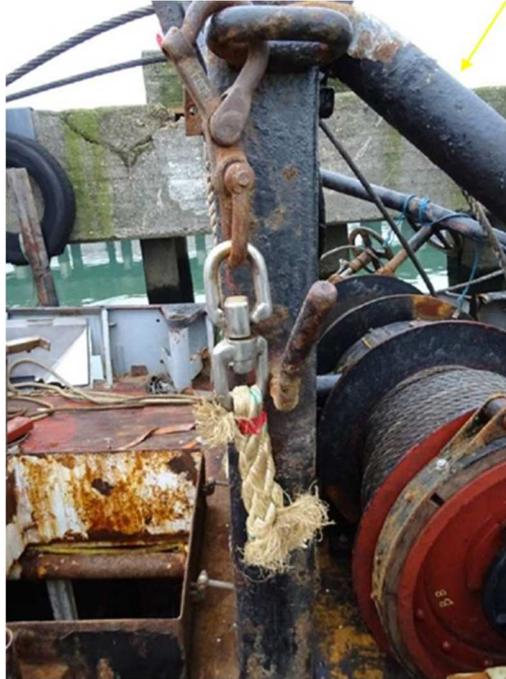
The spring line of the port side net had not been fastened to the cod end of the portside net and was found still in stowed position after the Z582 ASSANAT had been turned right side up. Reportedly salvage workers had cut the port side spring line during salvage operations. The snap hook and part of the port side spring line were left in stowed position.

*Figure 37 - Port side spring line snap hook in stowed position  
picture by Nautical Commission to the Court of Commerce at Antwerp*

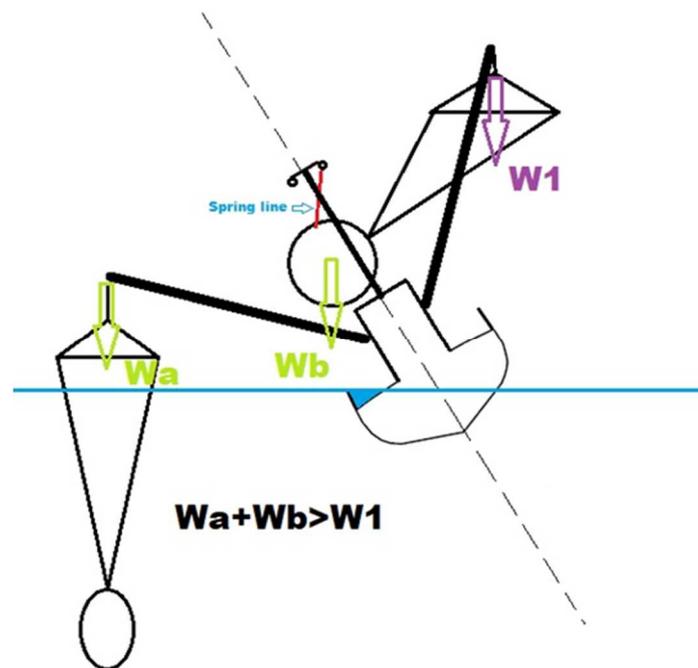
Figure 38 - Situation whereby Z582 ASSANAT capsized

Figure 38 indicates that at the time of capsizing both moments caused by the mass of the fishing gear and the distance from the centre of the vessel were not equal one to the other causing a list to Portside. Simulation, using the vessel's approved stability book, indicated that at the time of the capsizing the aforementioned particular situation caused a theoretical list to portside of approximately 27° whereby water could have entered the vessel.

Once the Z582 ASSANAT was listing to port, consequential water ingress on portside caused the vessel to list even more. At a certain stage, the beam of the starboard swung to portside and smashed into the wheel house thereby again increasing the list and finally topping over the vessel.
