Report ULM A-021/2018

Accident involving a TECNAM
P-92 aircraft, registration
EC-GR6, at the aerodrome of
Benabarre (Huesca) on 22
December 2018

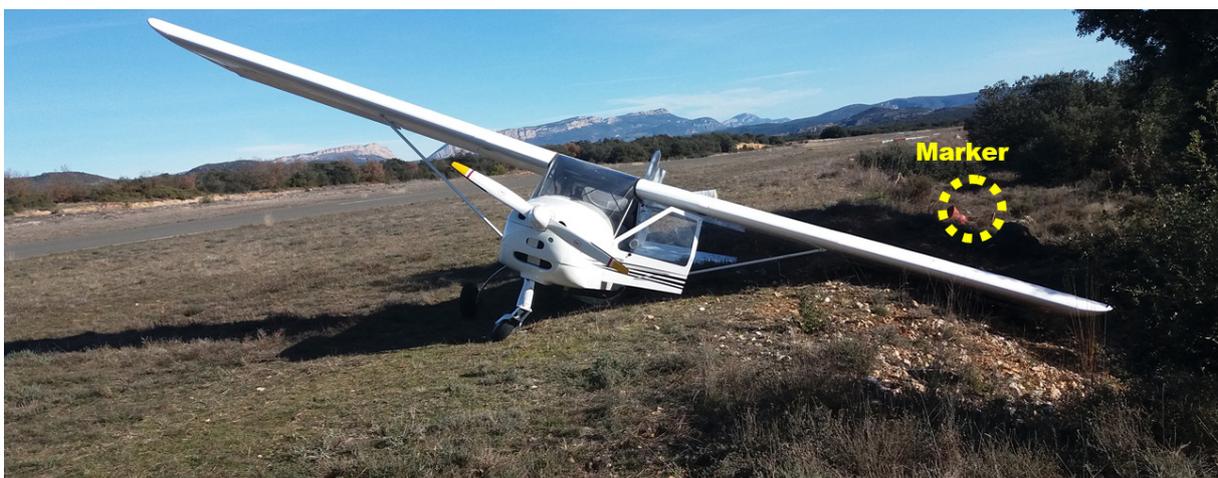
During the landing he veered off the runway to the left and the left main gear leg impacted a marker at the edge of the runway, causing the leg to detach. The airplane stopped 10 m beyond the broken marker, next to an embankment.

The only damage to the aircraft was the fracture of the bolts that fasten the left gear leg.

Figure 1. Final position of the aircraft

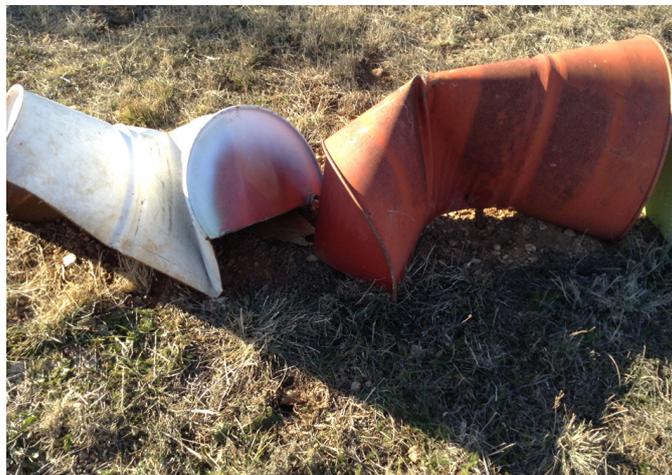
A marker was damaged.

Figure 2. Damaged marker

The aircraft's left wheel impacted the ninth marker on the left side (south of the runway), breaking it, separating the two parts (half barrels) that made it up and deforming it.

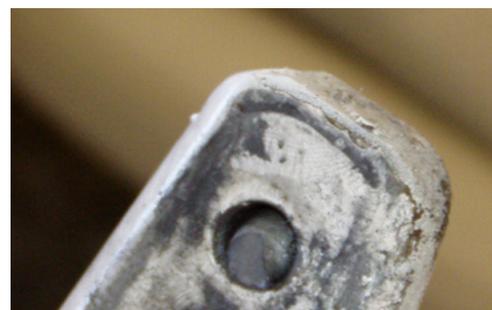
As a result of the impact, the screw that secures the left leg to the underside of the fuselage broke, causing the leg to detach.

Figure 6. Broken screw
