CIAIM-34/2014 REPORT

Loss of control, grounding and complete loss of cargo ship LUNO
on the breakwater of the outer harbour of Bayonne (France) on 5
February 2014

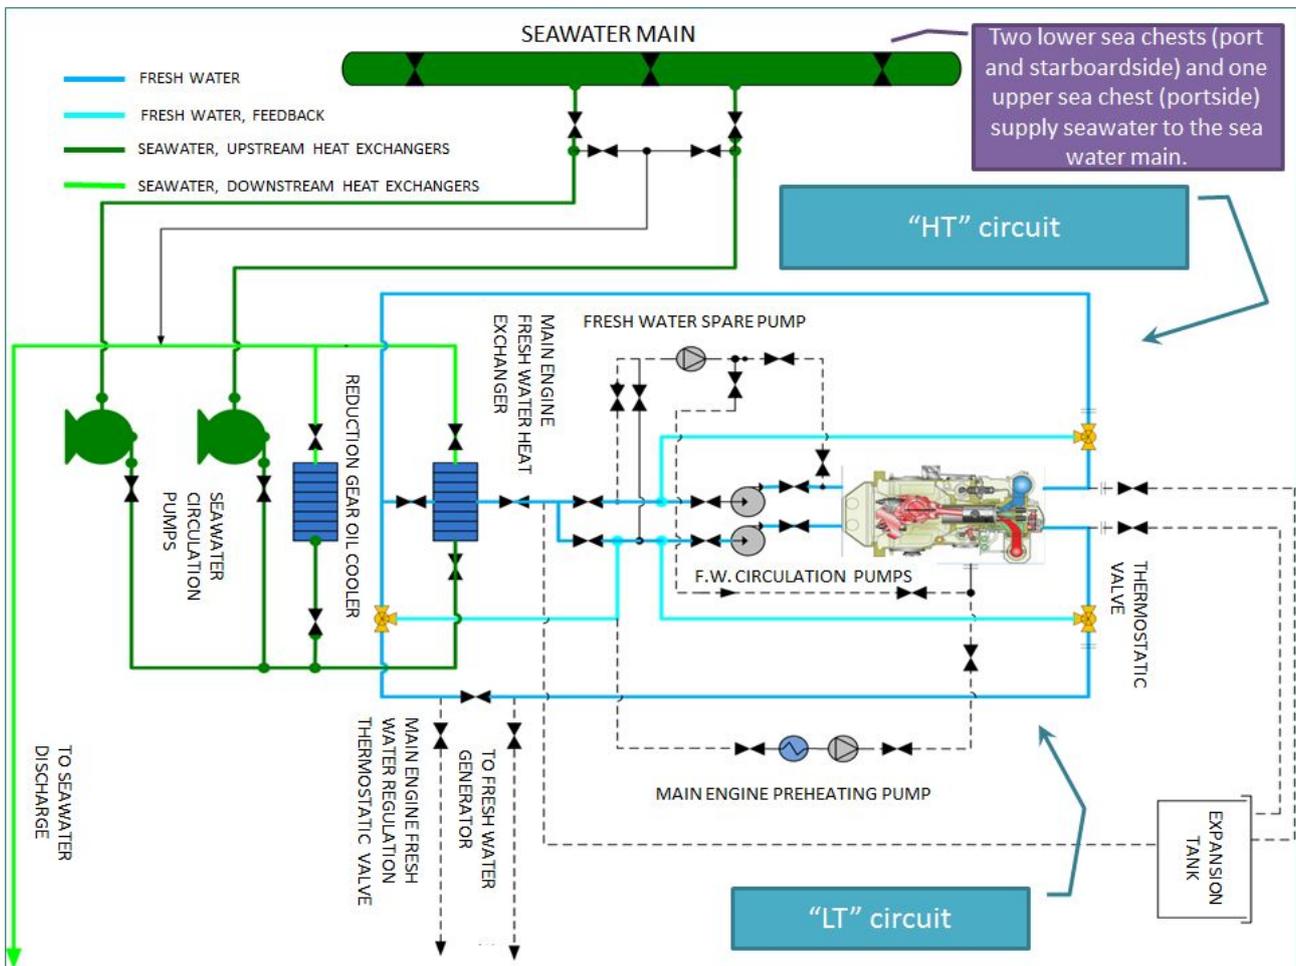
Figure 3. Diagram of LUNO's Propulsion Engine Cooling System.

Air drawn into the seawater main would create air pockets which might have caused seawater pumps to become unprimed, making it difficult to cool down the fresh water propulsion engine cooling system due to lack of flow.

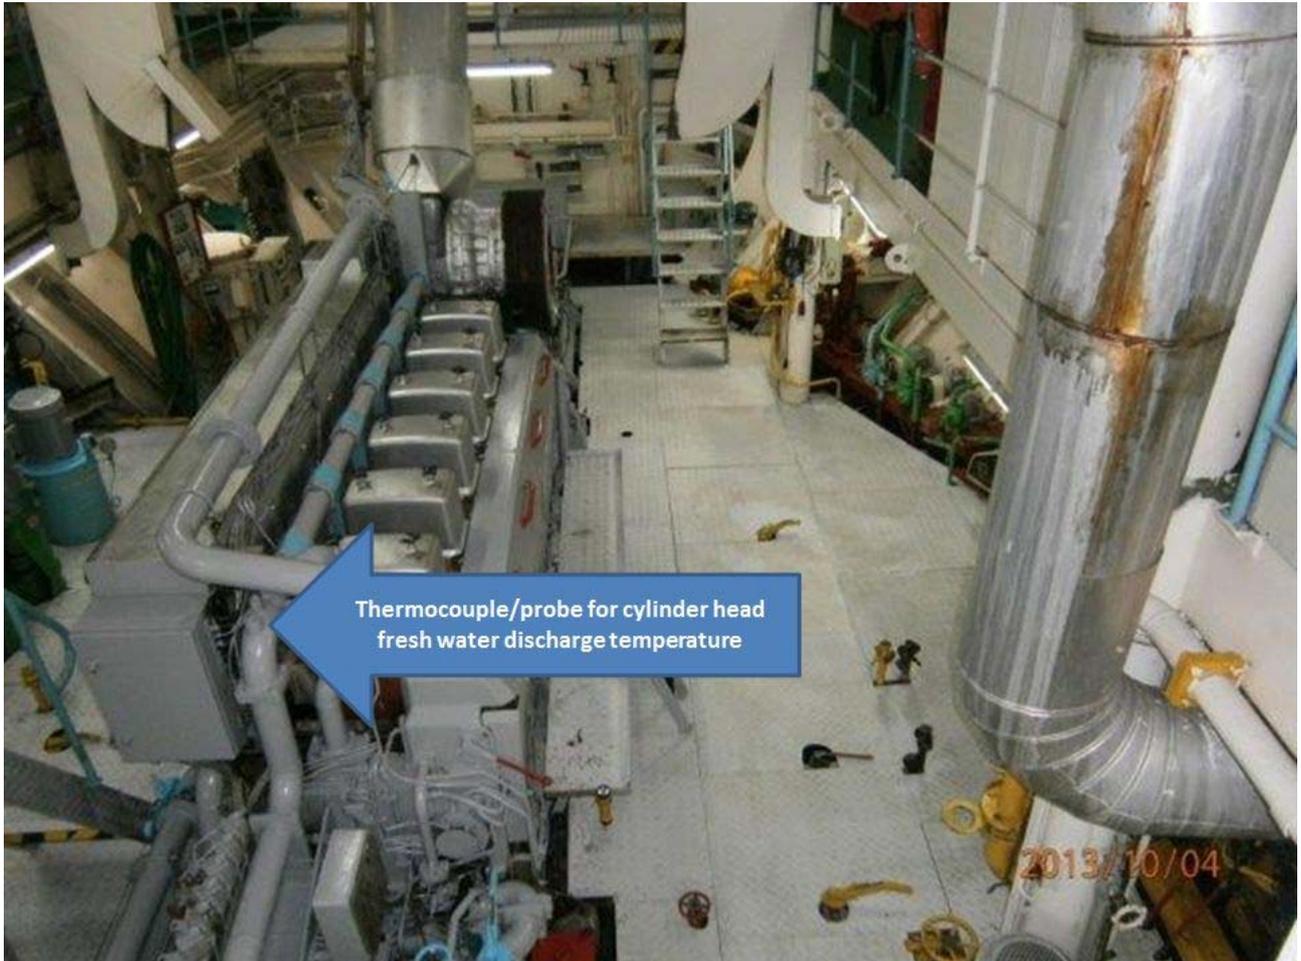
Figure 4. Location of the Sensor whose reading generated a High Temperature Alarm and subsequent Stop of Propulsion Engine Operation.

Thermostats were placed in a special housing, as shown in Figure 4, from where they could be removed to be checked. The correct disconnect switch temperature is usually stamped on the thermostat whenever it has not be reset for a different temperature value.

The parameters defined as alarm and stop limits were 90°C and 95°C respectively, according to WARTSILA (engine manufacturer) drawing "4V50L3102-5/5".

- 3) The HT circuit temperature that hardly usually exceeded 85°C (82 to 86°C²² normal range), reached 90°C (first high temperature alarm) and soon after surpassed 95°C. At this moment, the thermostat caused the main engine to stop. This sequence occurred on the two occasions the HT alarm went off and afterwards, the propulsion engine stopped its operation.

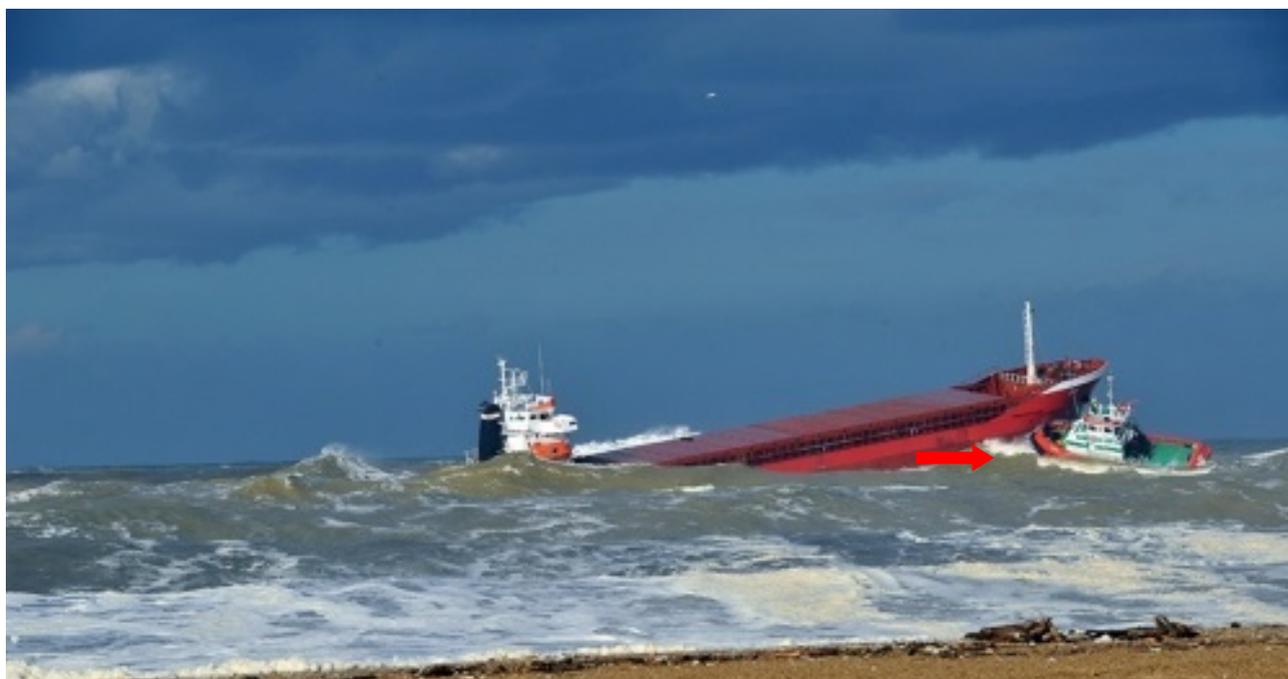
Figure 7. BALEA harbor tug pushing as requested.

M	10:06	BALEA did push on 5 occasions, but each time she was moved away due to the combined effect of the vessel's motion, mouth bar related sea rise and ebb tide stream. On the last occasion, the tugboat tilted up to 70° which almost made her capsize. Swelling dragged her towards the beach. See Figures 7, 8 and 9.
---	-------	--

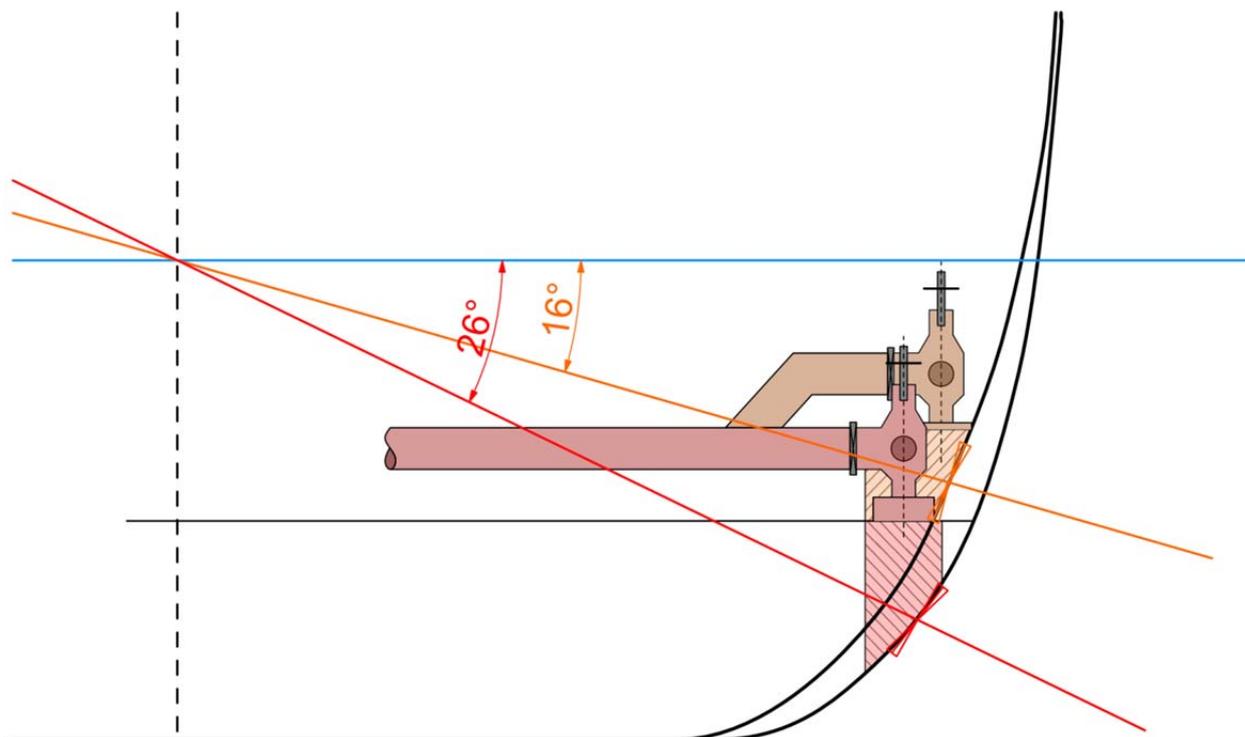
Figure 10. Detail of Upper and Lower LUNO's Sea Chests on Portside. Roll Angles at which Sea Chests were not submerged are indicated.

The CIAIM considers two causes to explain the presence of air inside the seawater main: Insufficient bleeding from the seawater circuit after maintenance at the shipyard or excessive air income into the seawater main through sea chests as a result of ship's motions before the accident. These causes are not mutually exclusive and both may have concurred.

It can be concluded from calculations that the sea state made the sea chests emerge during the whole voyage of LUNO from Pasajes until her arrival nearby Bayonne. Ship's motions were sharper from 08:54 hours when the ship set course abeam sea to south heading towards the pilot station. Then, lower sea chests emerged up to 68 times in one hour, i.e., at least once per minute²⁴.
