Interim Report A-032/2008

Accident involving aircraft
McDonnell Douglas DC-9-82
(MD-82), registration EC-HFP,
operated by Spanair, at
Madrid-Barajas airport
on 20 August 2008

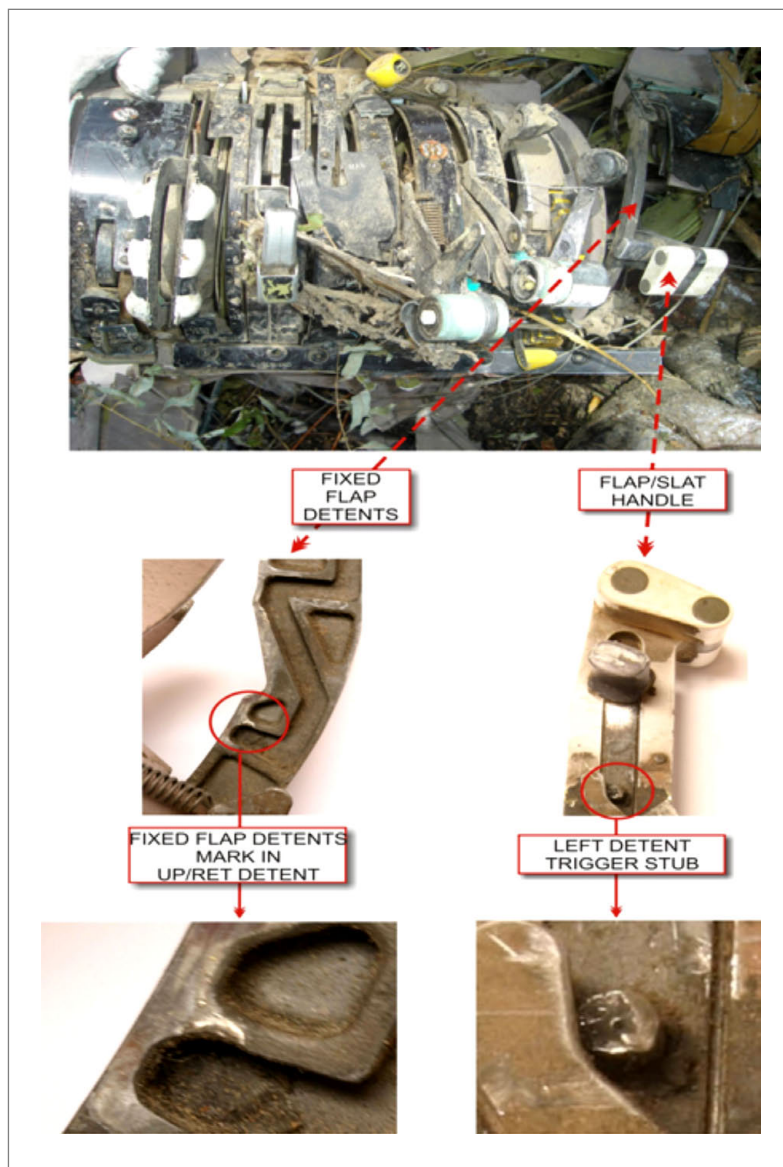
Figure 5. Detailed views of the flap/slat lever

The lever was recovered from the remains of the central pedestal, which showed considerable impact damage, especially to its right side, which was partially destroyed. The wheel used to adjust the notch on the right track of the flap lever was missing, as was its indicating window.

The flap/slat lever was still in its position, attached to the same pedestal axis as the adjustable track and, like the track, could be freely moved about the axis. The left stub, which is normally lodged in the fixed sliding track, had come out of the track and was appreciably twisted. The track was in place. A conspicuous mark was noted in the slot corresponding to the UP/RET position.

The track showed damage at the bottom of the housing corresponding to the mark for the UP/RET position. This damage consisted basically of a deformation of the material situated in the area adjacent to the bottom of the housing, where there was an elliptically shaped imprint on the wall of the track and drag marks on the surface of the deformed material. There was also indented material at the exit of the housing along the outer surface of the track.

On the inside of the track situated in front of the damaged wall noted in the paragraph above there was an elliptically shaped mark halfway along the wall.

There was considerable damage to the external flat surface and to the cylindrical surface of the fixed-position indicator stub.

After both components were studied, it was determined that the damage evident on the track probably resulted from the hard impact between the fixed-position indicator stub on the slats/flaps lever and the track and the subsequent relative movement between the pin and the track.

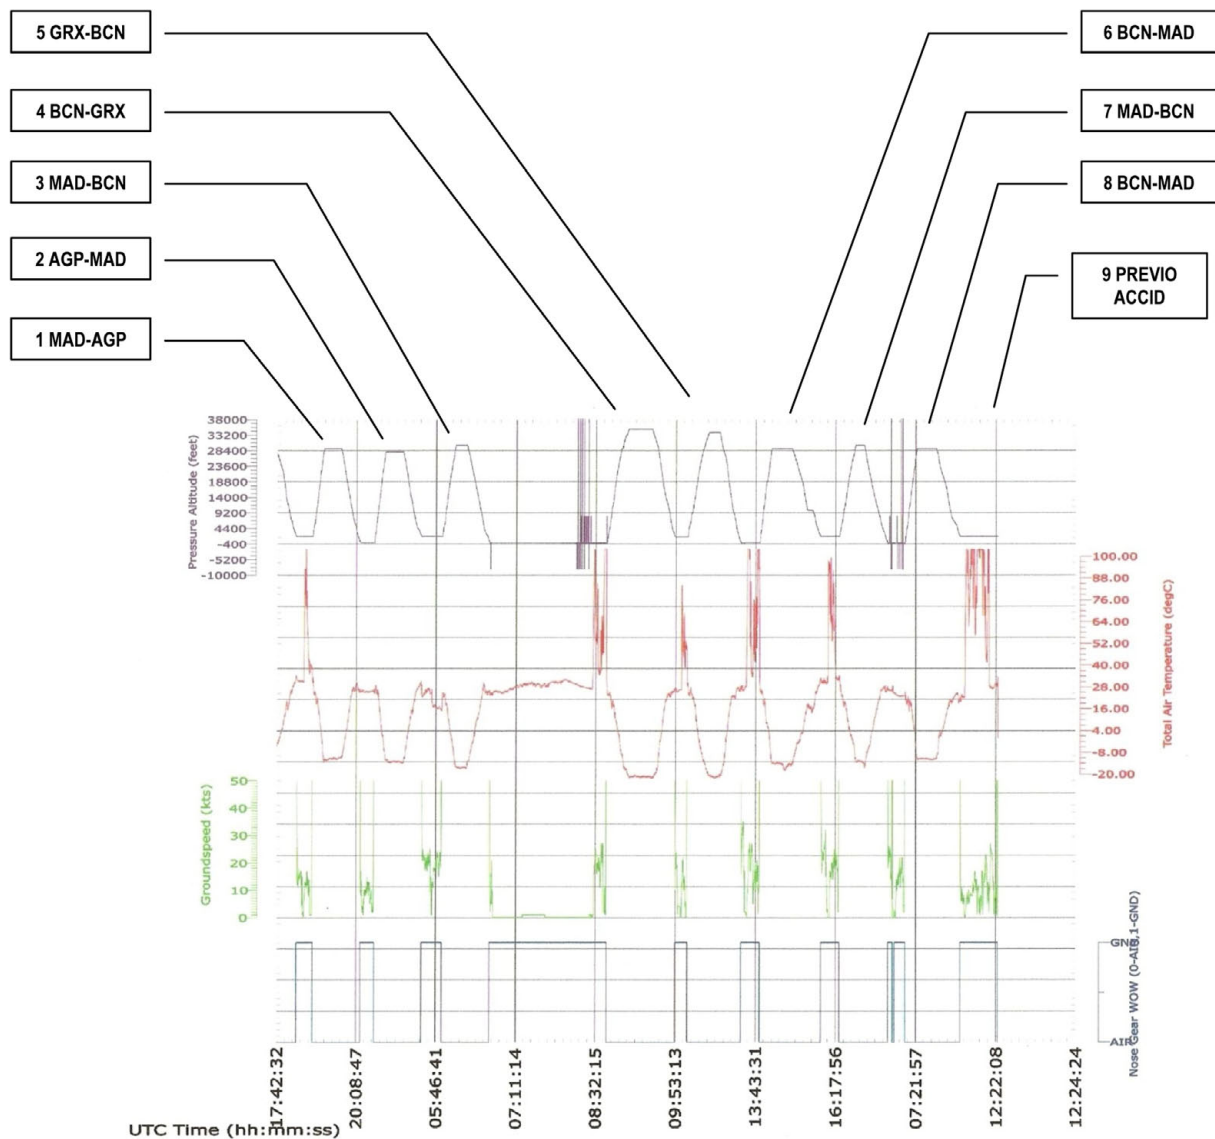
Figure 6. DFDR records of high temperature in RAT probe. EC-HFP

A study of the DFDR recordings reveals the following information:

- The total sequence from the first high-temperature reading recorded on the DFDR includes nine flights. It spans three days with two prolonged intermediate stays on the nights of 18-19 and 19-20.

- The RAT probe was heated on the ground on six occasions. The average event duration was 14:50 minutes (maximum 33 minutes, minimum 5 minutes).
- The recorded high RAT probe temperature events, on a day-by-day basis, took place on the 6th flight of the first day, the 2nd, 3rd, 4th and 5th flights of the second day, and the 2nd flight of the third day, immediately prior to the accident.
- On none of the three days was the high RAT probe temperature recorded on the day's first flight.
- An inverse relationship between airplane speed and the temperature indicated by the RAT is revealed, possibly due to the probe being cooled by the ram air produced by the airplane's motion while taxiing, leading to a reduction in its temperature.
- After takeoff, the temperature readings indicated normal values, possibly due to the cooling of the probe by the ram air.

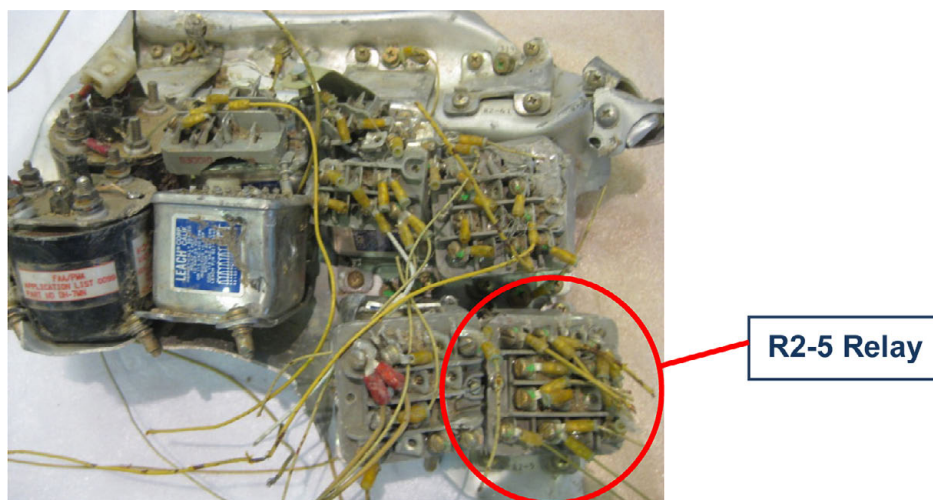
Figure 7. Recovered relay assembly which houses R2-5

It was recovered from the aircraft wreckage, joined to a part of its support plate on which there were a total of eight relays (see Figure 7). There was impact damage on the contacts located on the top side, on the cover, on one of its sides and on the base. In addition, the cover was partially lifted and there were fragments missing from its corners.

The R2-5 relay was inspected to determine if it could have failed. It was subjected to a visual inspection, a boroscopic inspection and a radiographic test. It was also subjected to continuity and functional tests. For the time being it has not been possible to disassemble the relay completely so as to study its internal components in detail.

Copious residue was noted on the outside of the cover, with a large amount of sand between all the contacts. Once the residue was cleaned, it was noted that two contacts

had deformed to the point of touching at the part furthest from the cover. A boroscope was used to examine the inside of the cover by means of the holes left by the missing pieces. Residue deposits were also seen on the inside as far as the boroscope could reach. There were no broken connections between the contacts and their respective entry points into the sealed part of the relay.

The results do not allow for a determination to be made of any possible link between the defects found with the relay and the abnormal operation of the RAT probe heating and the TOWS over the course of the accident. What is more, it cannot be concluded from the tests conducted whether the defective behavior exhibited by the relay was a consequence of the damage suffered in the accident.
